Install 331 lf of 8" Cured-in-Place Liner
from MH 5748-091 to MH 5748-090

SITE 11

Video Inspection Master Report

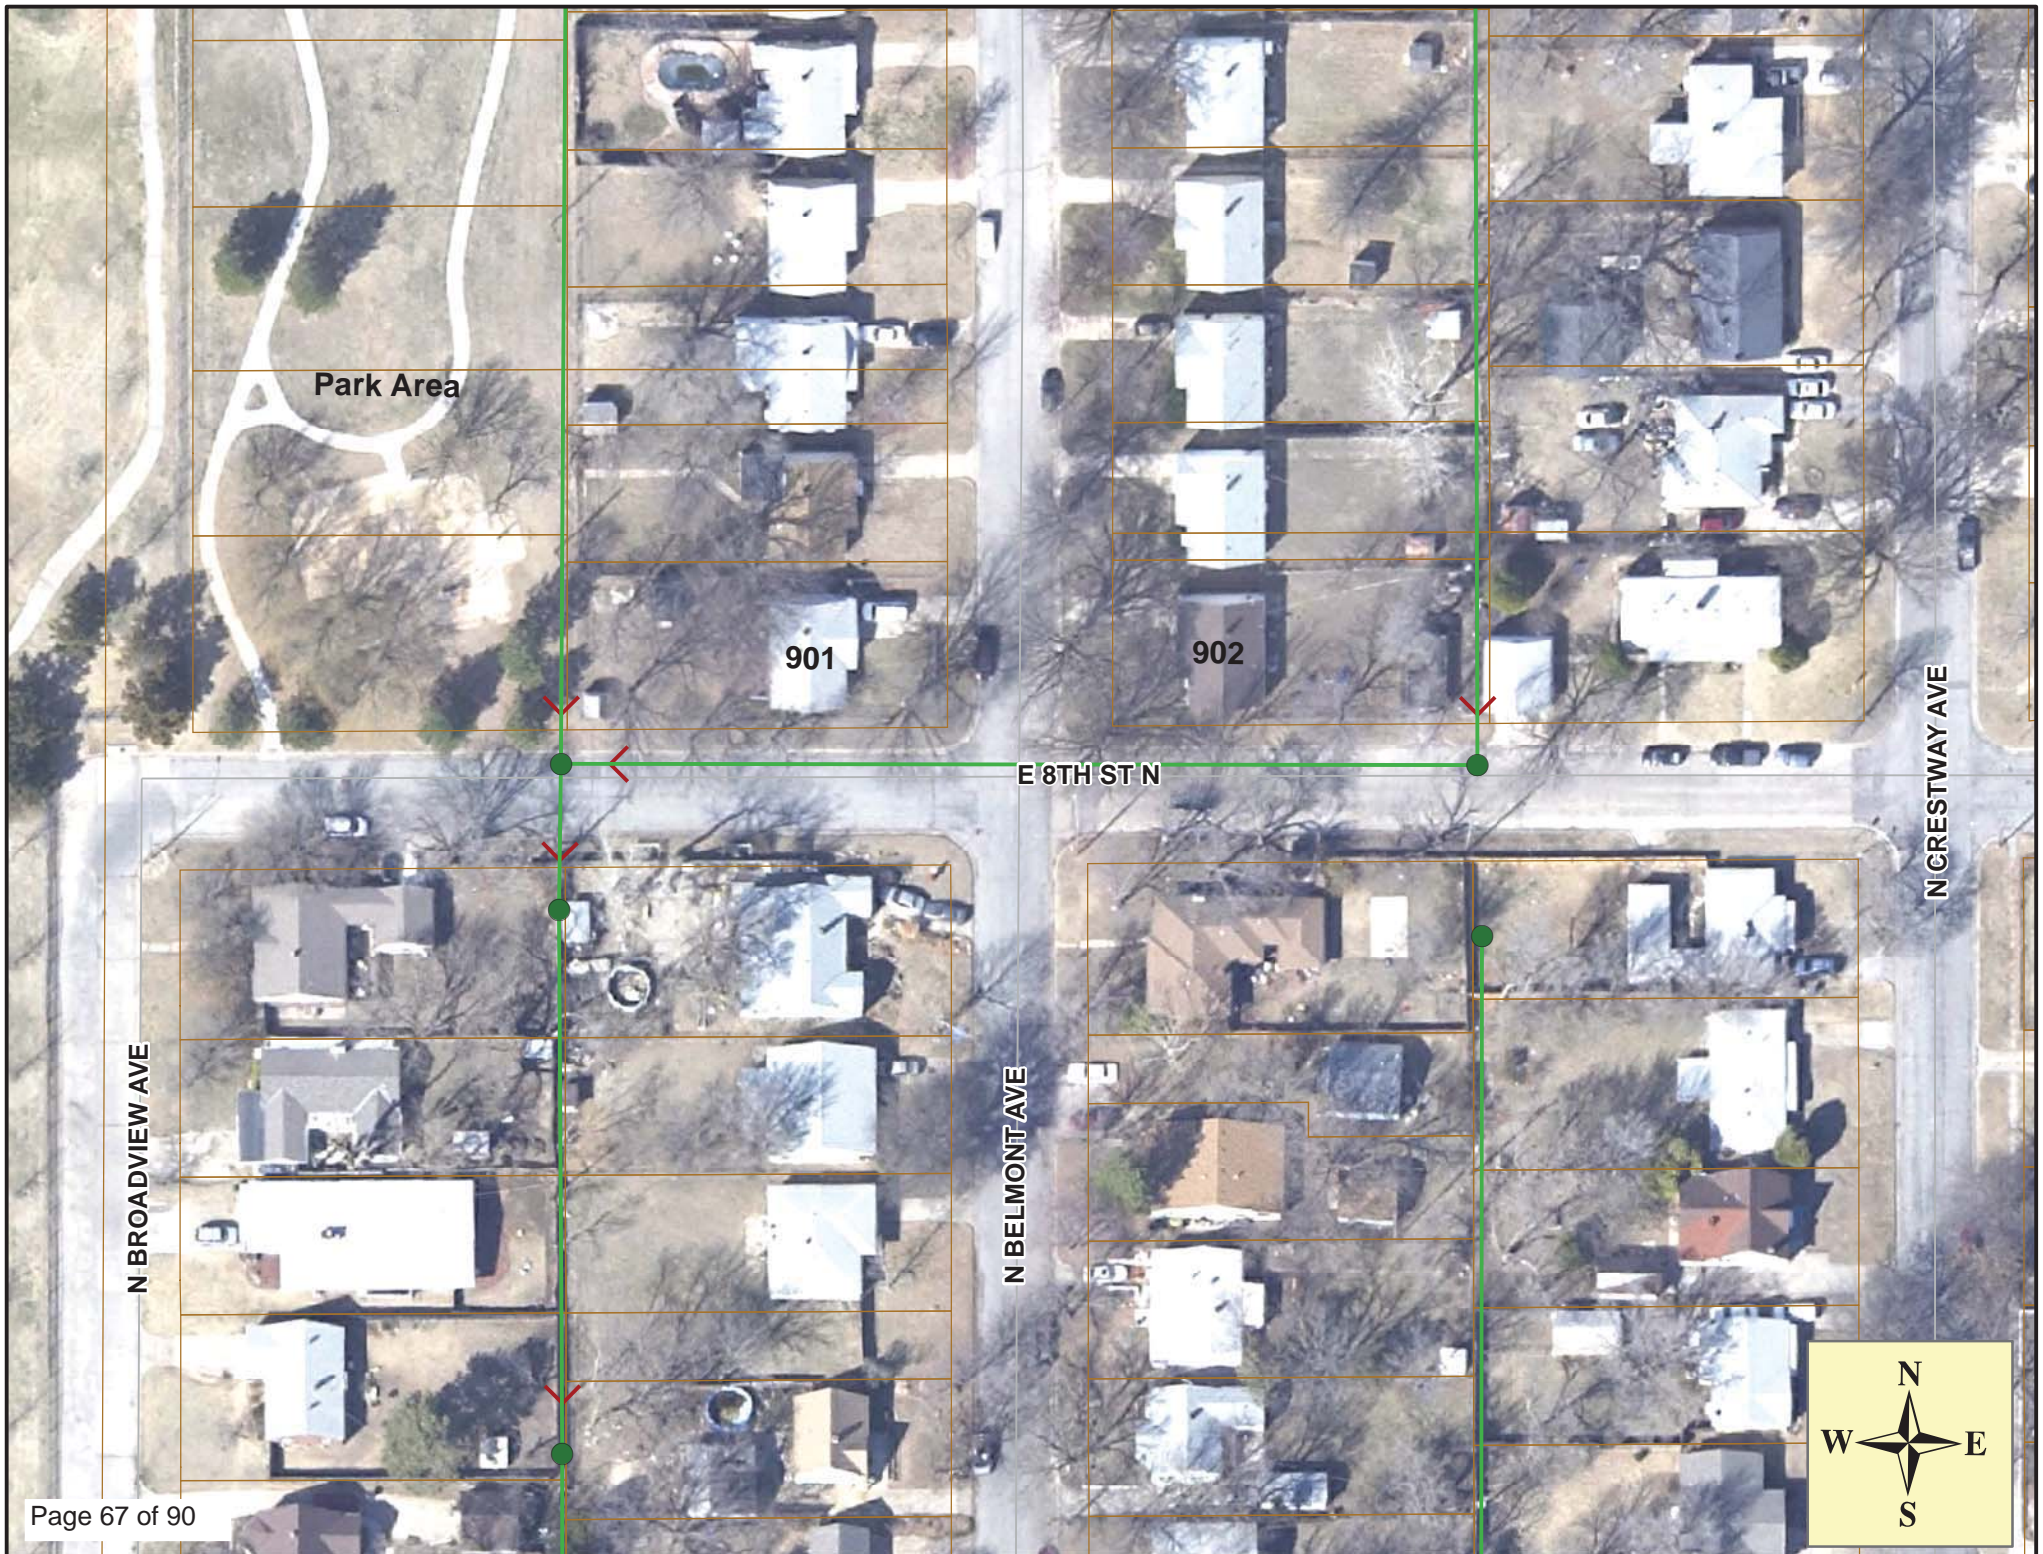
MH 5748-090
Est. pipe depth = 6.0 ft
Approx MH depth = 10.5

MH 5748-091
Approx depth = 13.0 ft

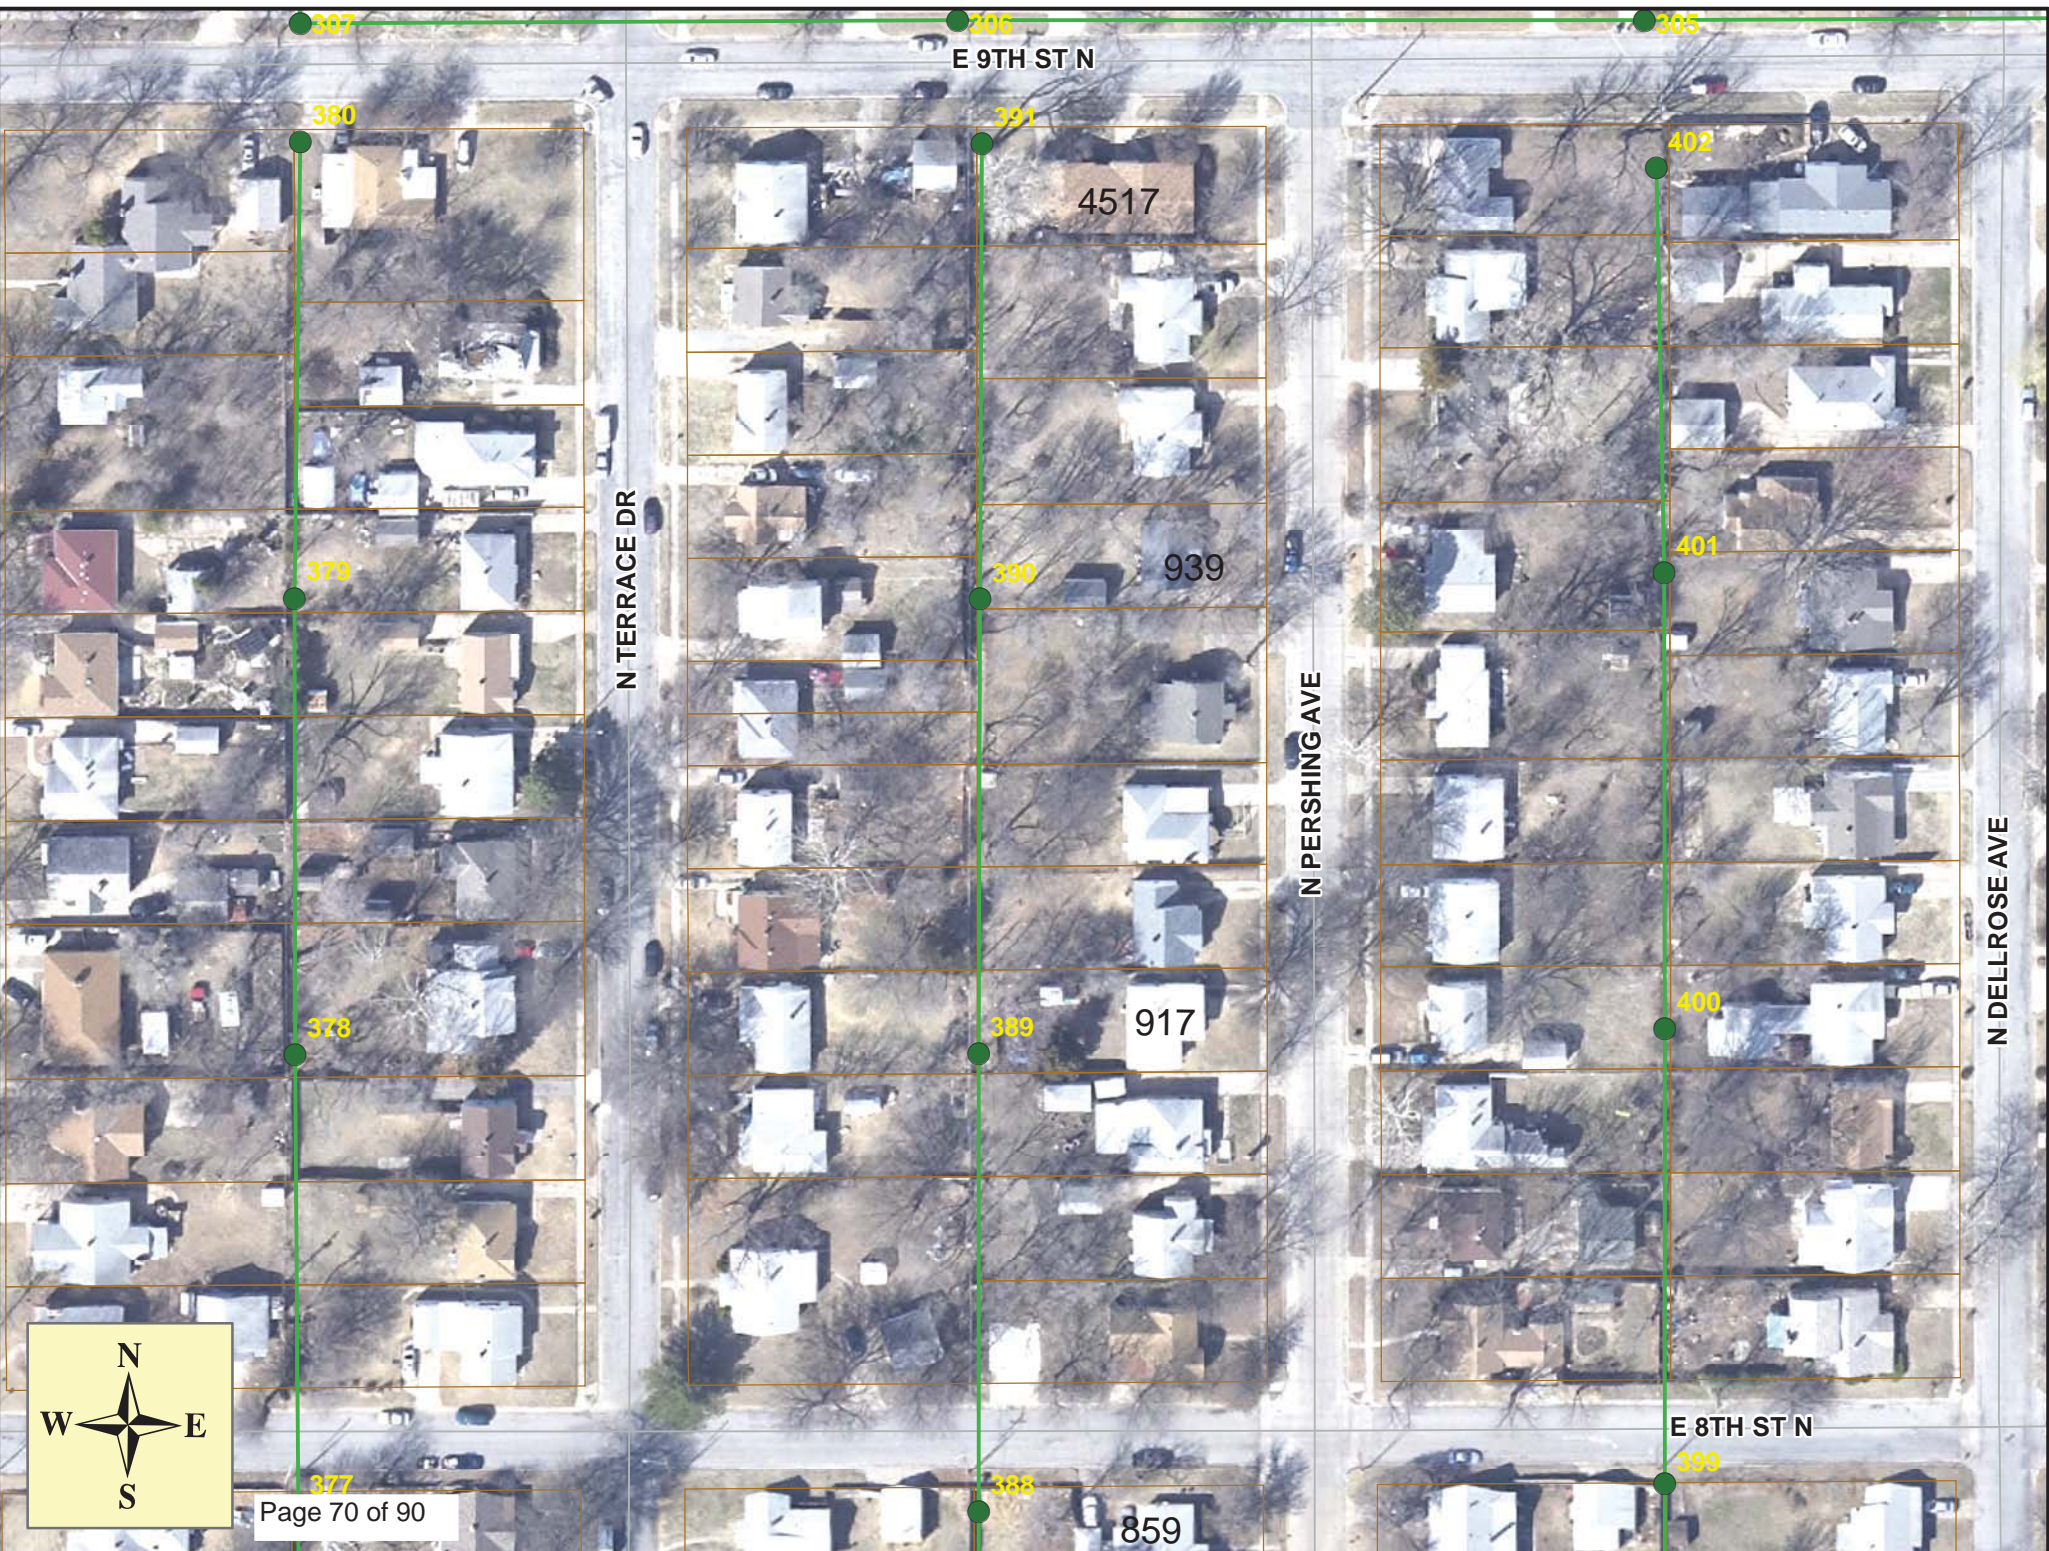
Lots of roots and small cracks on the north end of this line.

The downstream 15.5 feet of pipe was replaced by Sewer Maintenance, April 2013. Including the replacement of the two tap connections within that repair. -LML
