Install 770 lf of 8" Cured-in-Place Liner from MH 5646-117 to MH 5646-112

SITE 5

Video Inspection Master Report

SITE 6

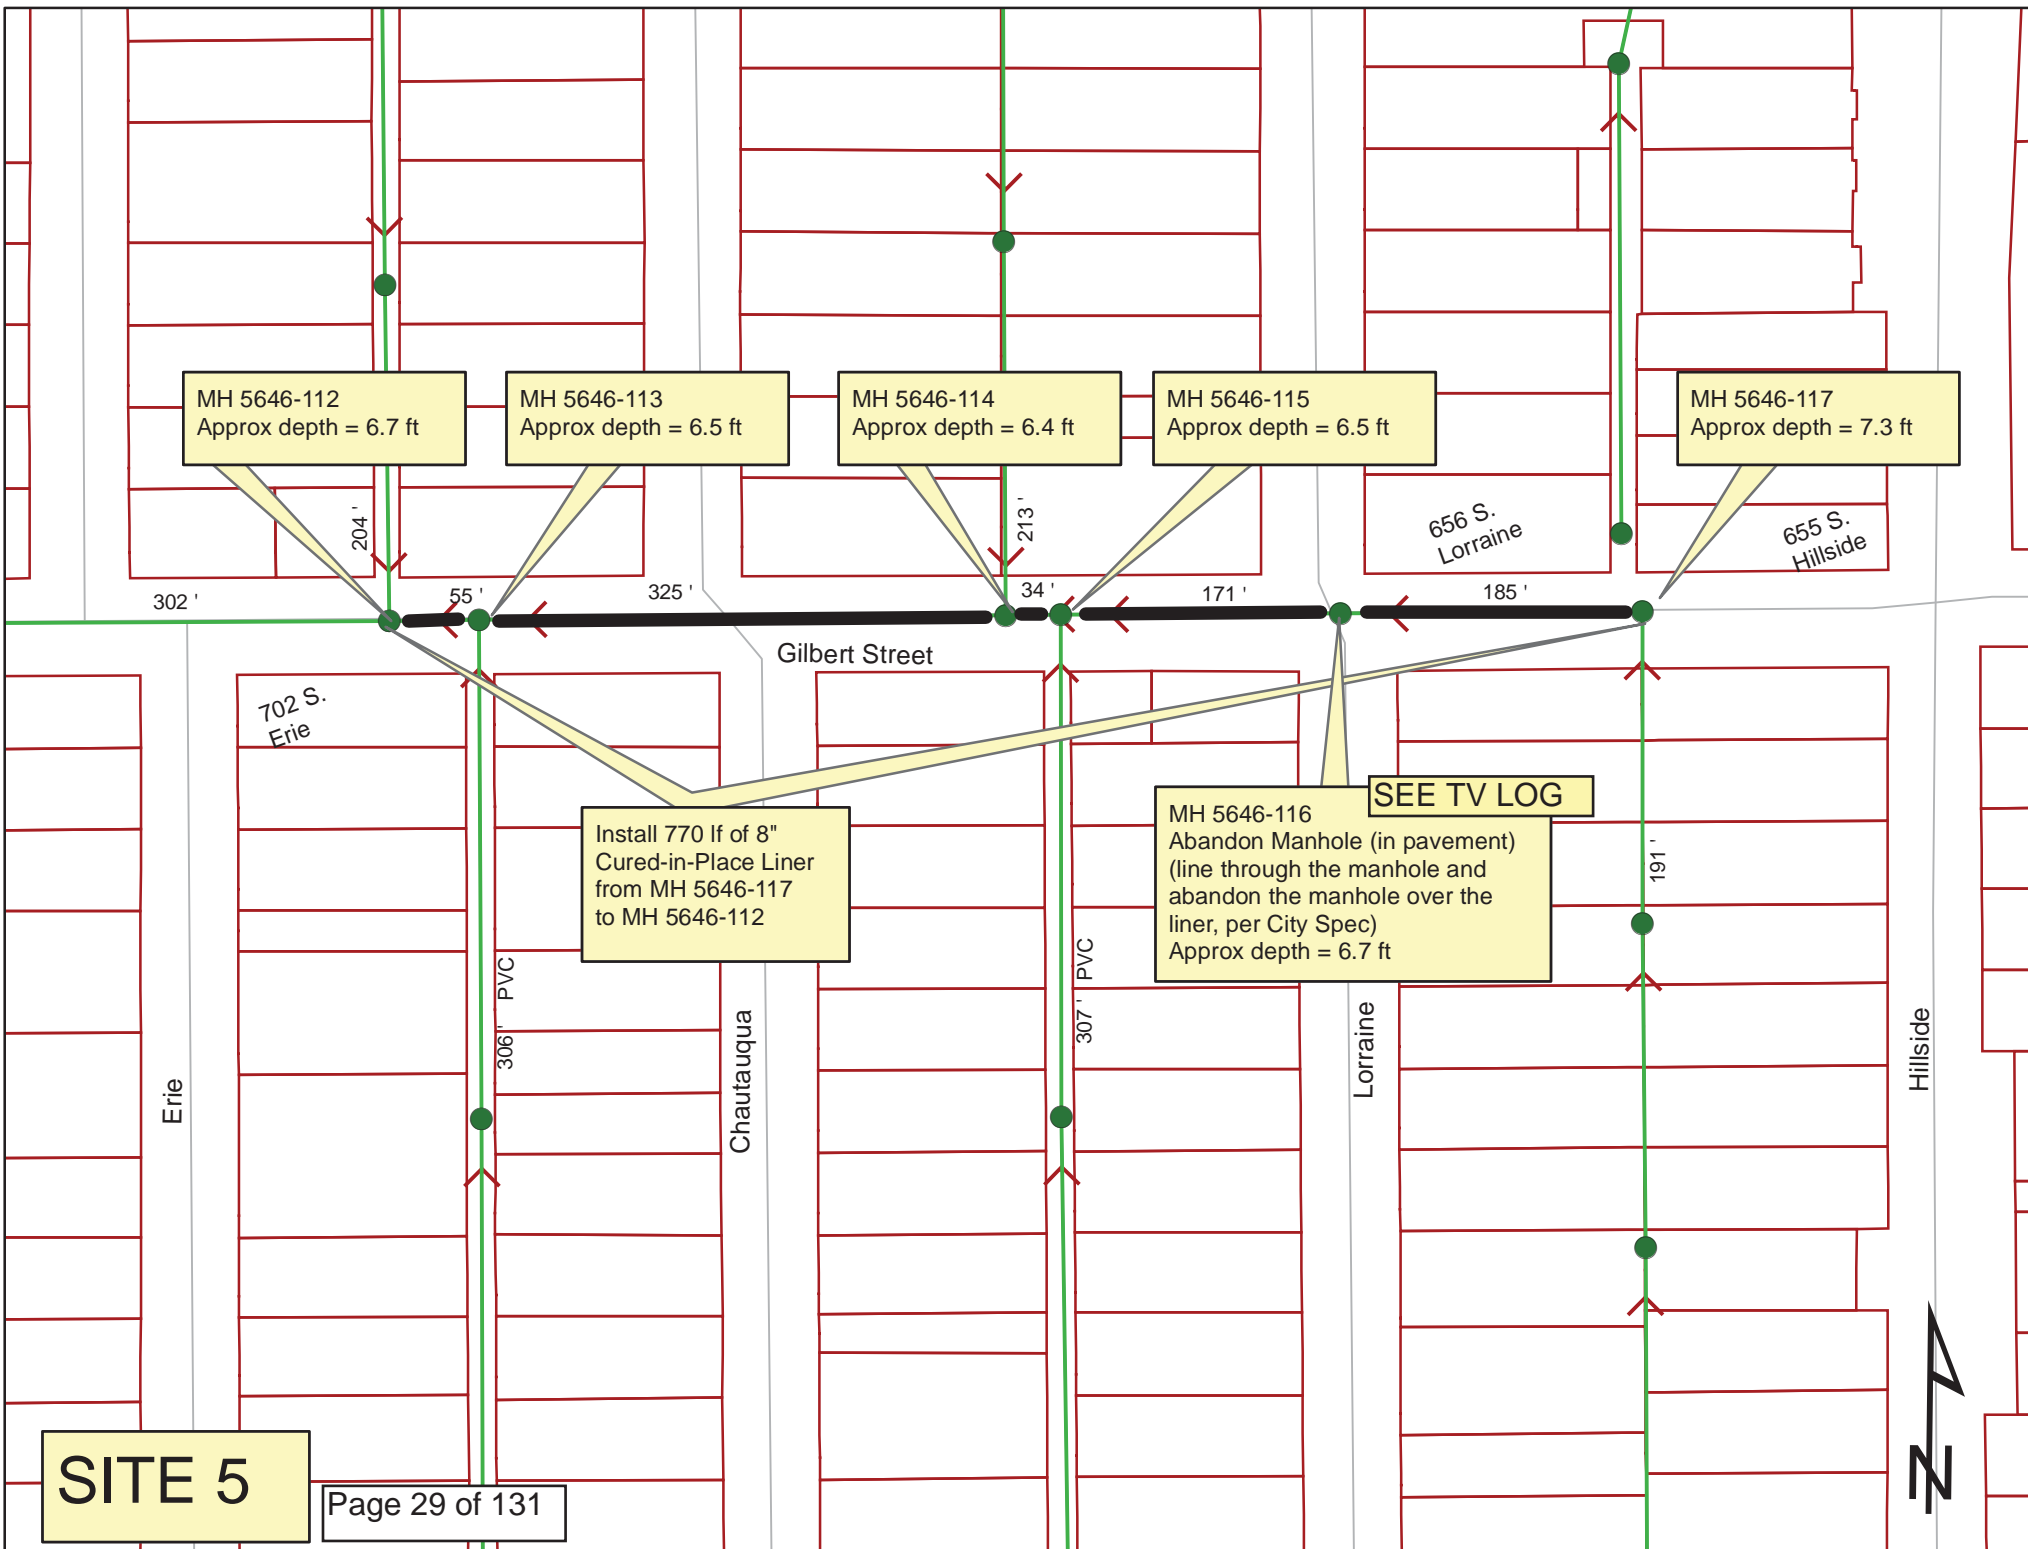
MH 5646-112
Approx depth = 6.7 ft

MH 5646-113
Approx depth = 6.5 ft

MH 5646-114
Approx depth = 6.4 ft

MH 5646-115
Approx depth = 6.5 ft

MH 5646-117
Approx depth = 7.3 ft

MH 5646-116
Abandon Manhole (in pavement) (line through the manhole and abandon the manhole over the liner, per City Spec)
Approx depth = 6.7 ft

MANHOLE 5646-116: Abandon Manhole means to remove the top 4 feet of the manhole and fill the manhole with sand (flushed & vibrated). Pavement removal and replacement cost shall be subsidiary. Contractor is responsible to ensure that the liner in the bottom of the manhole is secure and stable for the load of the abandonment. -LML

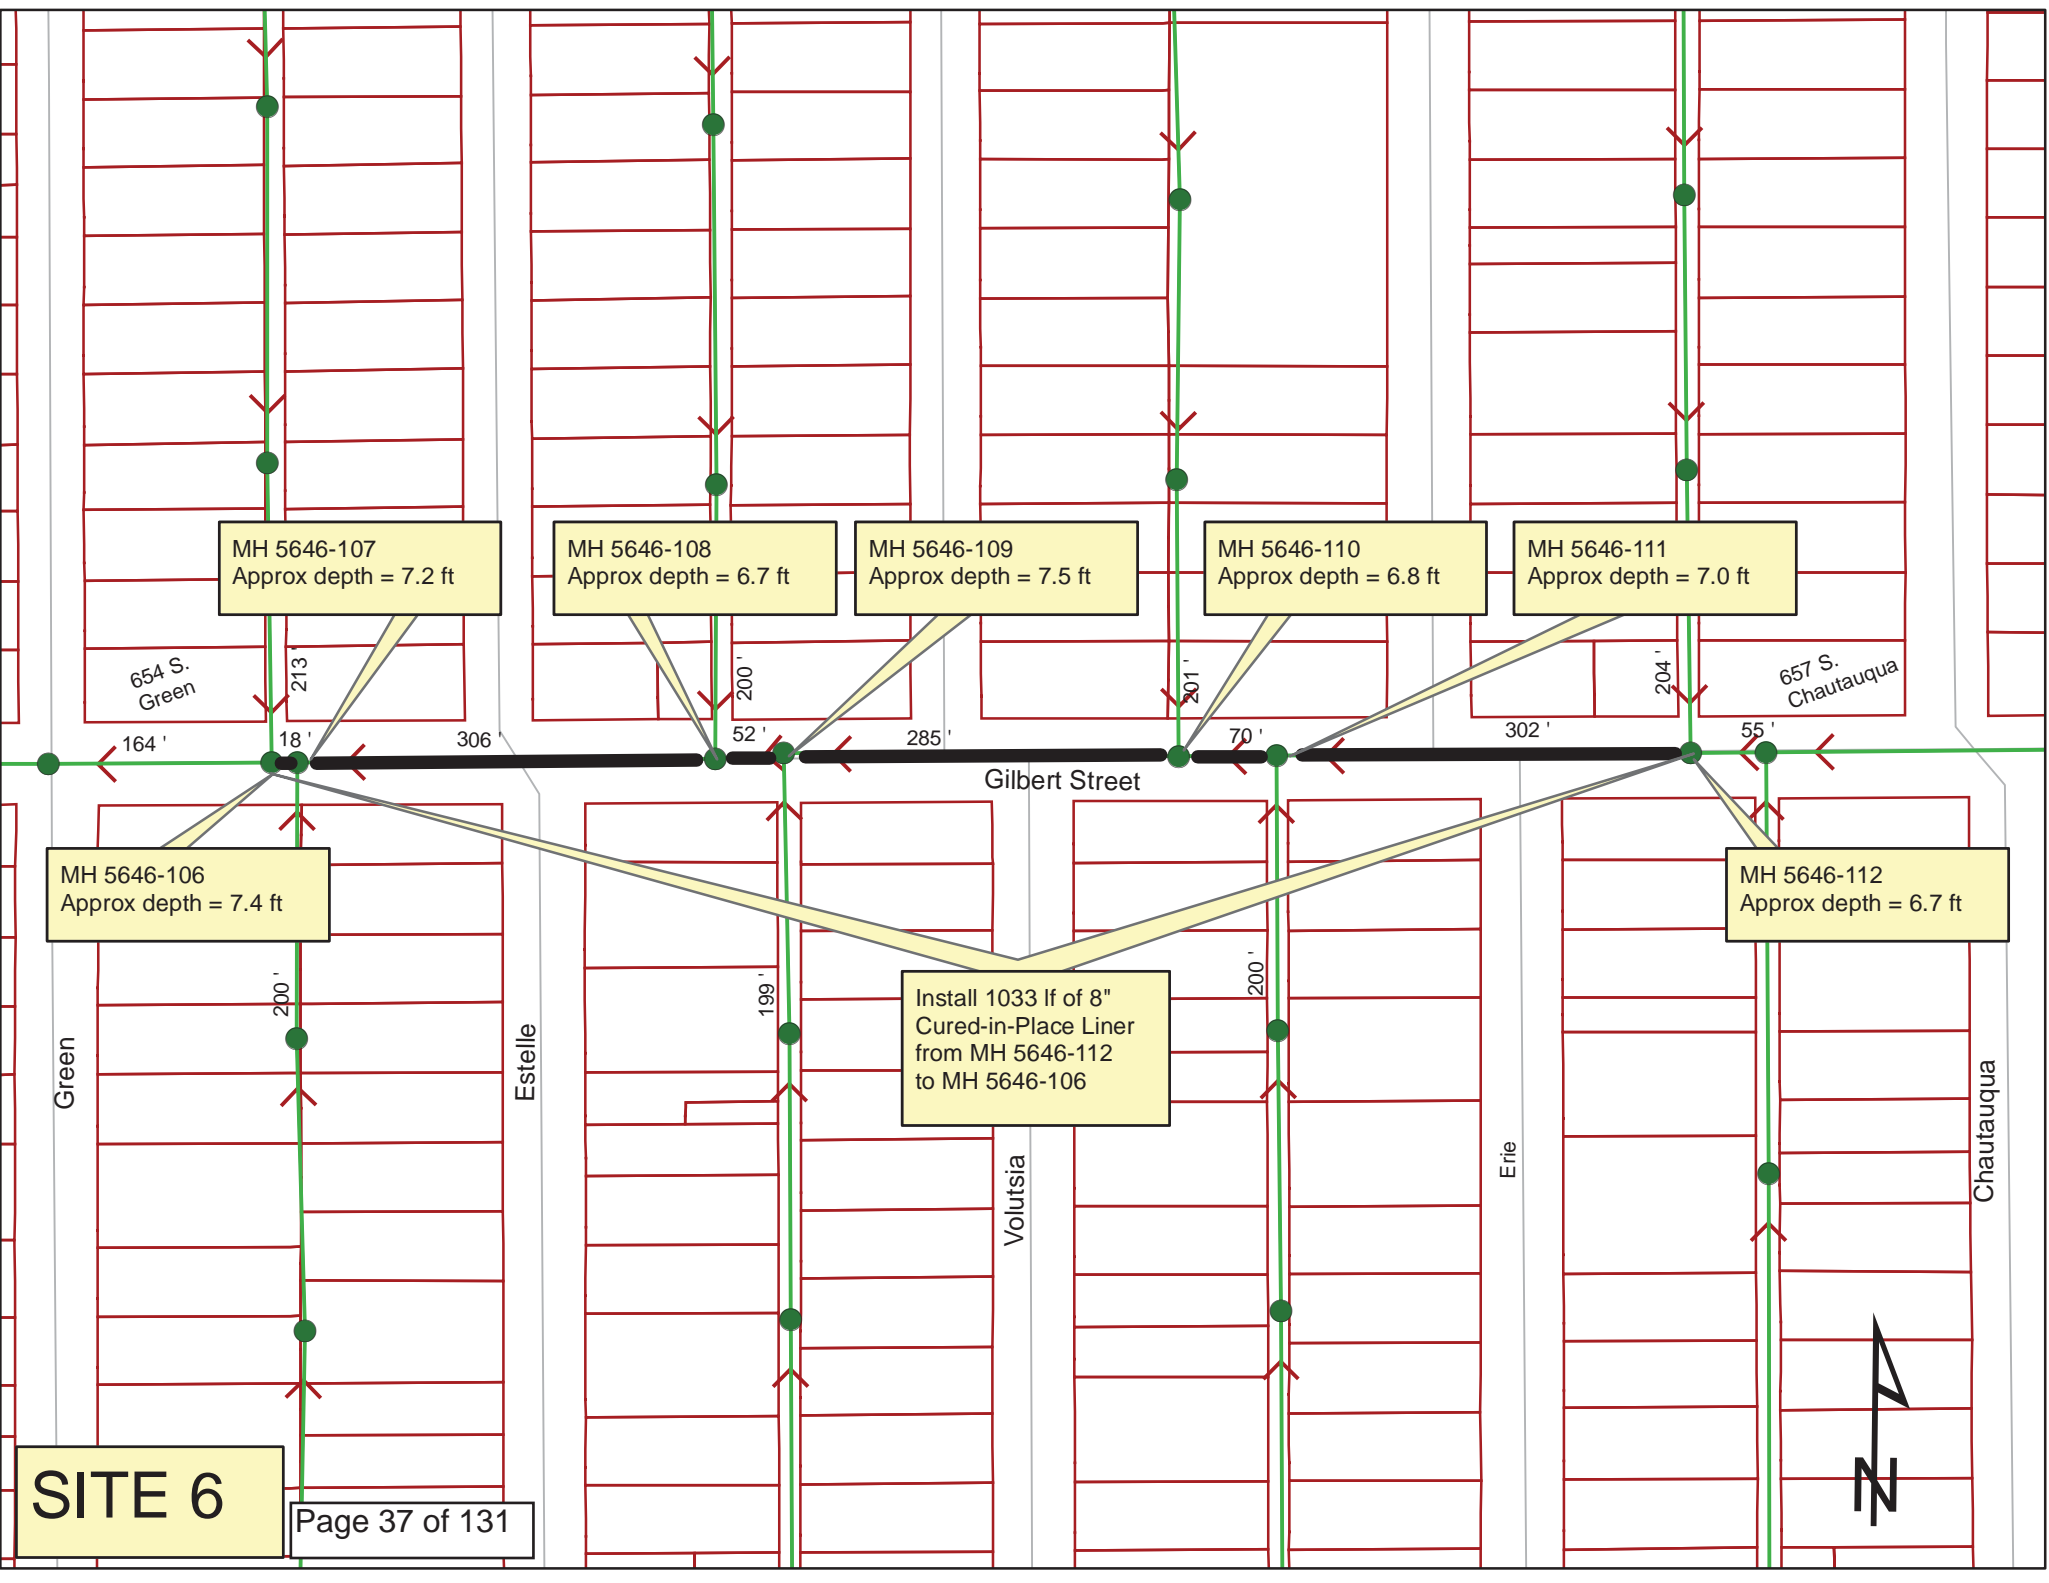
MH 5646-107
Approx depth = 7.2 ft

MH 5646-108
Approx depth = 6.7 ft

MH 5646-109
Approx depth = 7.5 ft

MH 5646-110
Approx depth = 6.8 ft

MH 5646-111
Approx depth = 7.0 ft

MH 5646-106
Approx depth = 7.4 ft

MH 5646-112
Approx depth = 6.7 ft

Comments: LINE IN POOR CONDITION DUE TO CRACKS AND BROKEN PIPE RECOMMEND #4 LINER

Install 1033 lf of 8"
Cured-in-Place Liner
from MH 5646-112
to MH 5646-106

No taps / Line through small sags
