Install 615 lf of 8" Cured-in-Place Liner from MH 5646-135 to MH 5646-111

SITE 7

Video Inspection Master Report

SITE 8

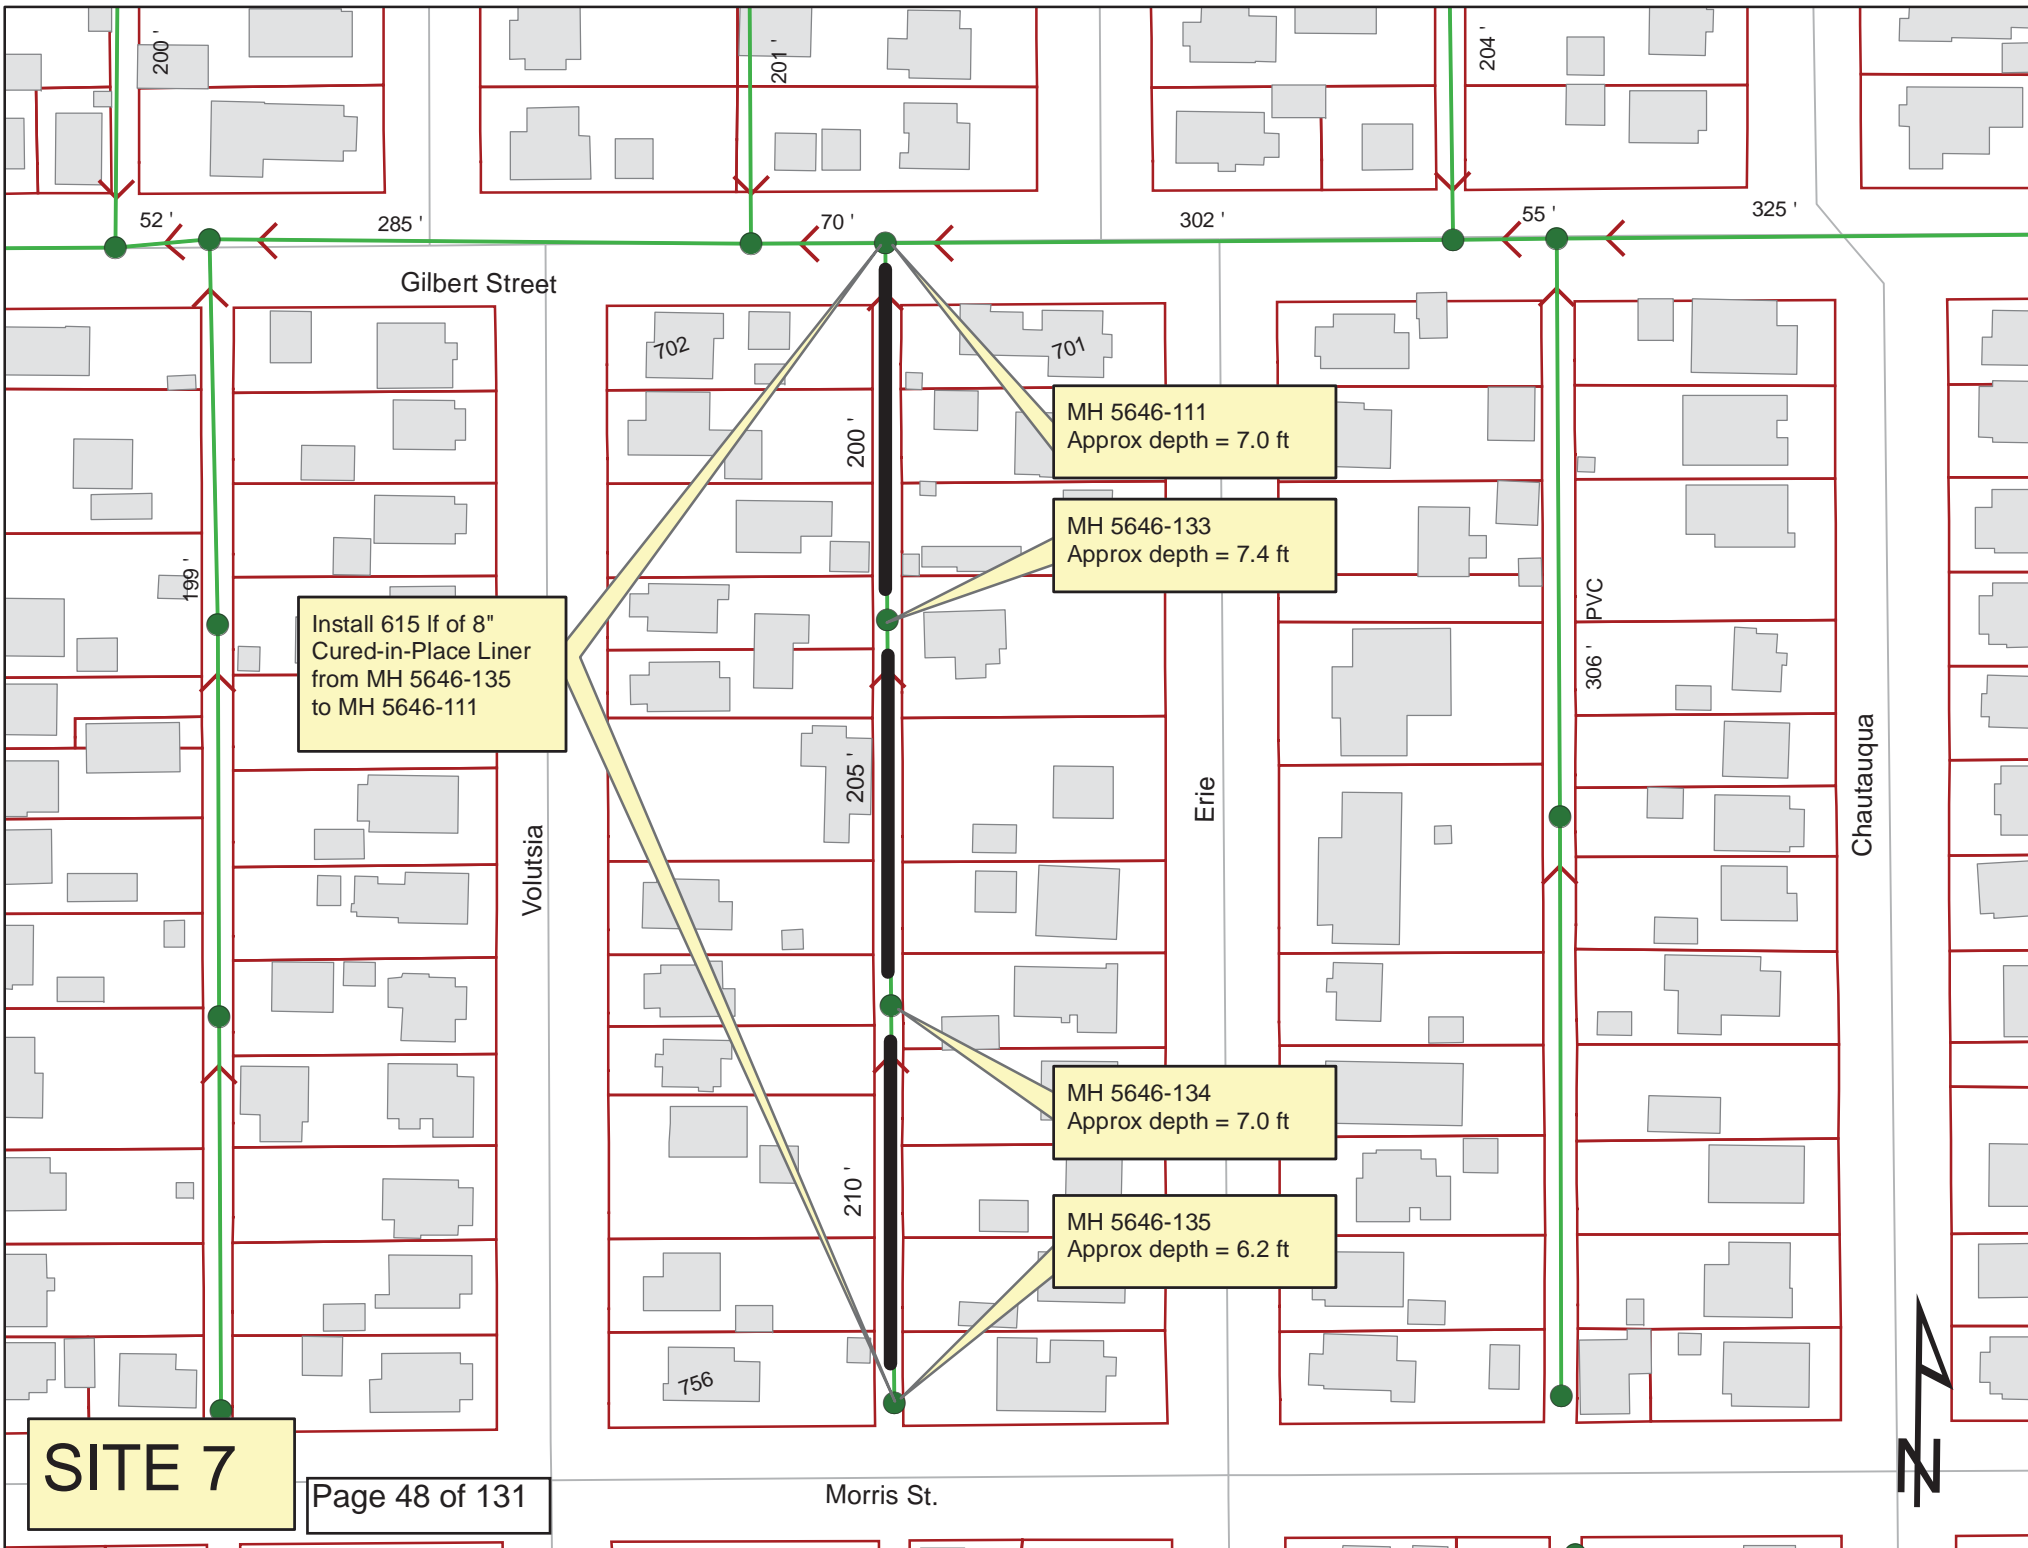
MH 5646-111
Approx depth = 7.0 ft

MH 5646-133
Approx depth = 7.4 ft

MH 5646-134
Approx depth = 7.0 ft

MH 5646-135
Approx depth = 6.2 ft
