Install 836 lf of 8"
Cured-in-Place Liner
from MH 5846-076
to MH 5846-012

SITE 15

Video Inspection Master Report

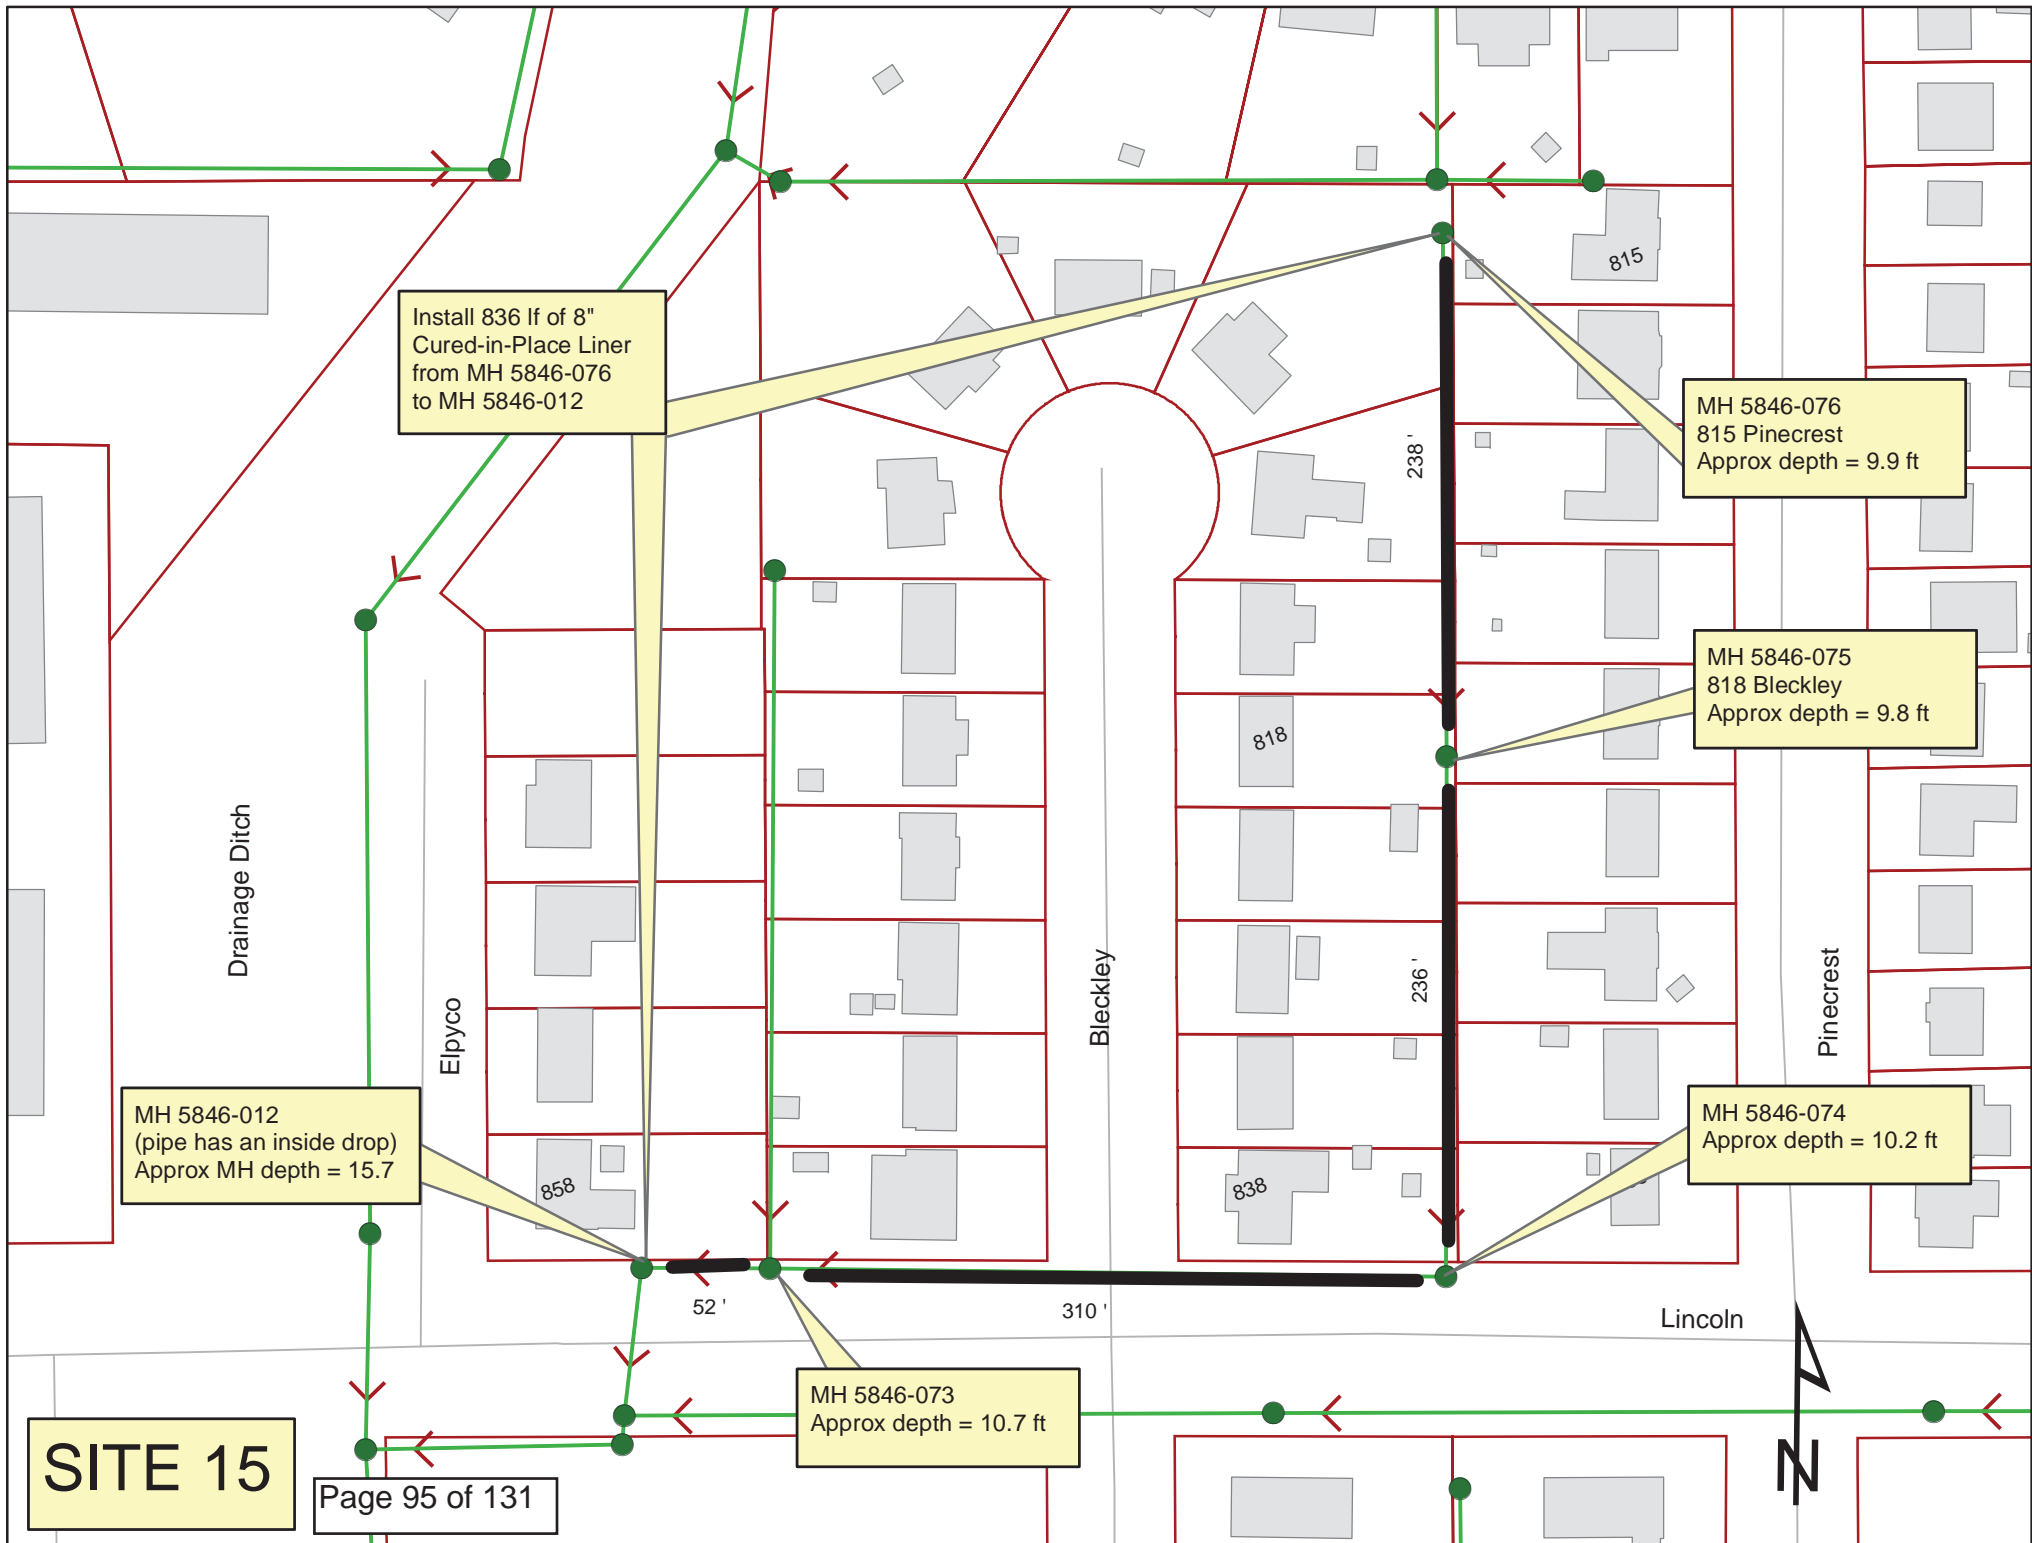
MH 5846-076
815 Pinecrest
Approx depth = 9.9 ft

MH 5846-075
818 Bleckley
Approx depth = 9.8 ft

MH 5846-074
Approx depth = 10.2 ft

MH 5846-012
(pipe has an inside drop)
Approx MH depth = 15.7

MH 5846-073
Approx depth = 10.7 ft
