SITE 3

Television Inspection Master Report

US Structure: 5650-239 2437 N POPLAR AVE Date Insp: 10/8/2009 Basin: EC02D
 DS Structure: 5650-238 2419 N POPLAR ST Dir Televised: Downstream To Upstream

US Structure: 5650-238 2419 N POPLAR ST Date Insp: 10/8/2009 Basin: EC02D
 DS Structure: 5650-207 2401 N POPLAR ST Dir Televised: Downstream To Upstream

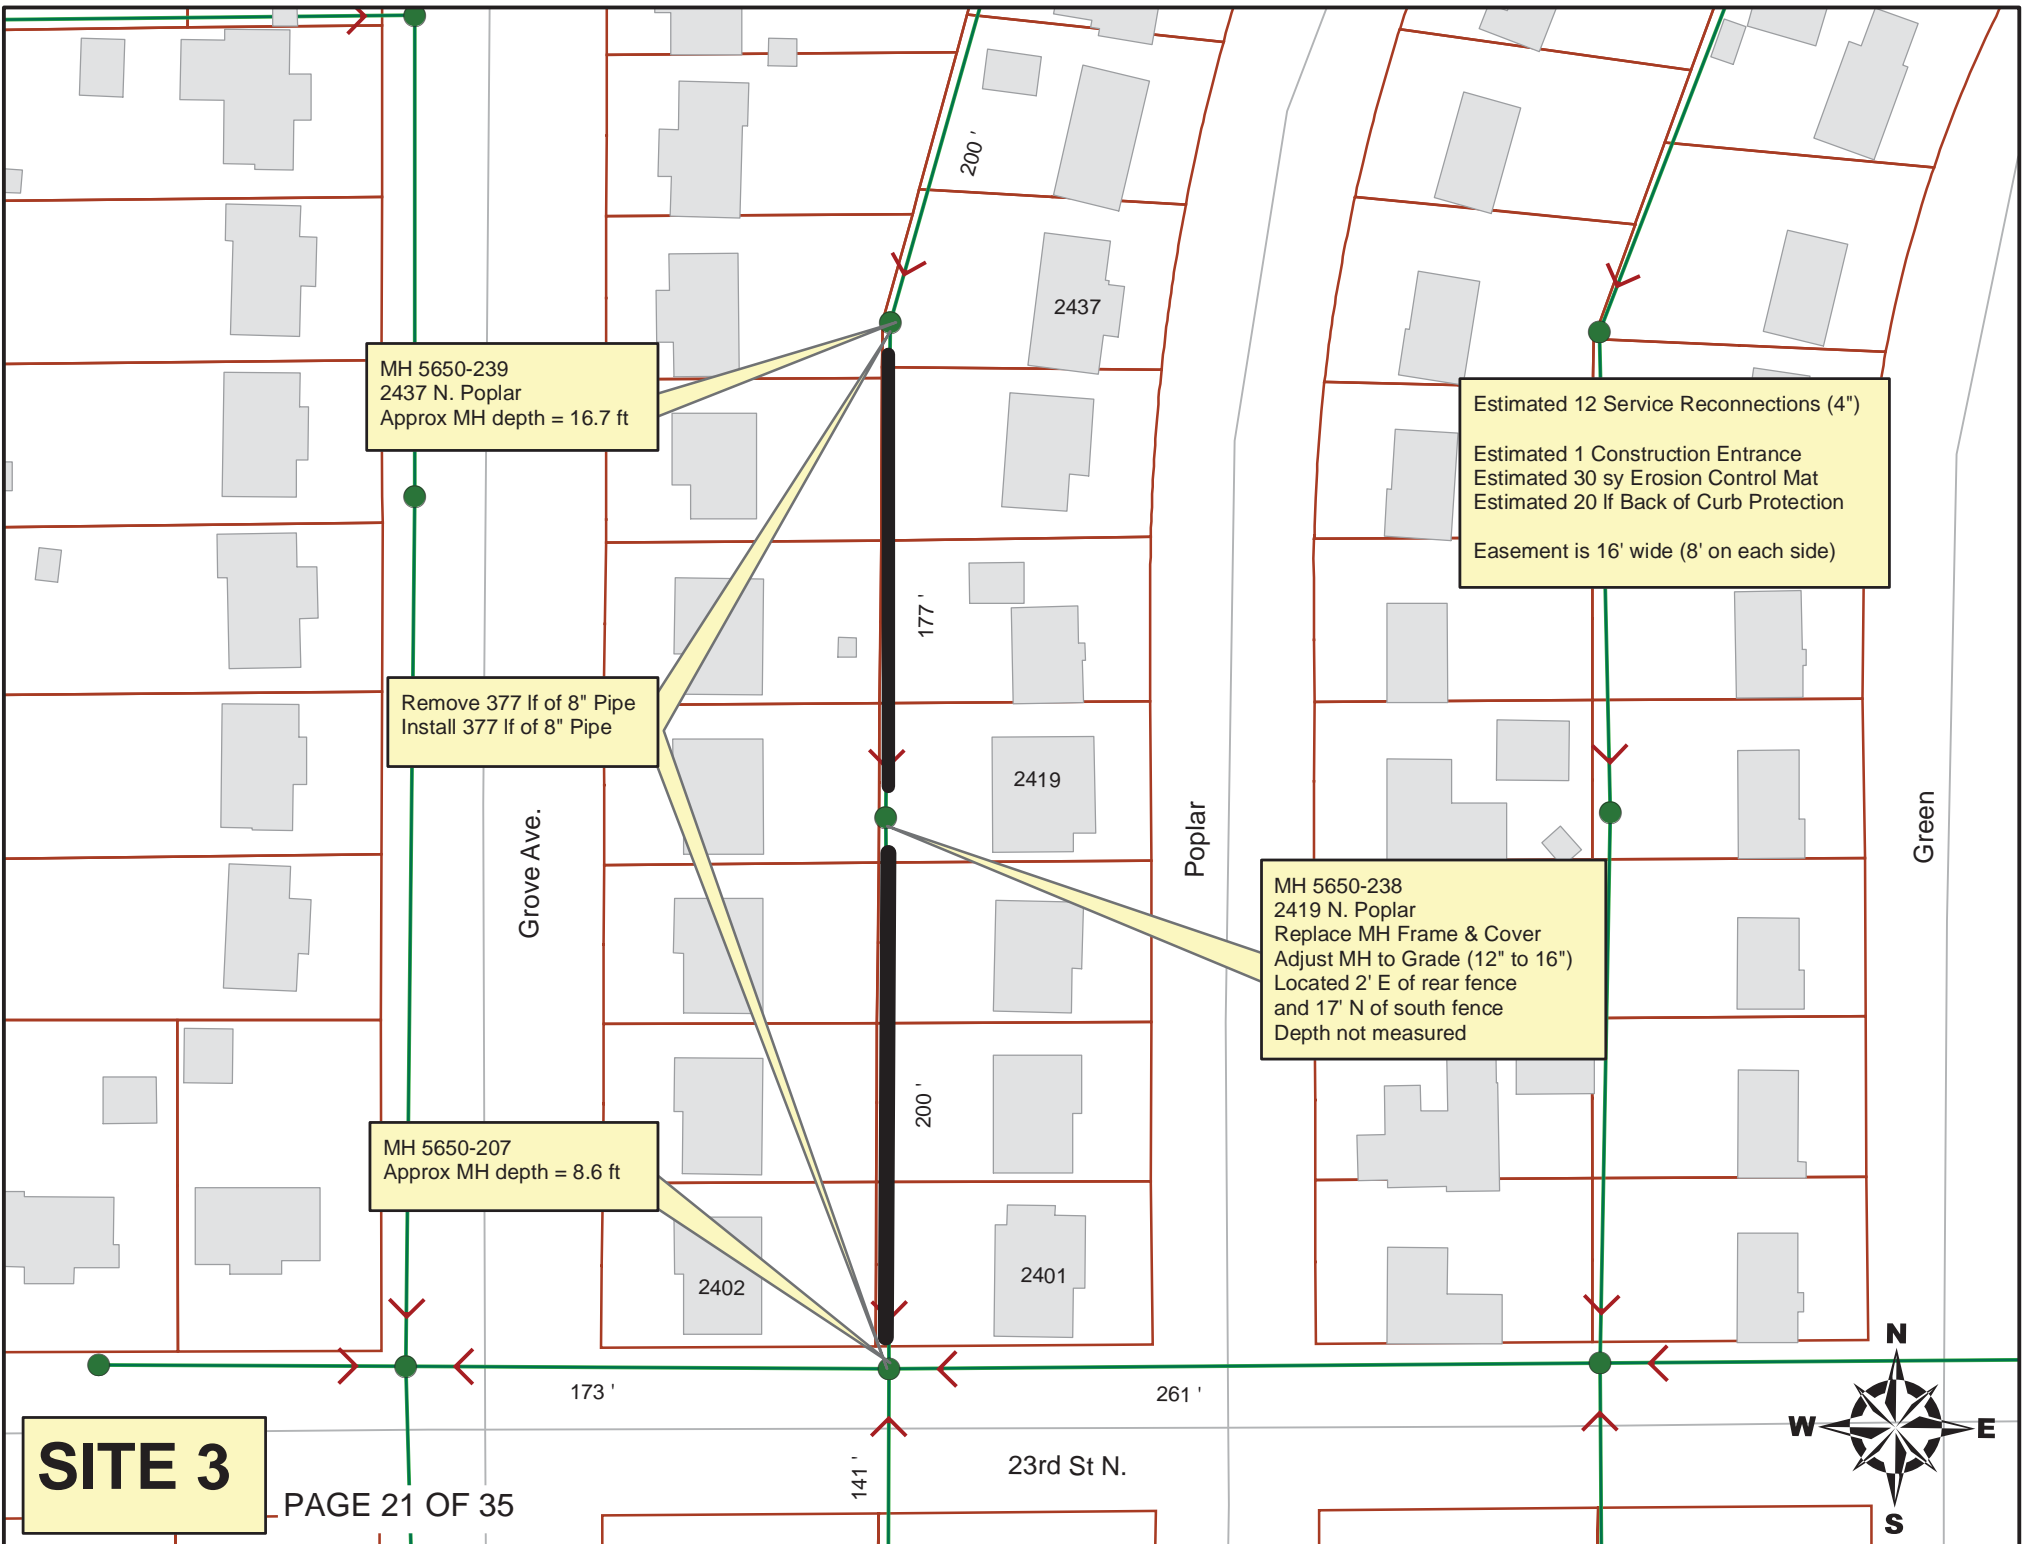
MH 5650-239
 2437 N. Poplar
 Approx MH depth = 16.7 ft

MH 5650-207
 Approx MH depth = 8.6 ft

Estimated 12 Service Reconnections (4")
 Estimated 1 Construction Entrance
 Estimated 30 sy Erosion Control Mat
 Estimated 20 lf Back of Curb Protection
 Easement is 16' wide (8' on each side)

MH 5650-238
 2419 N. Poplar
 Replace MH Frame & Cover
 Adjust MH to Grade (12" to 16")
 Located 2' E of rear fence
 and 17' N of south fence
 Depth not measured

Remove 377 lf of 8" Pipe
 Install 377 lf of 8" Pipe

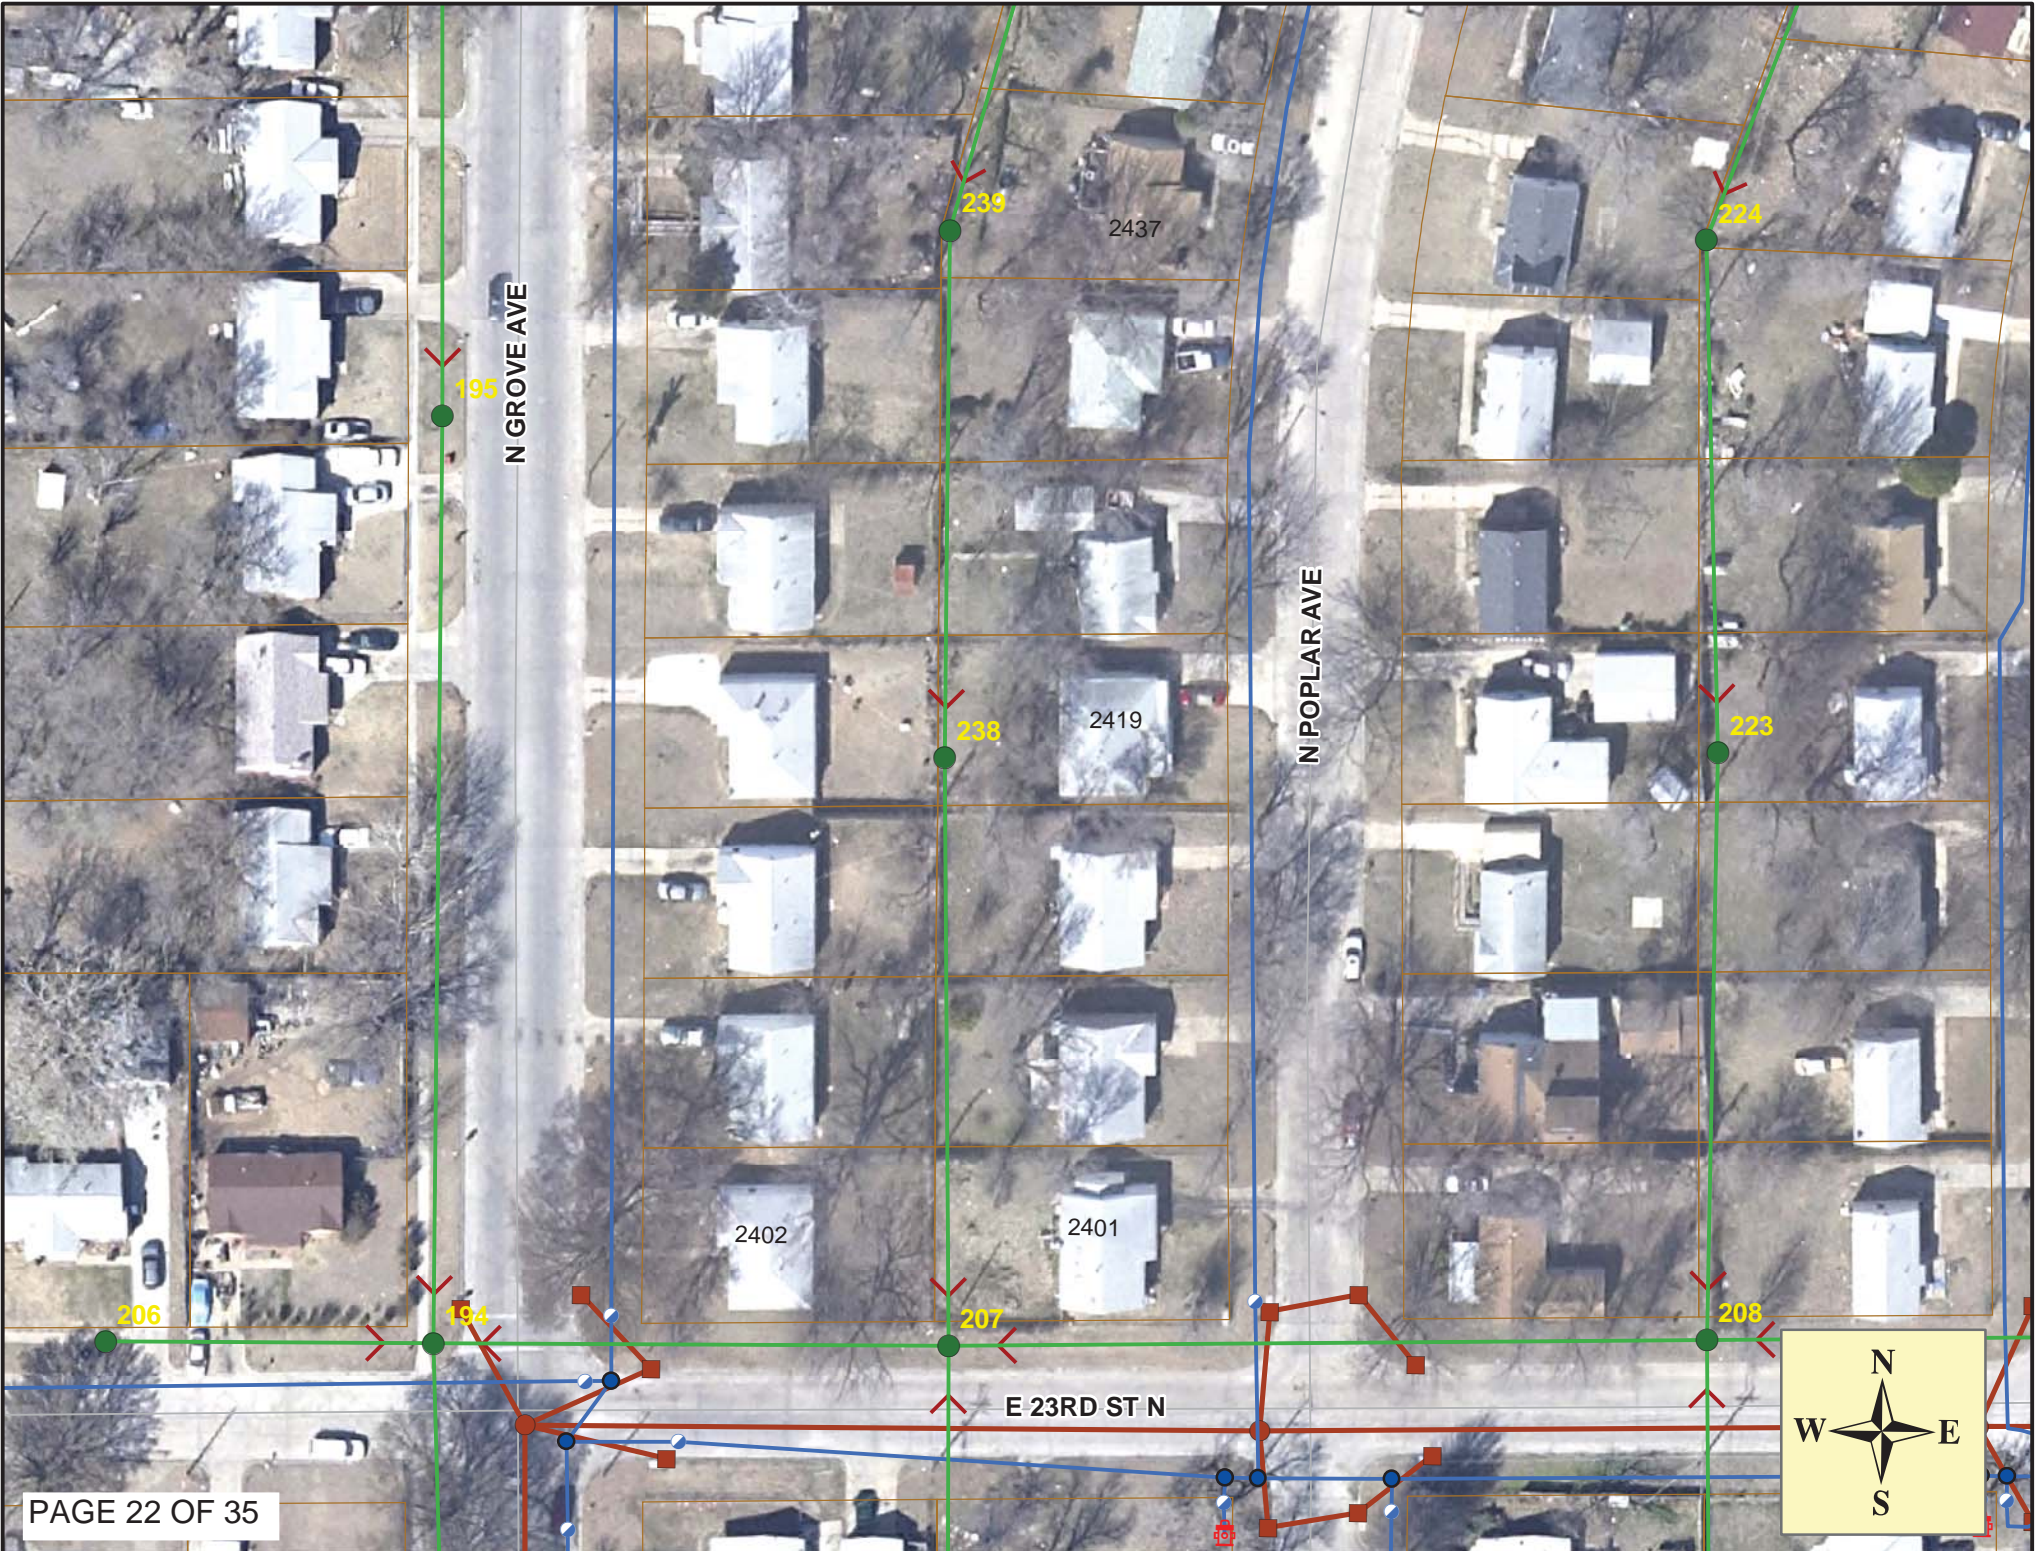
Obs. #	VTR Counter	Distance	Location	Description	Rating	Obsrvd (gpm)	Ratings			Remain (gpm)
							Est. (gpm)	Struct	Clean	
1		0.0		5650-238 DS Manhole	1	0.000	0	0	0.000	
2419 N POPLAR / TV AGAINST THE FLOW										
2		22.0		Sag begins	2	0.000	2	0	0.000	
3		24.4		Sag / camera submerges	4	0.000	10	0	0.000	
4		36.5		Sag / emerges	1	0.000	1	0	0.000	
5		36.6		Sag ends	1	0.000	1	0	0.000	
6		51.5		Break-In Conn	1	0.001	0	0	0.001	
2425 N POPLAR										
7		54.5		Wye Service	1	0.000	0	0	0.000	
2426 N GROVE										
8		115.0		Sealed Off Wye	1	0.000	0	0	0.000	
9		117.9		PVC Break-In Conn	1	0.001	0	0	0.001	
2432 N GROVE										
10		139.9		Break-In Conn	2	0.002	0	0	0.002	
2431 N POPLAR / poor cond.										
11		163.0		Sealed Off Wye	1	0.000	0	0	0.000	
12		166.0		Sealed Off Wye	1	0.000	0	0	0.000	
13		175.2	5650-239	US Manhole	1	0.000	0	0	0.000
