SITE 4

Television Inspection Master Report

US Structure: 5650-313 2720 E 21ST ST Date Insp: 1/5/2010 Basin: EC02D
 DS Structure: 5650-312 2237 N ESTELLE ST Dir Televised: Upstream To Downstream

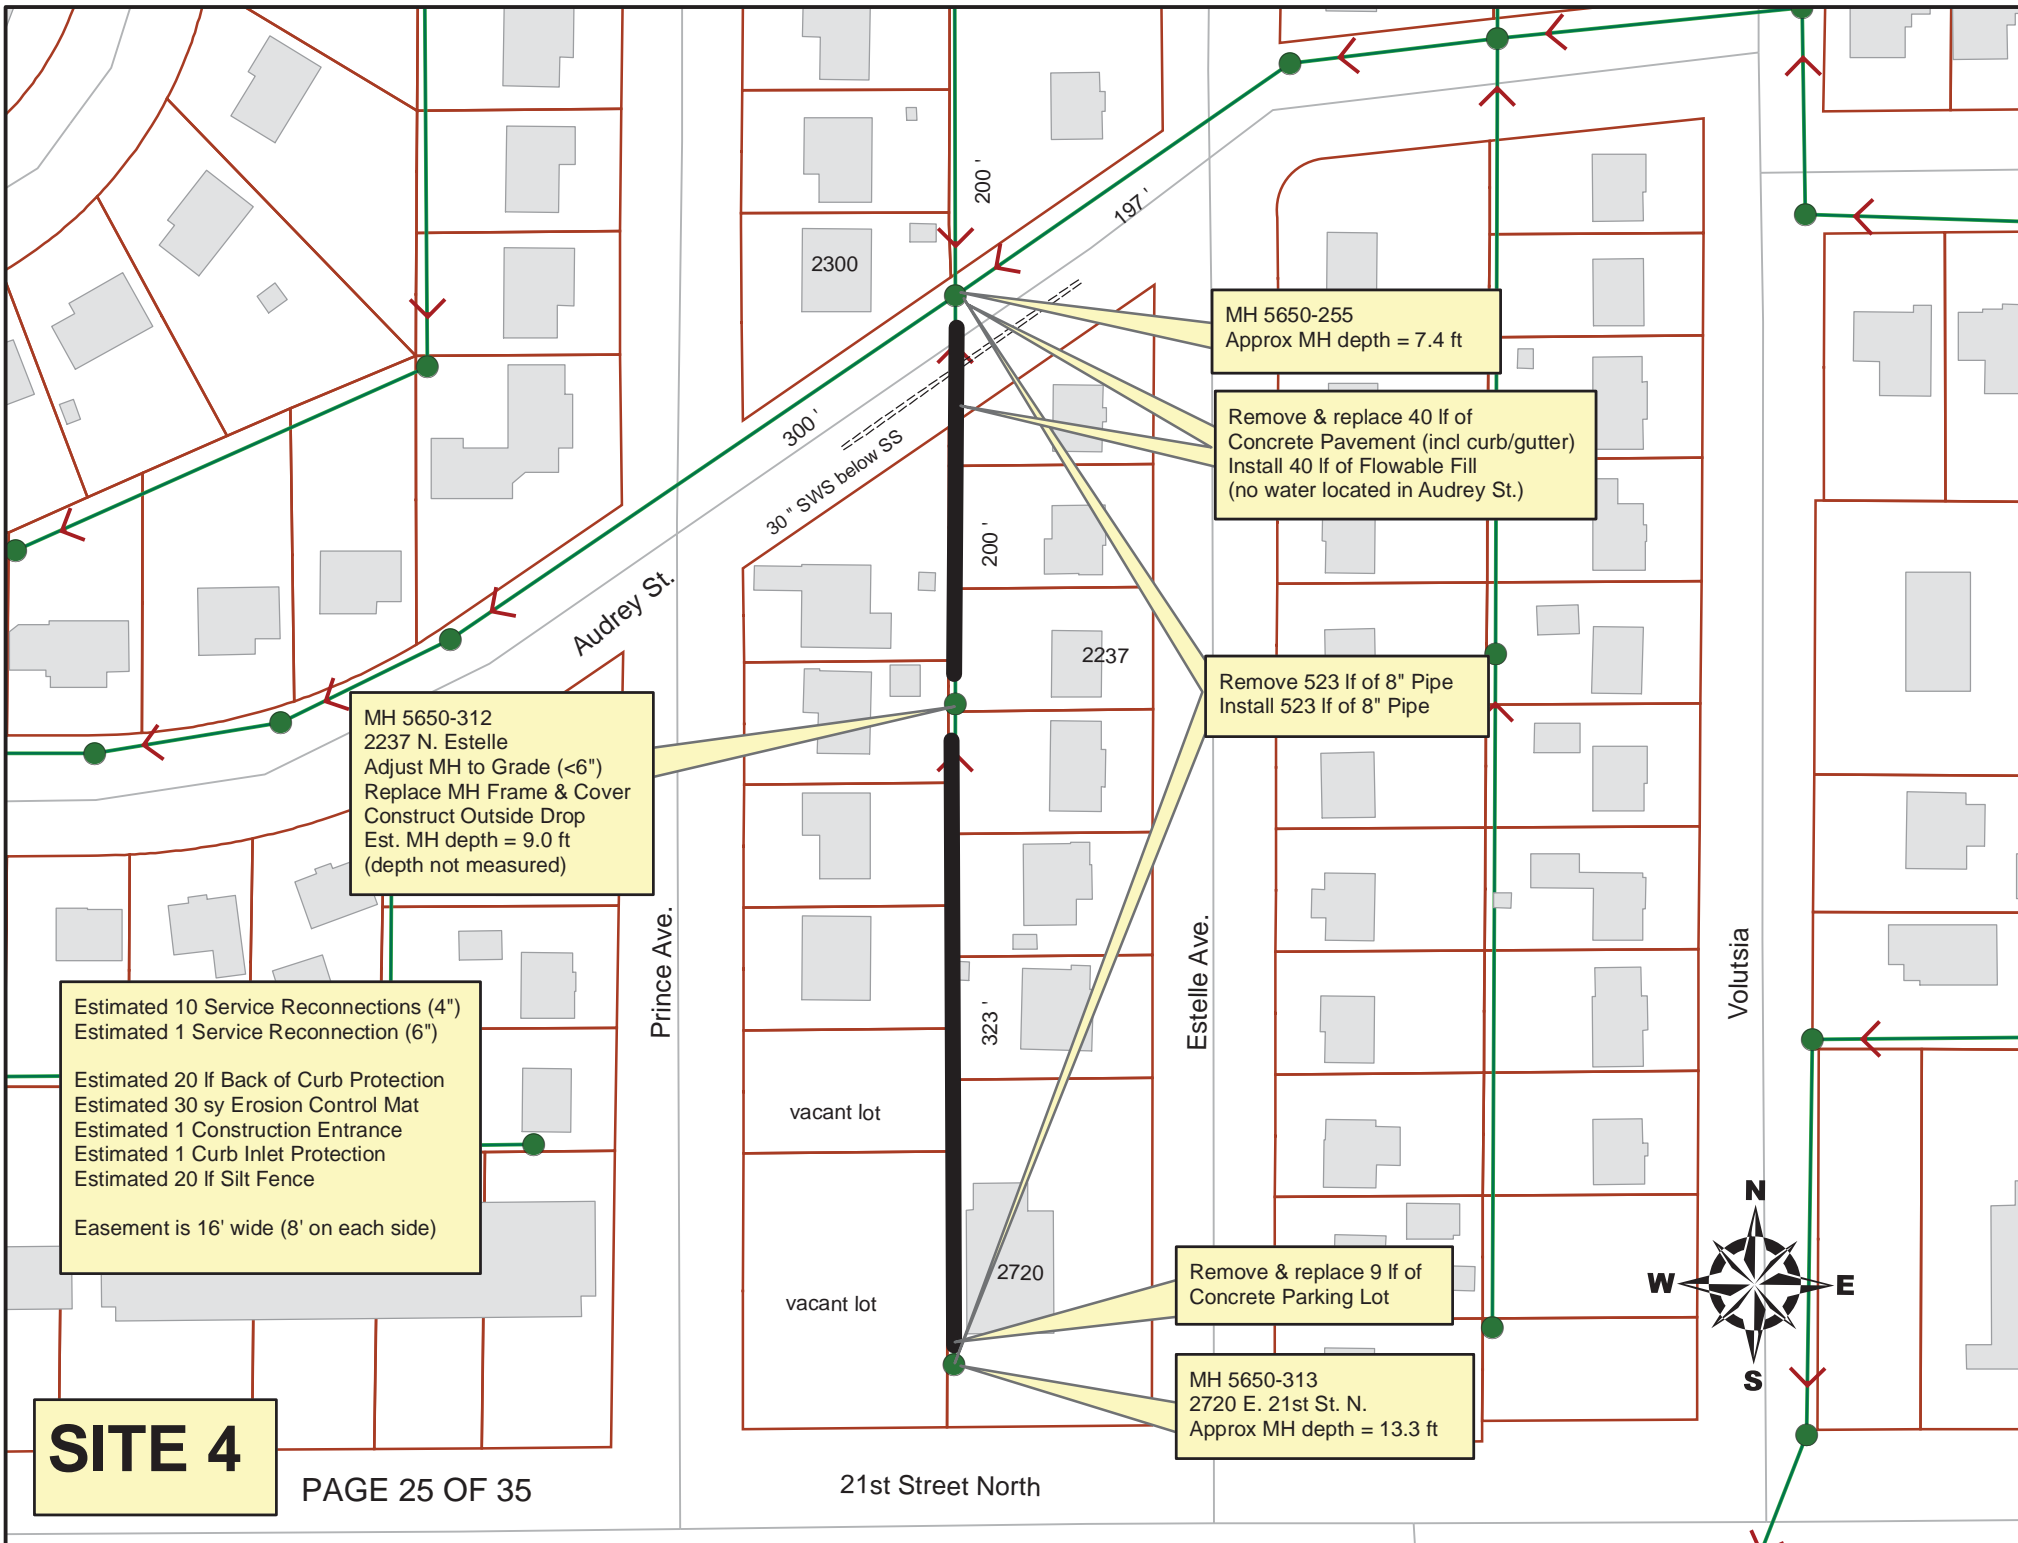
MH 5650-312
 2237 N. Estelle
 Adjust MH to Grade (<6")
 Replace MH Frame & Cover
 Construct Outside Drop
 Est. MH depth = 9.0 ft
 (depth not measured)

MH 5650-255
 Approx MH depth = 7.4 ft

MH 5650-313
 2720 E. 21st St. N.
 Approx MH depth = 13.3 ft

Remove & replace 40 lf of
 Concrete Pavement (incl curb/gutter)
 Install 40 lf of Flowable Fill
 (no water located in Audrey St.)

Remove 523 lf of 8" Pipe
 Install 523 lf of 8" Pipe

Remove & replace 9 lf of
 Concrete Parking Lot

Estimated 10 Service Reconnections (4")
 Estimated 1 Service Reconnection (6")
 Estimated 20 lf Back of Curb Protection
 Estimated 30 sy Erosion Control Mat
 Estimated 1 Construction Entrance
 Estimated 1 Curb Inlet Protection
 Estimated 20 lf Silt Fence
 Easement is 16' wide (8' on each side)
