Video Inspection Master Report

US Structure: 5347-411 212 S ATHENIAN AVE Date Insp: 6/10/2013 Basin: C07G
 DS Structure: 5347-408 244 S ATHENIAN AVE Dir Televised: Downstream To Upstream

US Structure: 5347-408 **244 S ATHENIAN AVE** **Date Insp:** 6/10/2013 **Basin:** C07G
DS Structure: 5347-406 **2016** W. MAPLE **Dir Televised:** Upstream To Downstream

US Structure: **5347-420** 2009 W BURTON Date Insp: **6/10/2013** Basin: **C07G**
 DS Structure: **5347-418U** 212 S CLARENCE Dir Televised:Upstream To Downstream

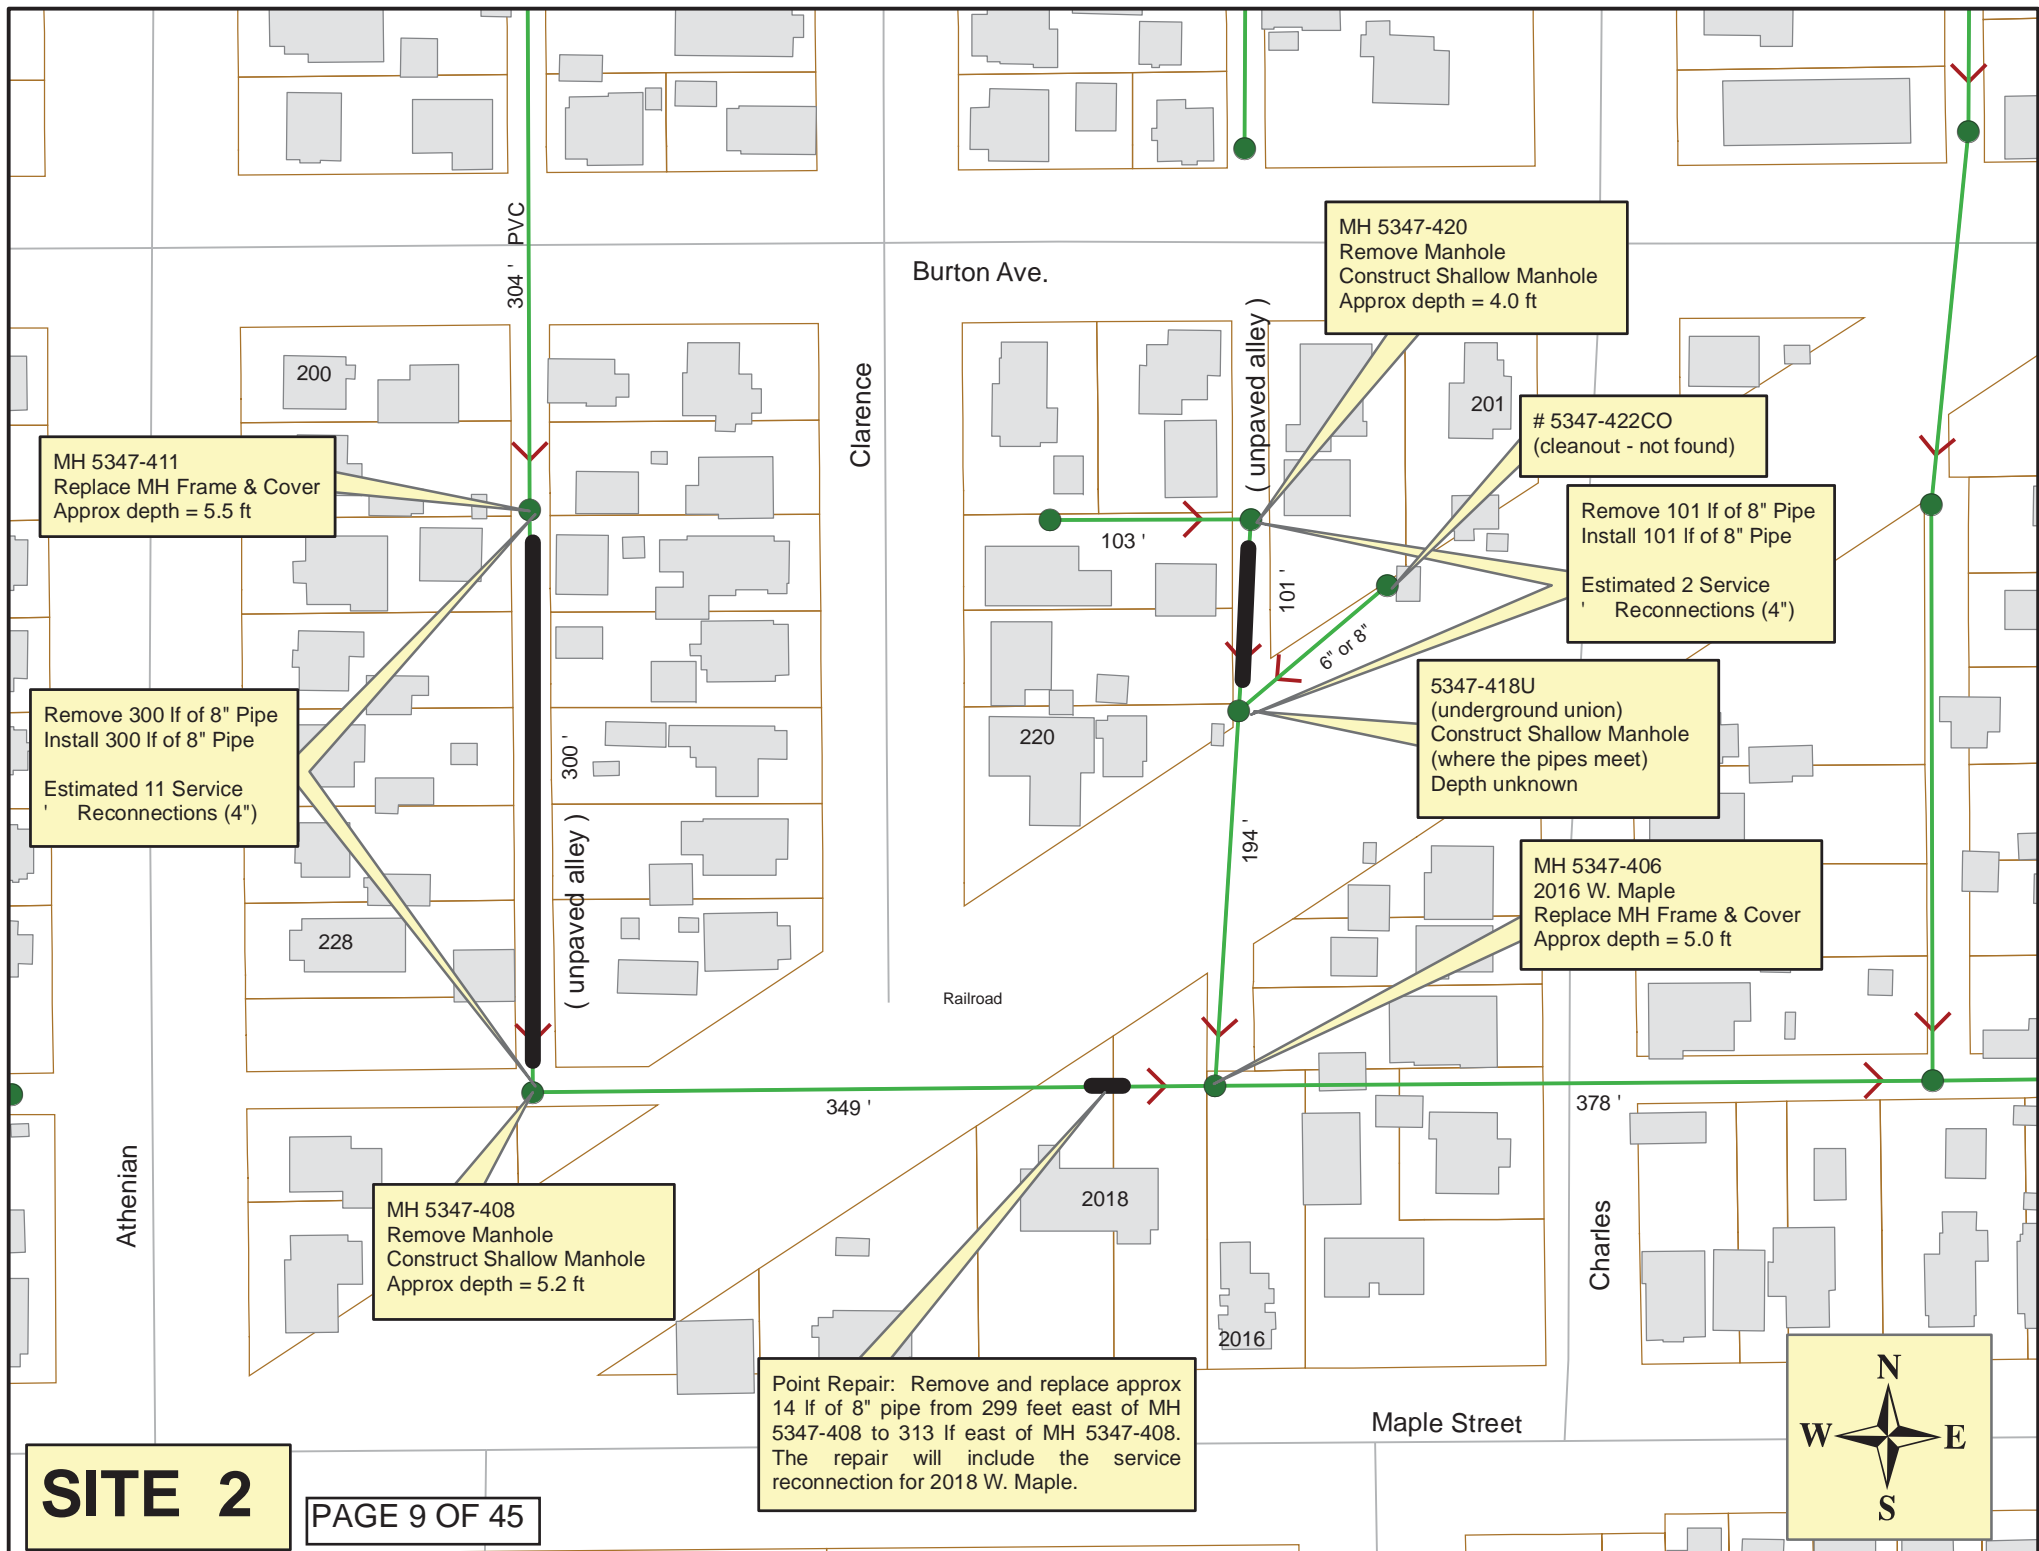
MH 5347-411
 Replace MH Frame & Cover
 Approx depth = 5.5 ft

MH 5347-408
 Remove Manhole
 Construct Shallow Manhole
 Approx depth = 5.2 ft

MH 5347-420
 Remove Manhole
 Construct Shallow Manhole
 Approx depth = 4.0 ft

5347-422CO
 (cleanout - not found)

5347-418U
 (underground union)
 Construct Shallow Manhole
 (where the pipes meet)
 Depth unknown

MH 5347-406
 2016 W. Maple
 Replace MH Frame & Cover
 Approx depth = 5.0 ft

Remove 300 lf of 8" Pipe
 Install 300 lf of 8" Pipe
 Estimated 11 Service
 Reconnections (4")

Remove 101 lf of 8" Pipe
 Install 101 lf of 8" Pipe
 Estimated 2 Service
 Reconnections (4")

Point Repair: Remove and replace approx
 14 lf of 8" pipe from 299 feet east of MH
 5347-408 to 313 lf east of MH 5347-408.
 The repair will include the service
 reconnection for 2018 W. Maple.
