SITE 5

PAGE 21 OF 45

Video Inspection Master Report

US Structure: 5347-267 532 N MARTINSON ST Date Insp: 6/7/2013 Basin: C07B
 DS Structure: 5347-264 504 N MARTINSON AVE Dir Televised:Upstream To Downstream

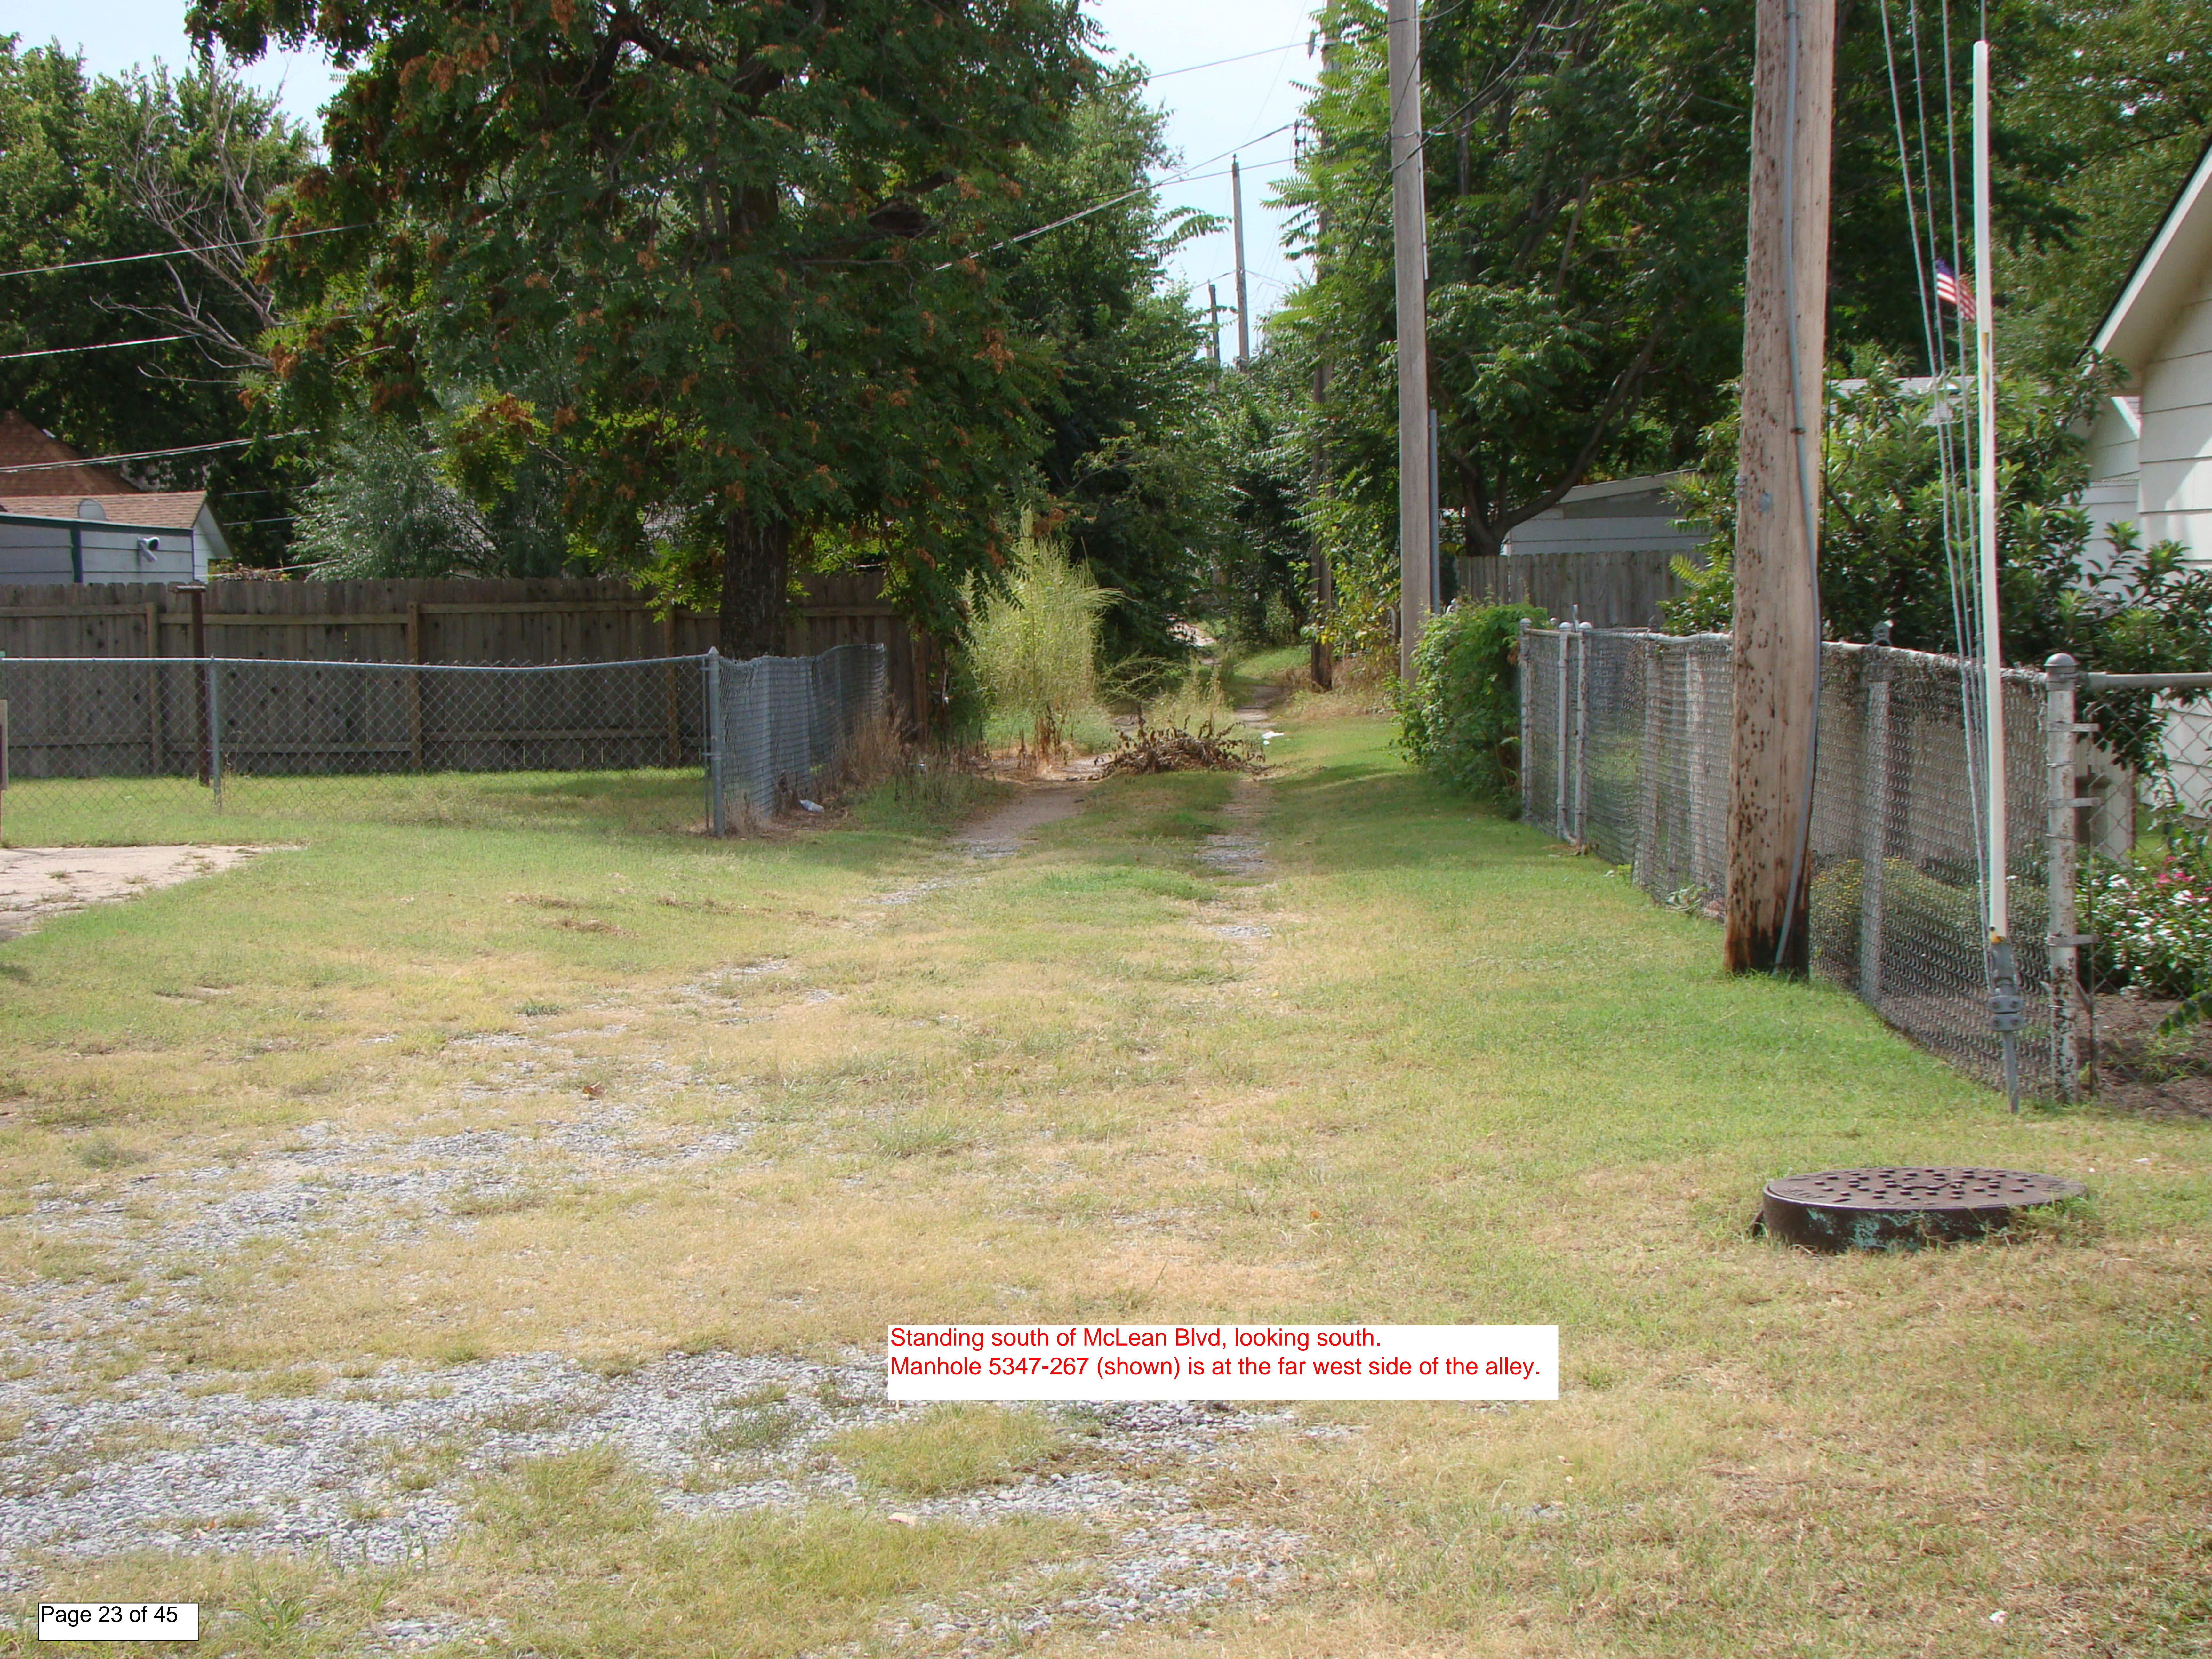
Standing south of McLean Blvd, looking south.
Manhole 5347-267 (shown) is at the far west side of the alley.

MH 5347-267
Replace MH Frame & Cover
Est. MH depth = 4.5 ft
