Remove 597 lf of 8" Pipe
 Install 597 lf of 8" Pipe
 Estimated 21 Service Reconnections (4")

Video Inspection Master Report

US Structure: 5347-155 407 N FERN Date Insp: 6/5/2013 Basin: C07B
 DS Structure: 5347-152 340 N MILLWOOD AVE Dir Televised: Upstream To Downstream

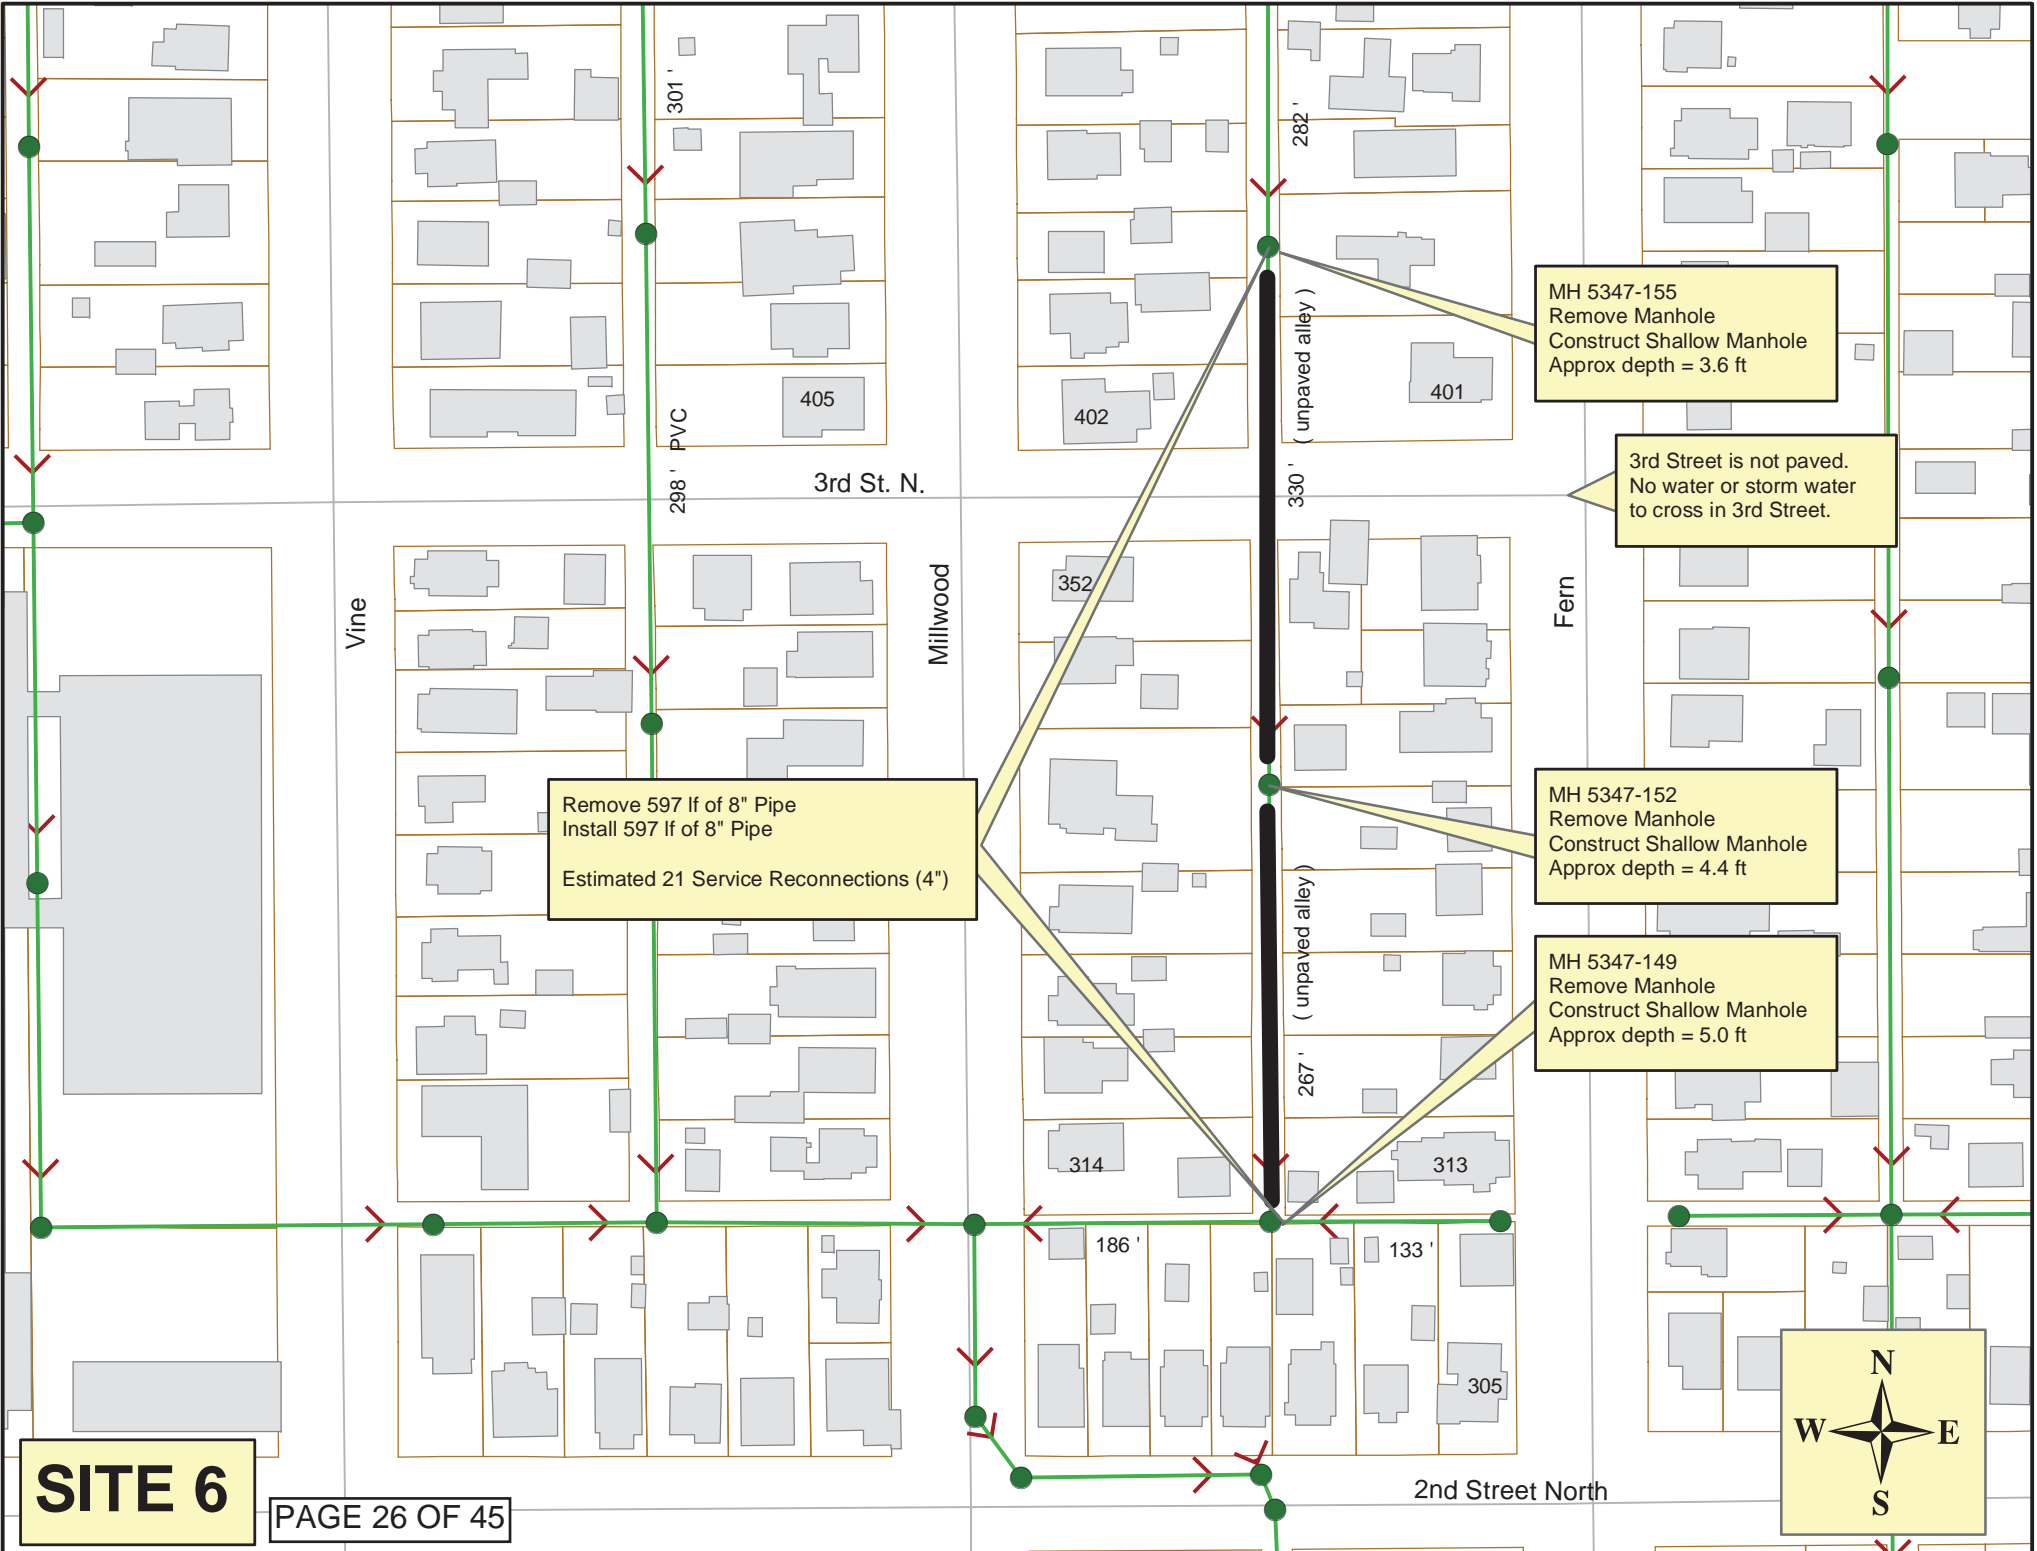
3rd Street is not paved.
 No water or storm water
 to cross in 3rd Street.

MH 5347-155
 Remove Manhole
 Construct Shallow Manhole
 Approx depth = 3.6 ft

MH 5347-152
 Remove Manhole
 Construct Shallow Manhole
 Approx depth = 4.4 ft

MH 5347-149
 Remove Manhole
 Construct Shallow Manhole
 Approx depth = 5.0 ft
