**SITE 2**

Sheet 8 of 22

## Video Inspection Master Report

US Structure: 5650-272                      2351 N CHAUTAUQUA AVE    Date Insp: 7/30/2013                      Basin: EC02D  
 DS Structure: 5650-271                      2331 N CHAUTAUQUA ST    Dir Televised: Downstream To Upstream

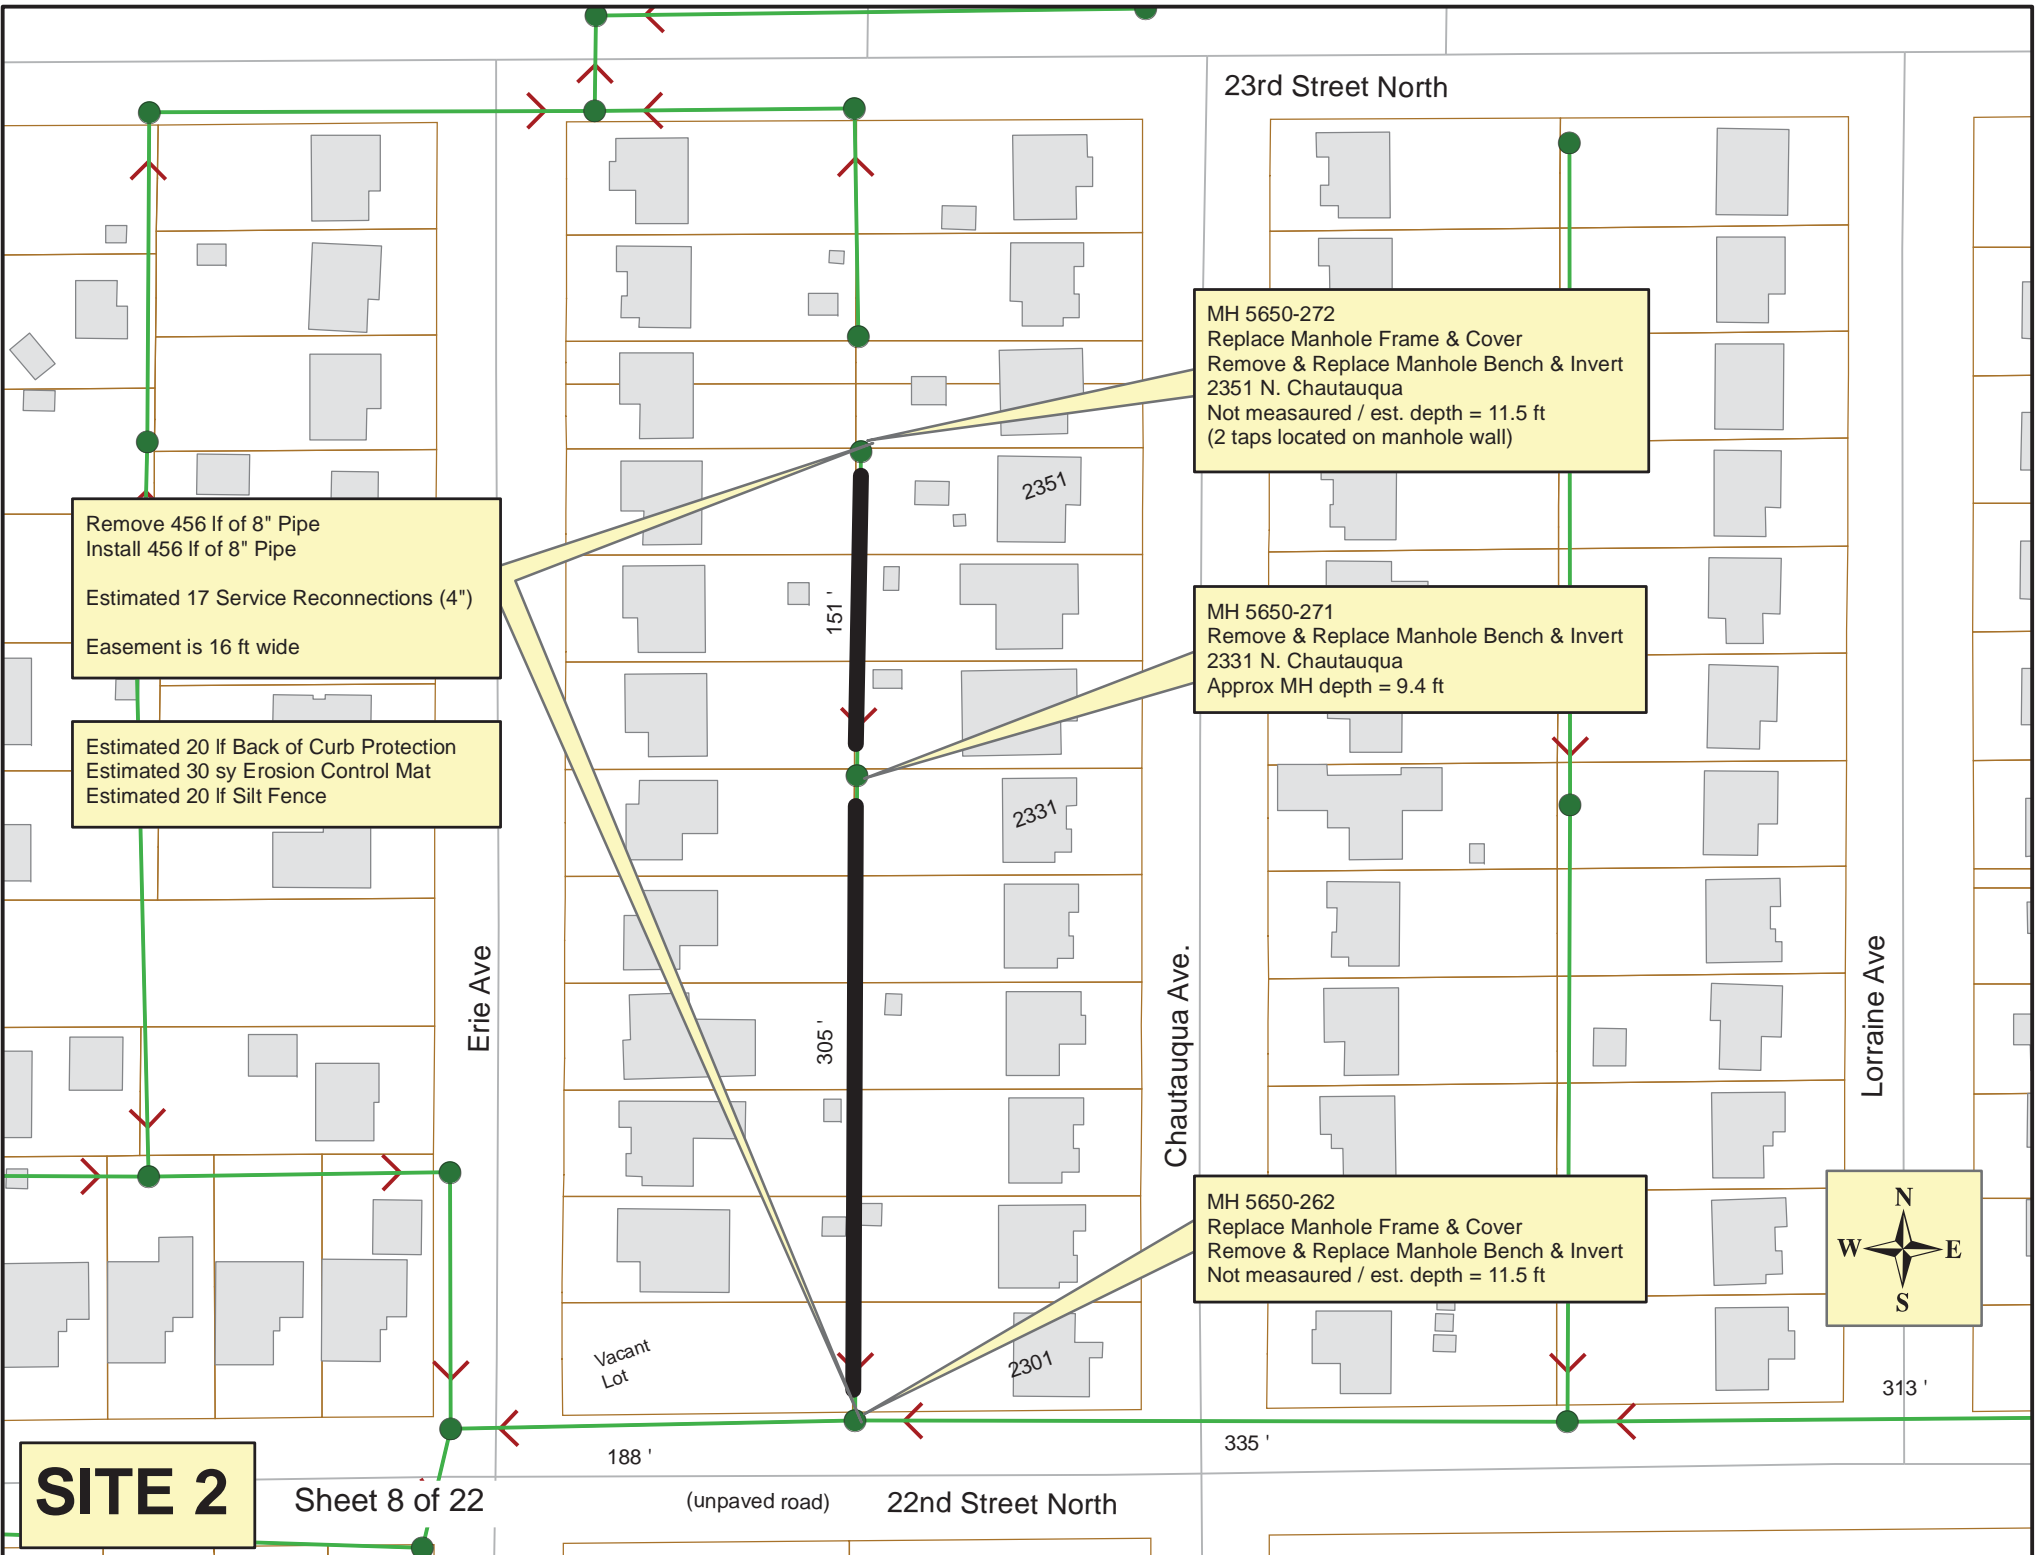
MH 5650-272  
 Replace Manhole Frame & Cover  
 Remove & Replace Manhole Bench & Invert  
 2351 N. Chautauqua  
 Not measured / est. depth = 11.5 ft  
 (2 taps located on manhole wall)

MH 5650-271  
 Remove & Replace Manhole Bench & Invert  
 2331 N. Chautauqua  
 Approx MH depth = 9.4 ft

MH 5650-262  
 Replace Manhole Frame & Cover  
 Remove & Replace Manhole Bench & Invert  
 Not measured / est. depth = 11.5 ft

Remove 456 lf of 8" Pipe  
 Install 456 lf of 8" Pipe  
 Estimated 17 Service Reconnections (4")  
 Easement is 16 ft wide

Estimated 20 lf Back of Curb Protection  
 Estimated 30 sy Erosion Control Mat  
 Estimated 20 lf Silt Fence
