**SITE 4**

## Video Inspection Master Report

US Structure: 5546-586                      1117 S IDA AVE                      Date Insp: 9/13/2011                      Basin: C02B  
 DS Structure: 5546-585                      1125 S IDA AVE                      Dir Televised: Upstream To Downstream

Project No. : D-024                      Dia: 8                      Material: VCP                      Length: 192.6                      Slope: 0.002                      Surface: Unpaved alley

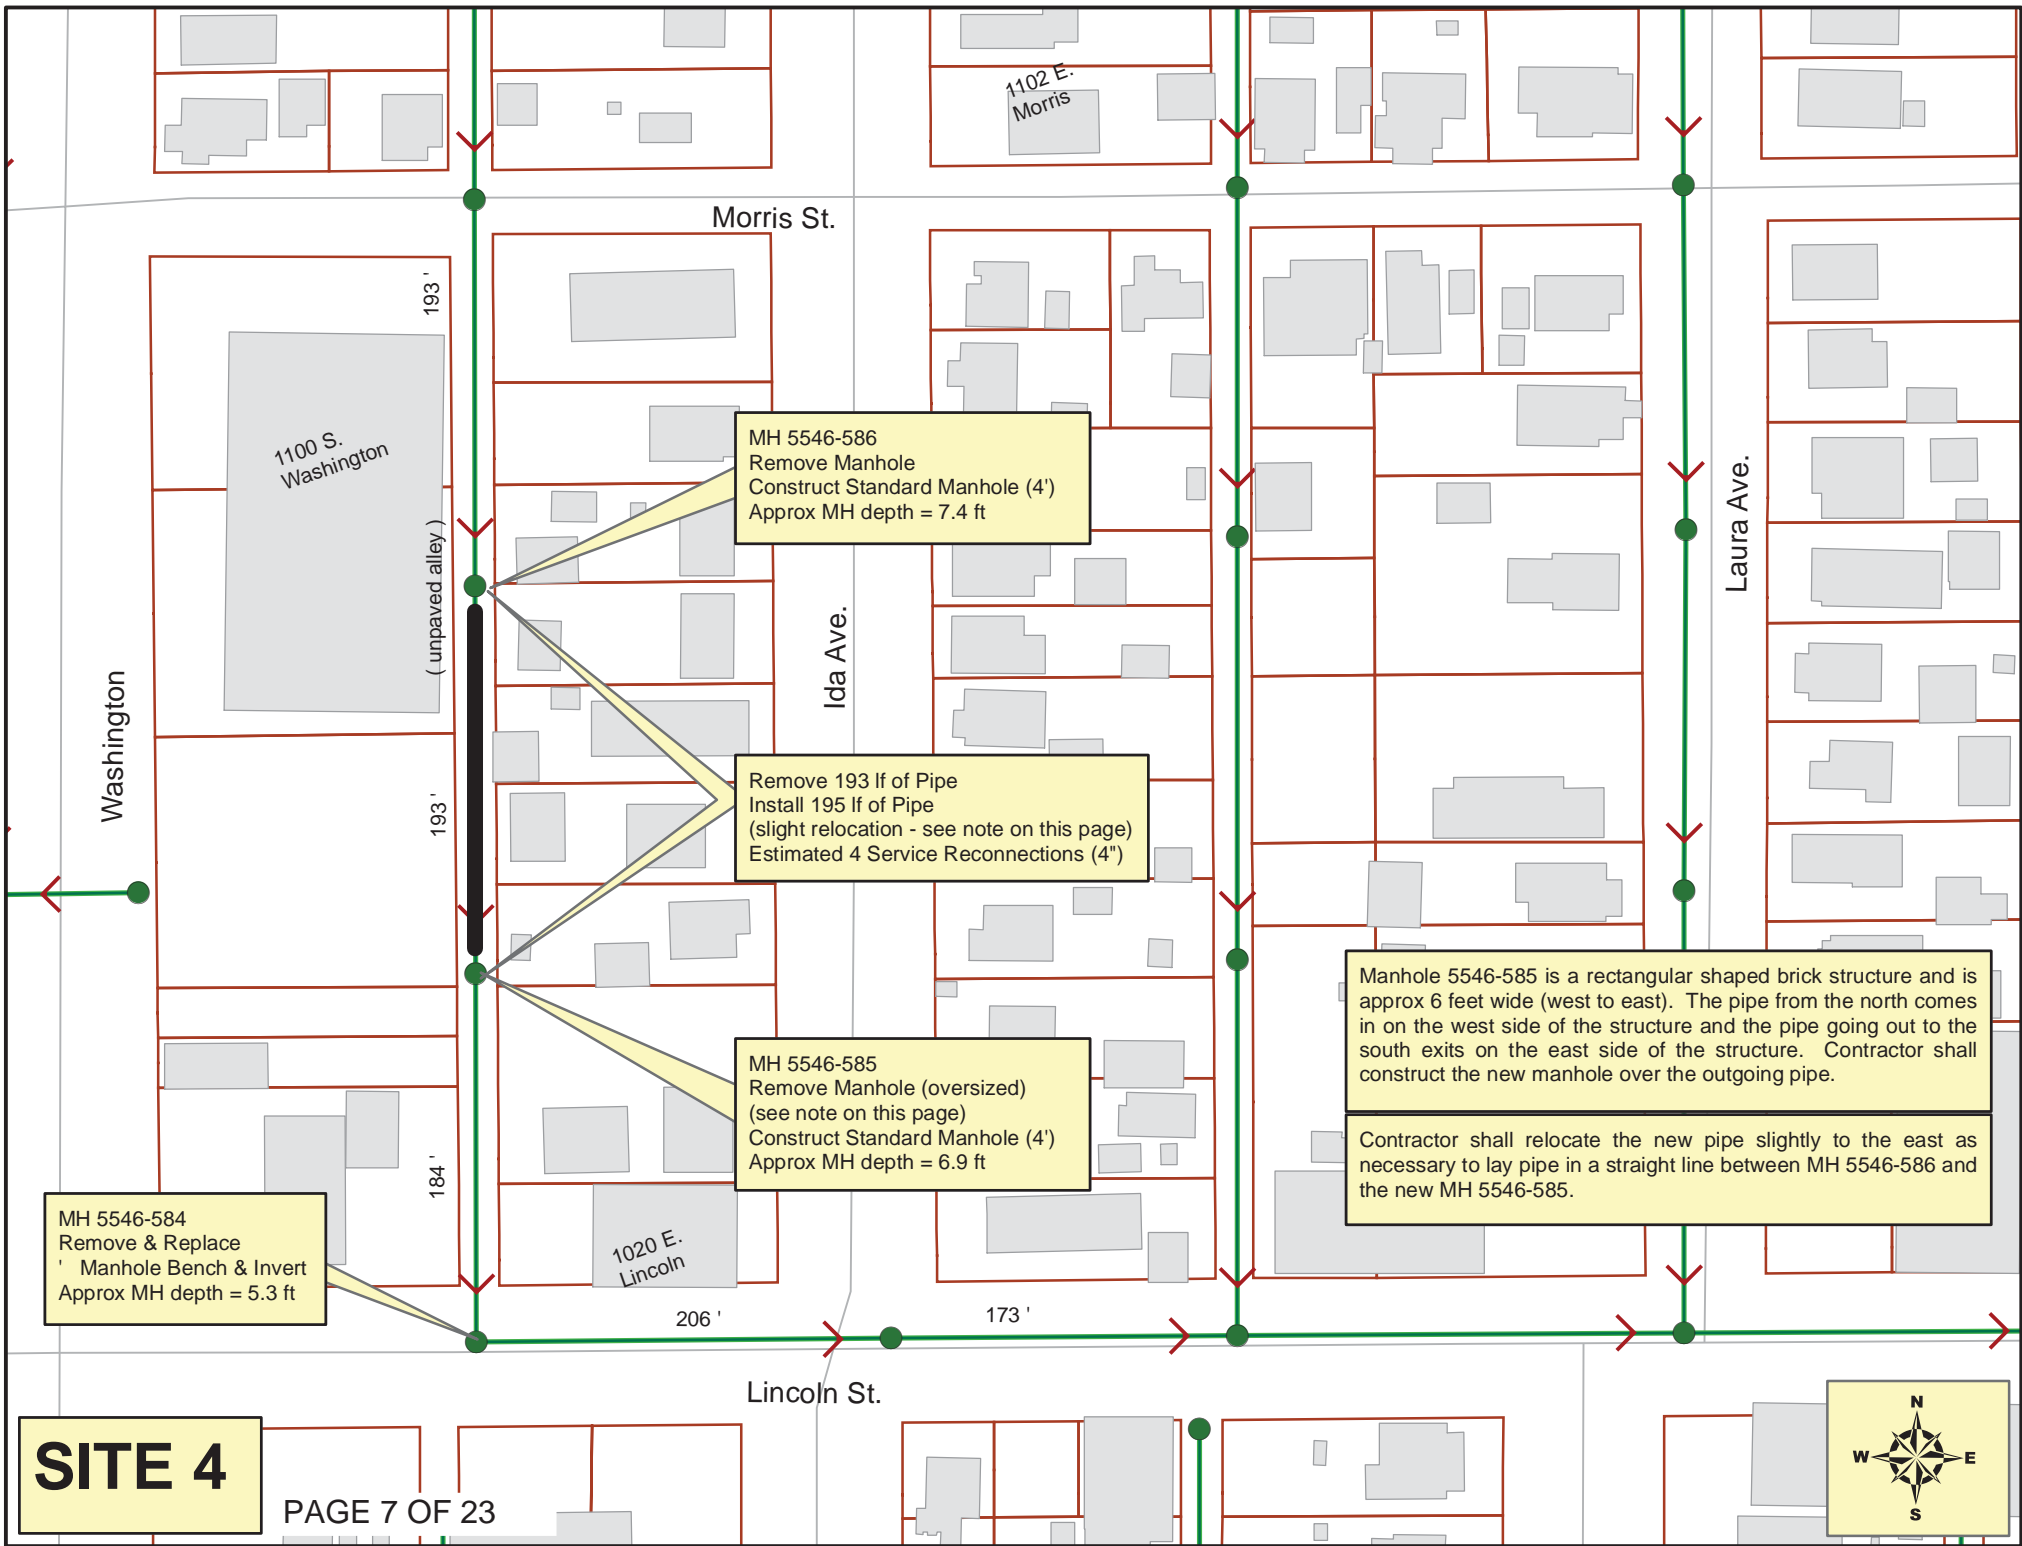
MH 5546-586  
 Remove Manhole  
 Construct Standard Manhole (4")  
 Approx MH depth = 7.4 ft

Remove 193 lf of Pipe  
 Install 195 lf of Pipe  
 (slight relocation - see note on this page)  
 Estimated 4 Service Reconnections (4")

MH 5546-585  
 Remove Manhole (oversized)  
 (see note on this page)  
 Construct Standard Manhole (4")  
 Approx MH depth = 6.9 ft

Manhole 5546-585 is a rectangular shaped brick structure and is approx 6 feet wide (west to east). The pipe from the north comes in on the west side of the structure and the pipe going out to the south exits on the east side of the structure. Contractor shall construct the new manhole over the outgoing pipe.

MH 5546-584  
 Remove & Replace  
 Manhole Bench & Invert  
 Approx MH depth = 5.3 ft

Contractor shall relocate the new pipe slightly to the east as necessary to lay pipe in a straight line between MH 5546-586 and the new MH 5546-585.
