SITE 5

Video Inspection Master Report

US Structure: 5546-605 729 S LAURA ST Date Insp: 9/15/2011 Basin: C02B
 DS Structure: 5546-604 735 S LAURA ST Dir Televised: Upstream To Downstream

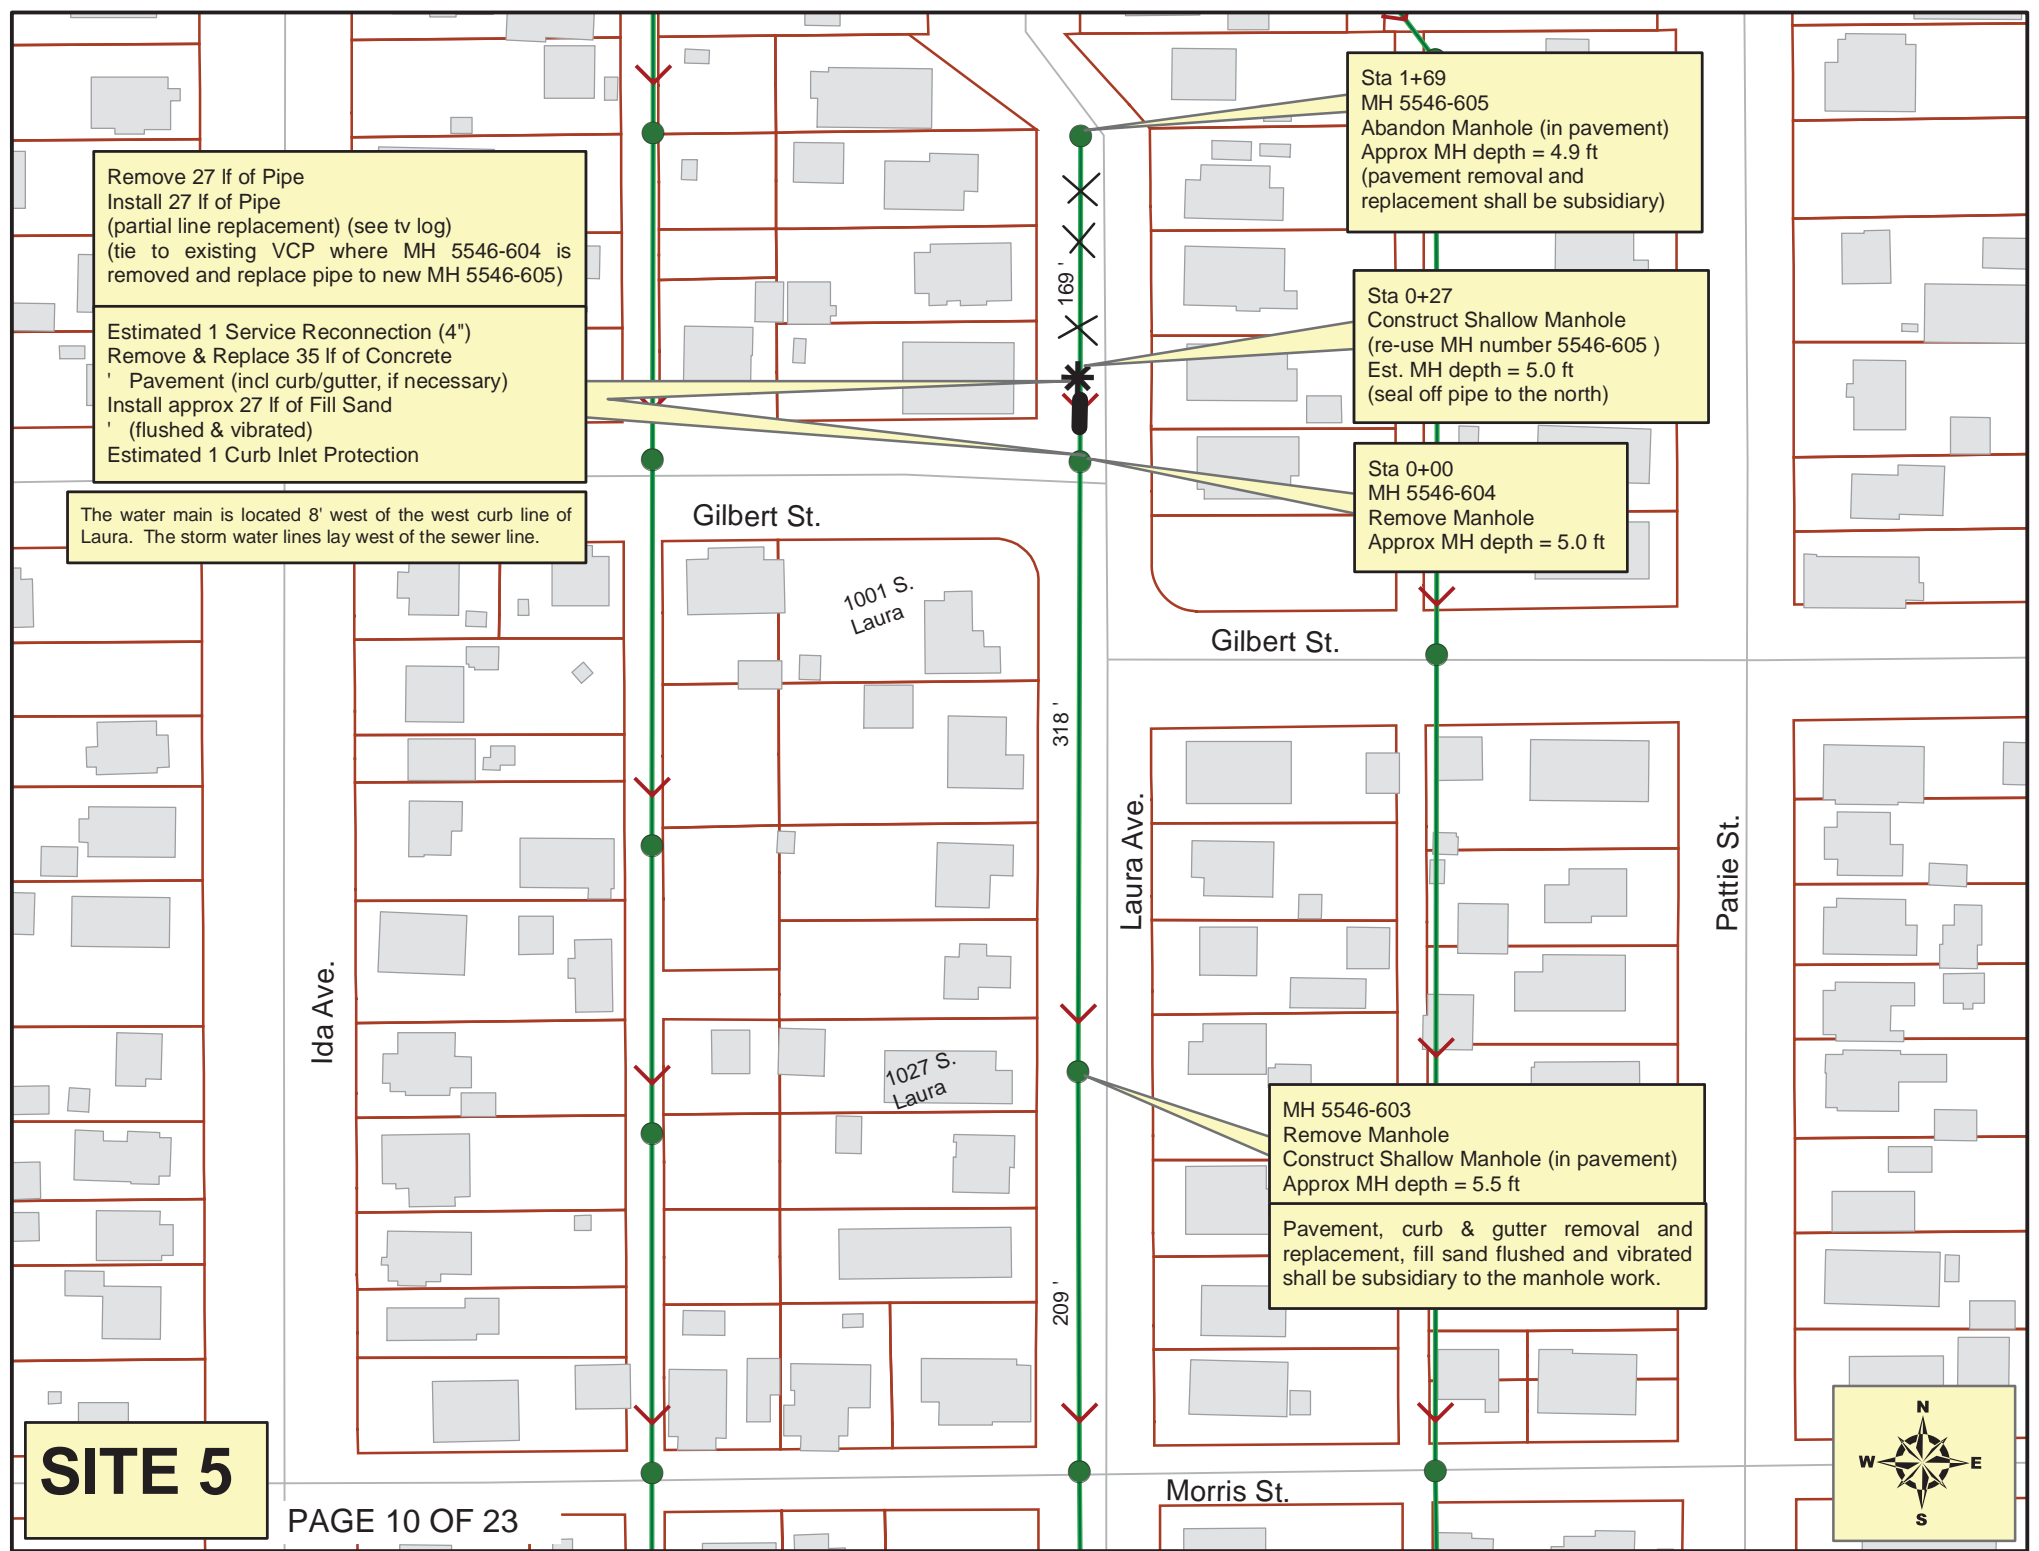
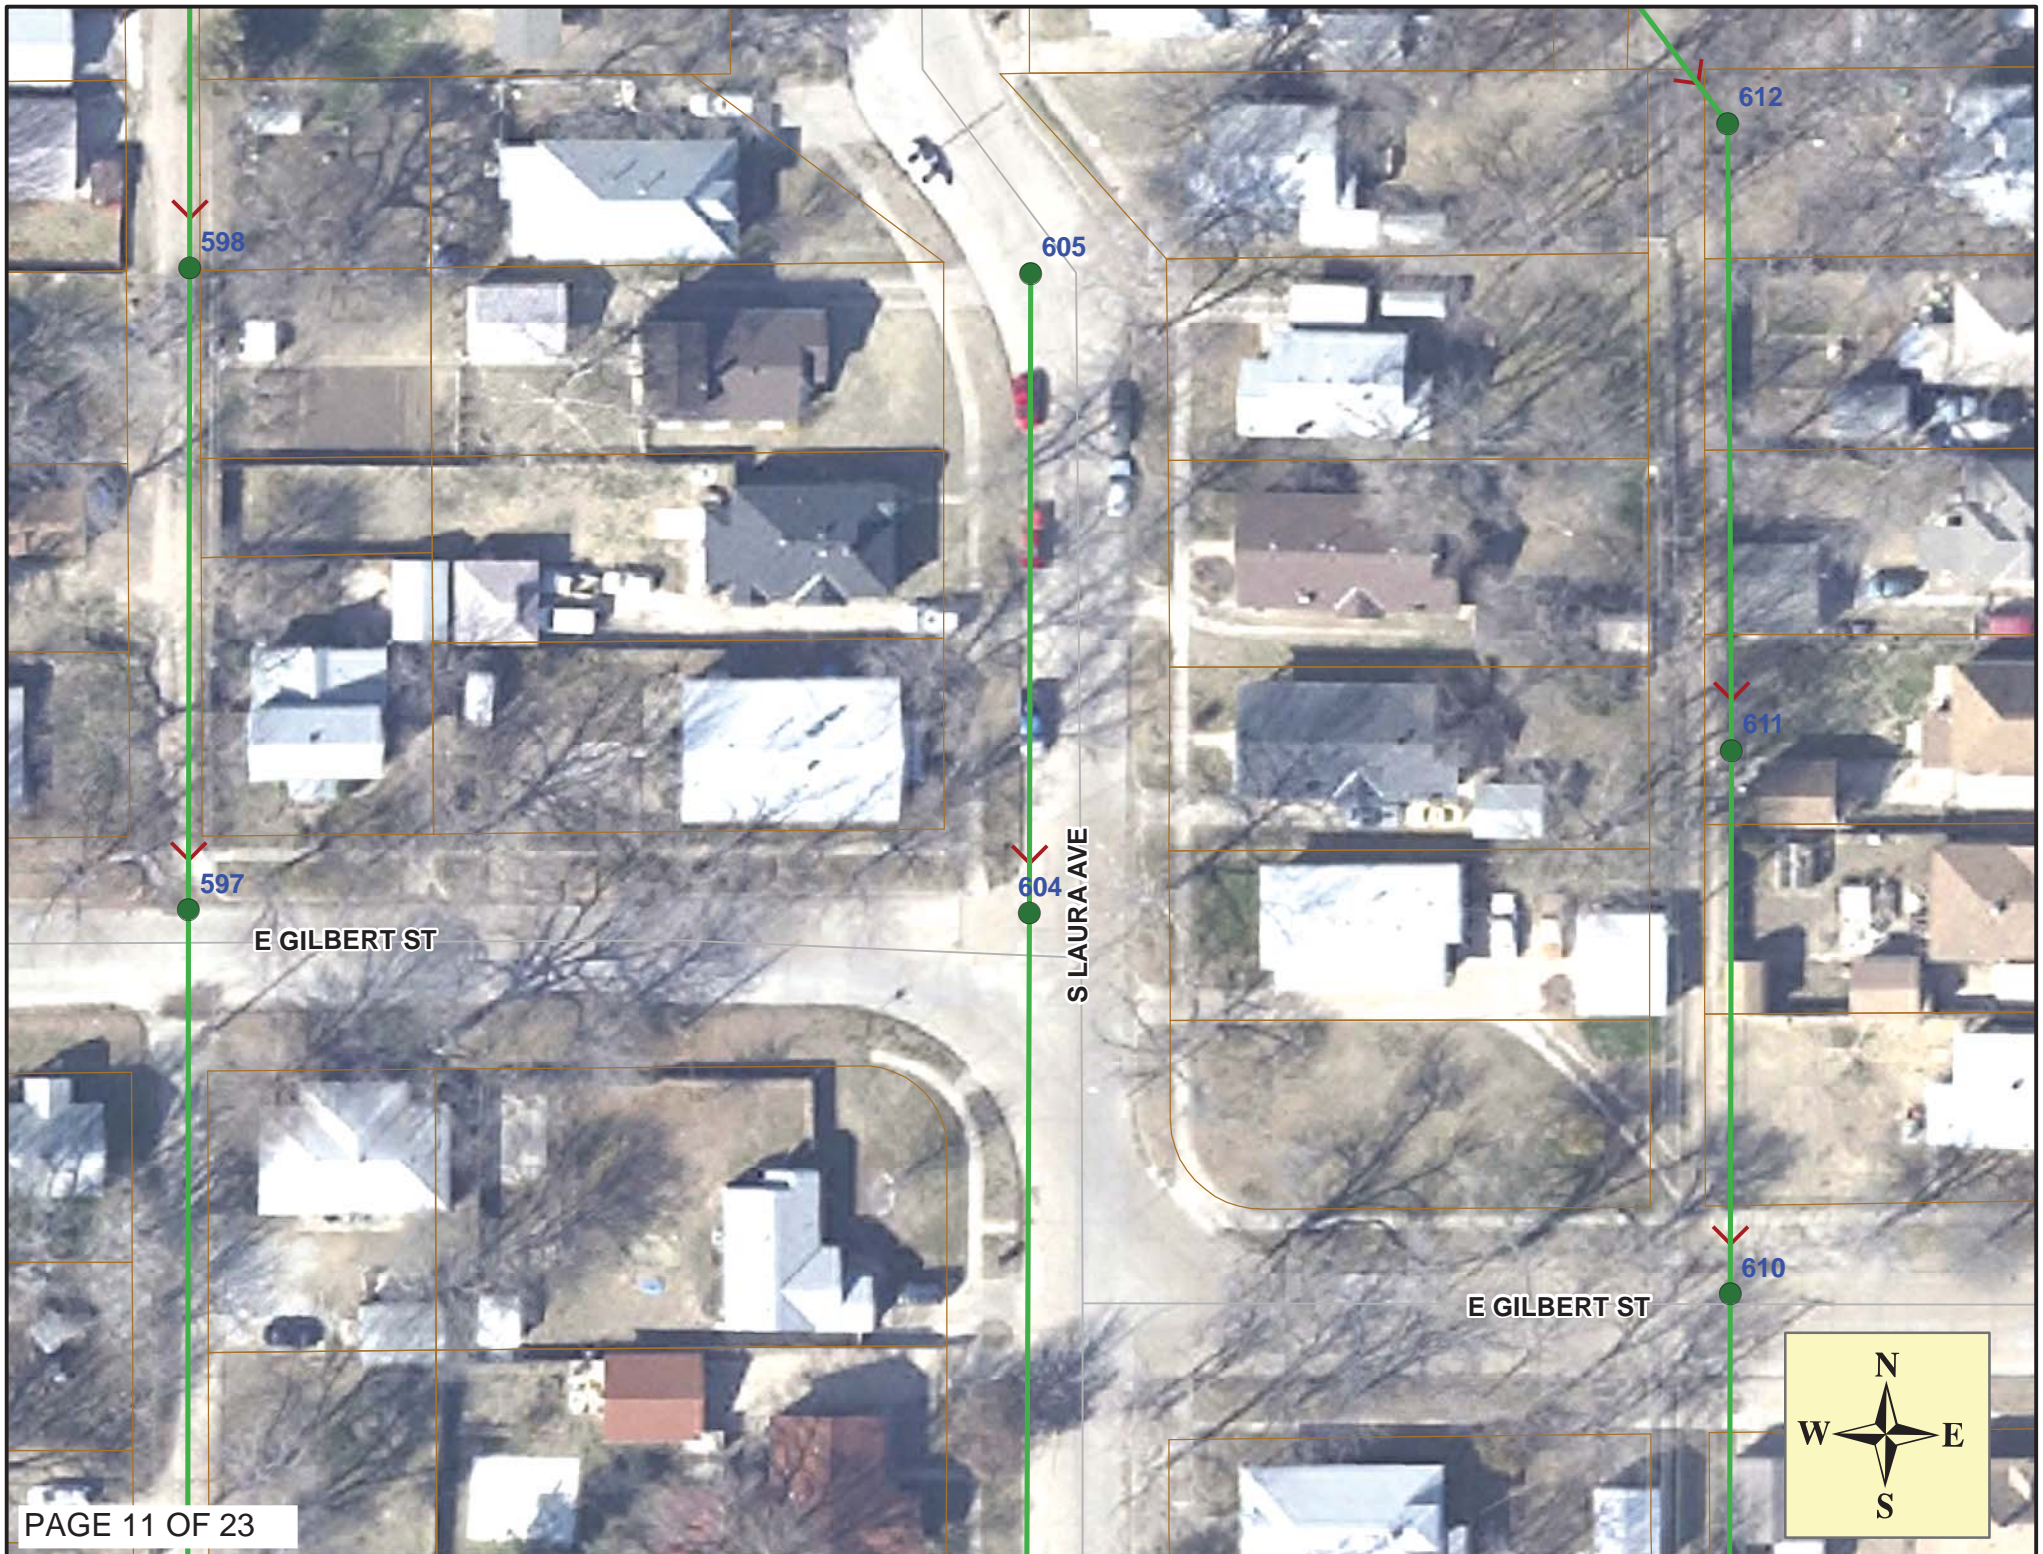
Sta 1+69
MH 5546-605
Abandon Manhole (in pavement)
Approx MH depth = 4.9 ft
(pavement removal and replacement shall be subsidiary)

Sta 0+27
Construct Shallow Manhole
(re-use MH number 5546-605)
Est. MH depth = 5.0 ft
(seal off pipe to the north)

Sta 0+00
MH 5546-604
Remove Manhole
Approx MH depth = 5.0 ft

MH 5546-603
Remove Manhole
Construct Shallow Manhole (in pavement)
Approx MH depth = 5.5 ft

Remove 27 lf of Pipe
Install 27 lf of Pipe
(partial line replacement) (see tv log)
(tie to existing VCP where MH 5546-604 is removed and replace pipe to new MH 5546-605)

Estimated 1 Service Reconnection (4")
Remove & Replace 35 lf of Concrete
Pavement (incl curb/gutter, if necessary)
Install approx 27 lf of Fill Sand
(flushed & vibrated)
Estimated 1 Curb Inlet Protection
