**SITE 7**

# Television Inspection Master Report

US Structure: 5745-114      2001 S OLIVER ST      Date Insp: 3/26/2010      Basin: C01E  
 DS Structure: 5745-113      2033 S OLIVER ST      Dir Televised: Downstream To Upstream

Project No. : E-234      Dia/Ht: 8      Material: VCP      Length: 351.0      Slope: 0.400  
 Crew: 692      Tape ID: DVD #0565

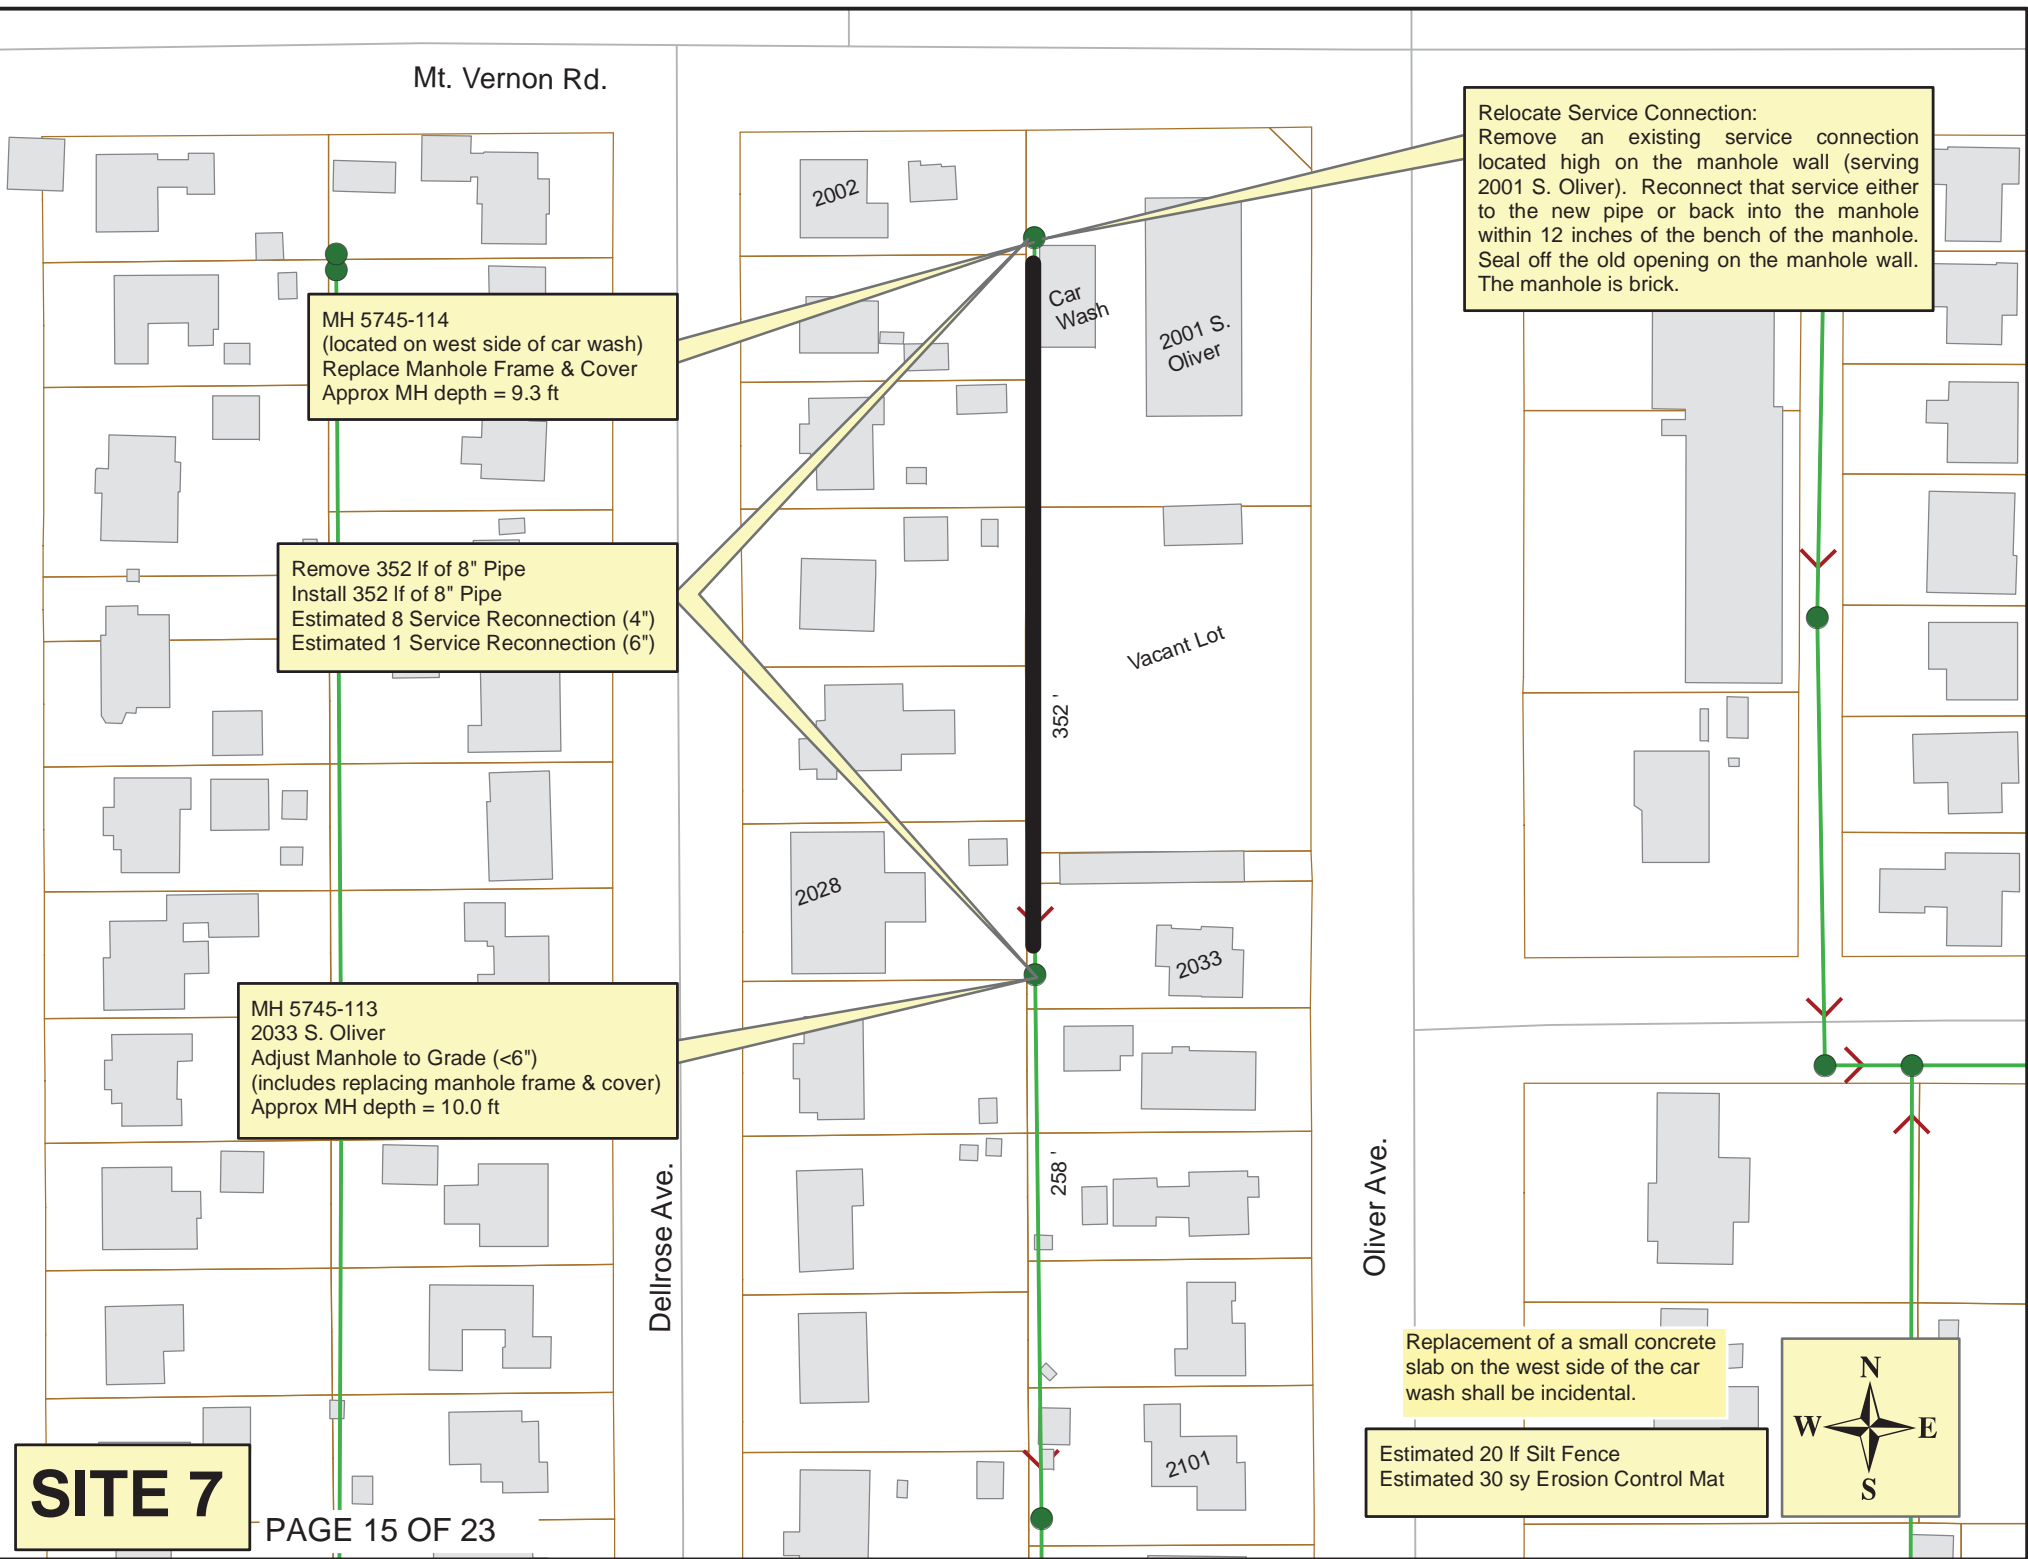
MH 5745-114  
(located on west side of car wash)  
Replace Manhole Frame & Cover  
Approx MH depth = 9.3 ft

MH 5745-113  
2033 S. Oliver  
Adjust Manhole to Grade (<6")  
(includes replacing manhole frame & cover)  
Approx MH depth = 10.0 ft

Relocate Service Connection:  
Remove an existing service connection  
located high on the manhole wall (serving  
2001 S. Oliver). Reconnect that service  
either to the new pipe or back into the manhole  
within 12 inches of the bench of the manhole.  
Seal off the old opening on the manhole wall.  
The manhole is brick.

Remove 352 lf of 8" Pipe  
Install 352 lf of 8" Pipe  
Estimated 8 Service Reconnection (4")  
Estimated 1 Service Reconnection (6")

Replacement of a small concrete  
slab on the west side of the car  
wash shall be incidental.  
Estimated 20 lf Silt Fence  
Estimated 30 sy Erosion Control Mat
