Television Inspection Master Report

US Manhole: 5744-800
DS Manhole: 5744-791

2970 S SAYLES AVE
3030 S SAYLES CT

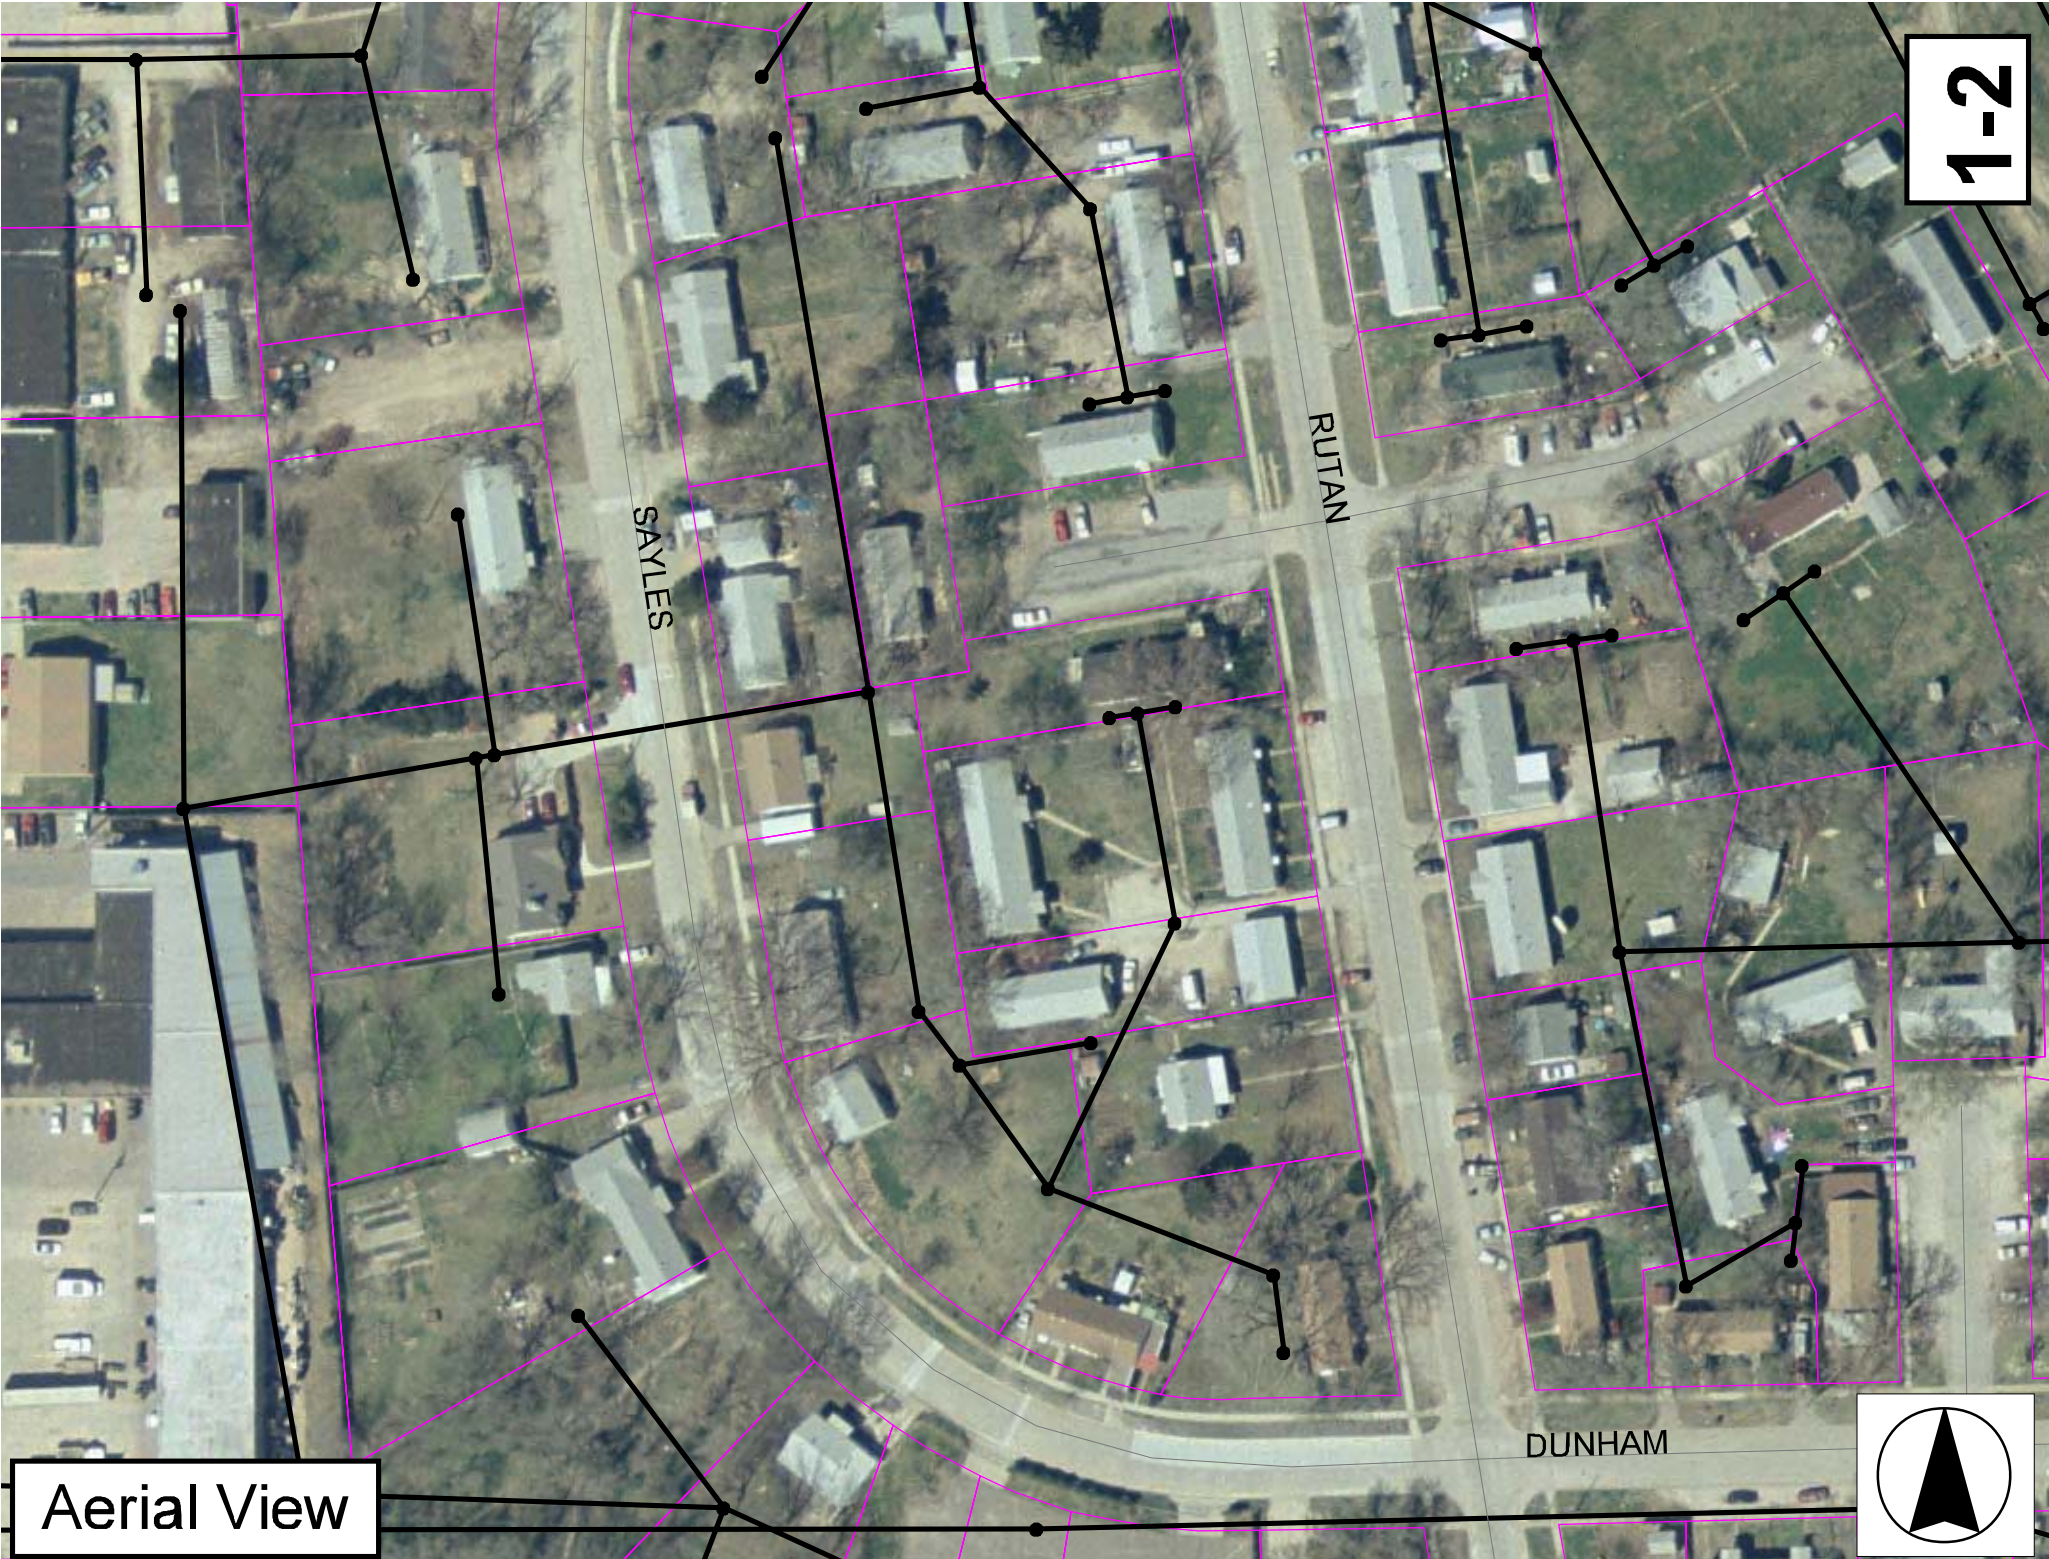
1-2

MH # 5744-146
Rework Manhole Bench & Invert
(to include sealing around the pipe entering the manhole from the west)
Approx depth = 6.6 ft.

MH # 5744-798 (Cleanout)
Construct Shallow Manhole where the cleanout/bend exists
Approx depth = 4.5 ft

MH # 5744-799
Replace Manhole Frame & Cover
Approx depth = 4.2 ft

MH # 5744-800
Approx depth = 10.0 ft

MH # 5744-791
Replace Manhole Frame & Cover
Approx depth = 8.1 ft

MH # 5744-792
NOT FOUND

MH # 5744-793
Replace Manhole Frame & Cover
Rework Manhole Bench & Invert
Approx depth = 6.9 ft

Remove and replace 290 lf of 8" pipe from MH 5744-800 to MH 5744-791

Remove 239 lf of 6" pipe and install 239 lf of 8" pipe from MH 5744-799 to MH 5744-146

Remove and replace 192 lf of 8" pipe from MH 5744-146 to MH 5744-791 (straight line - as though MH 5744-792 doesn't exist)
