MAP 3

Television Inspection Master Report

US Manhole: 5744-688
DS Manhole: 5744-686

3129 S CLIFTON ST

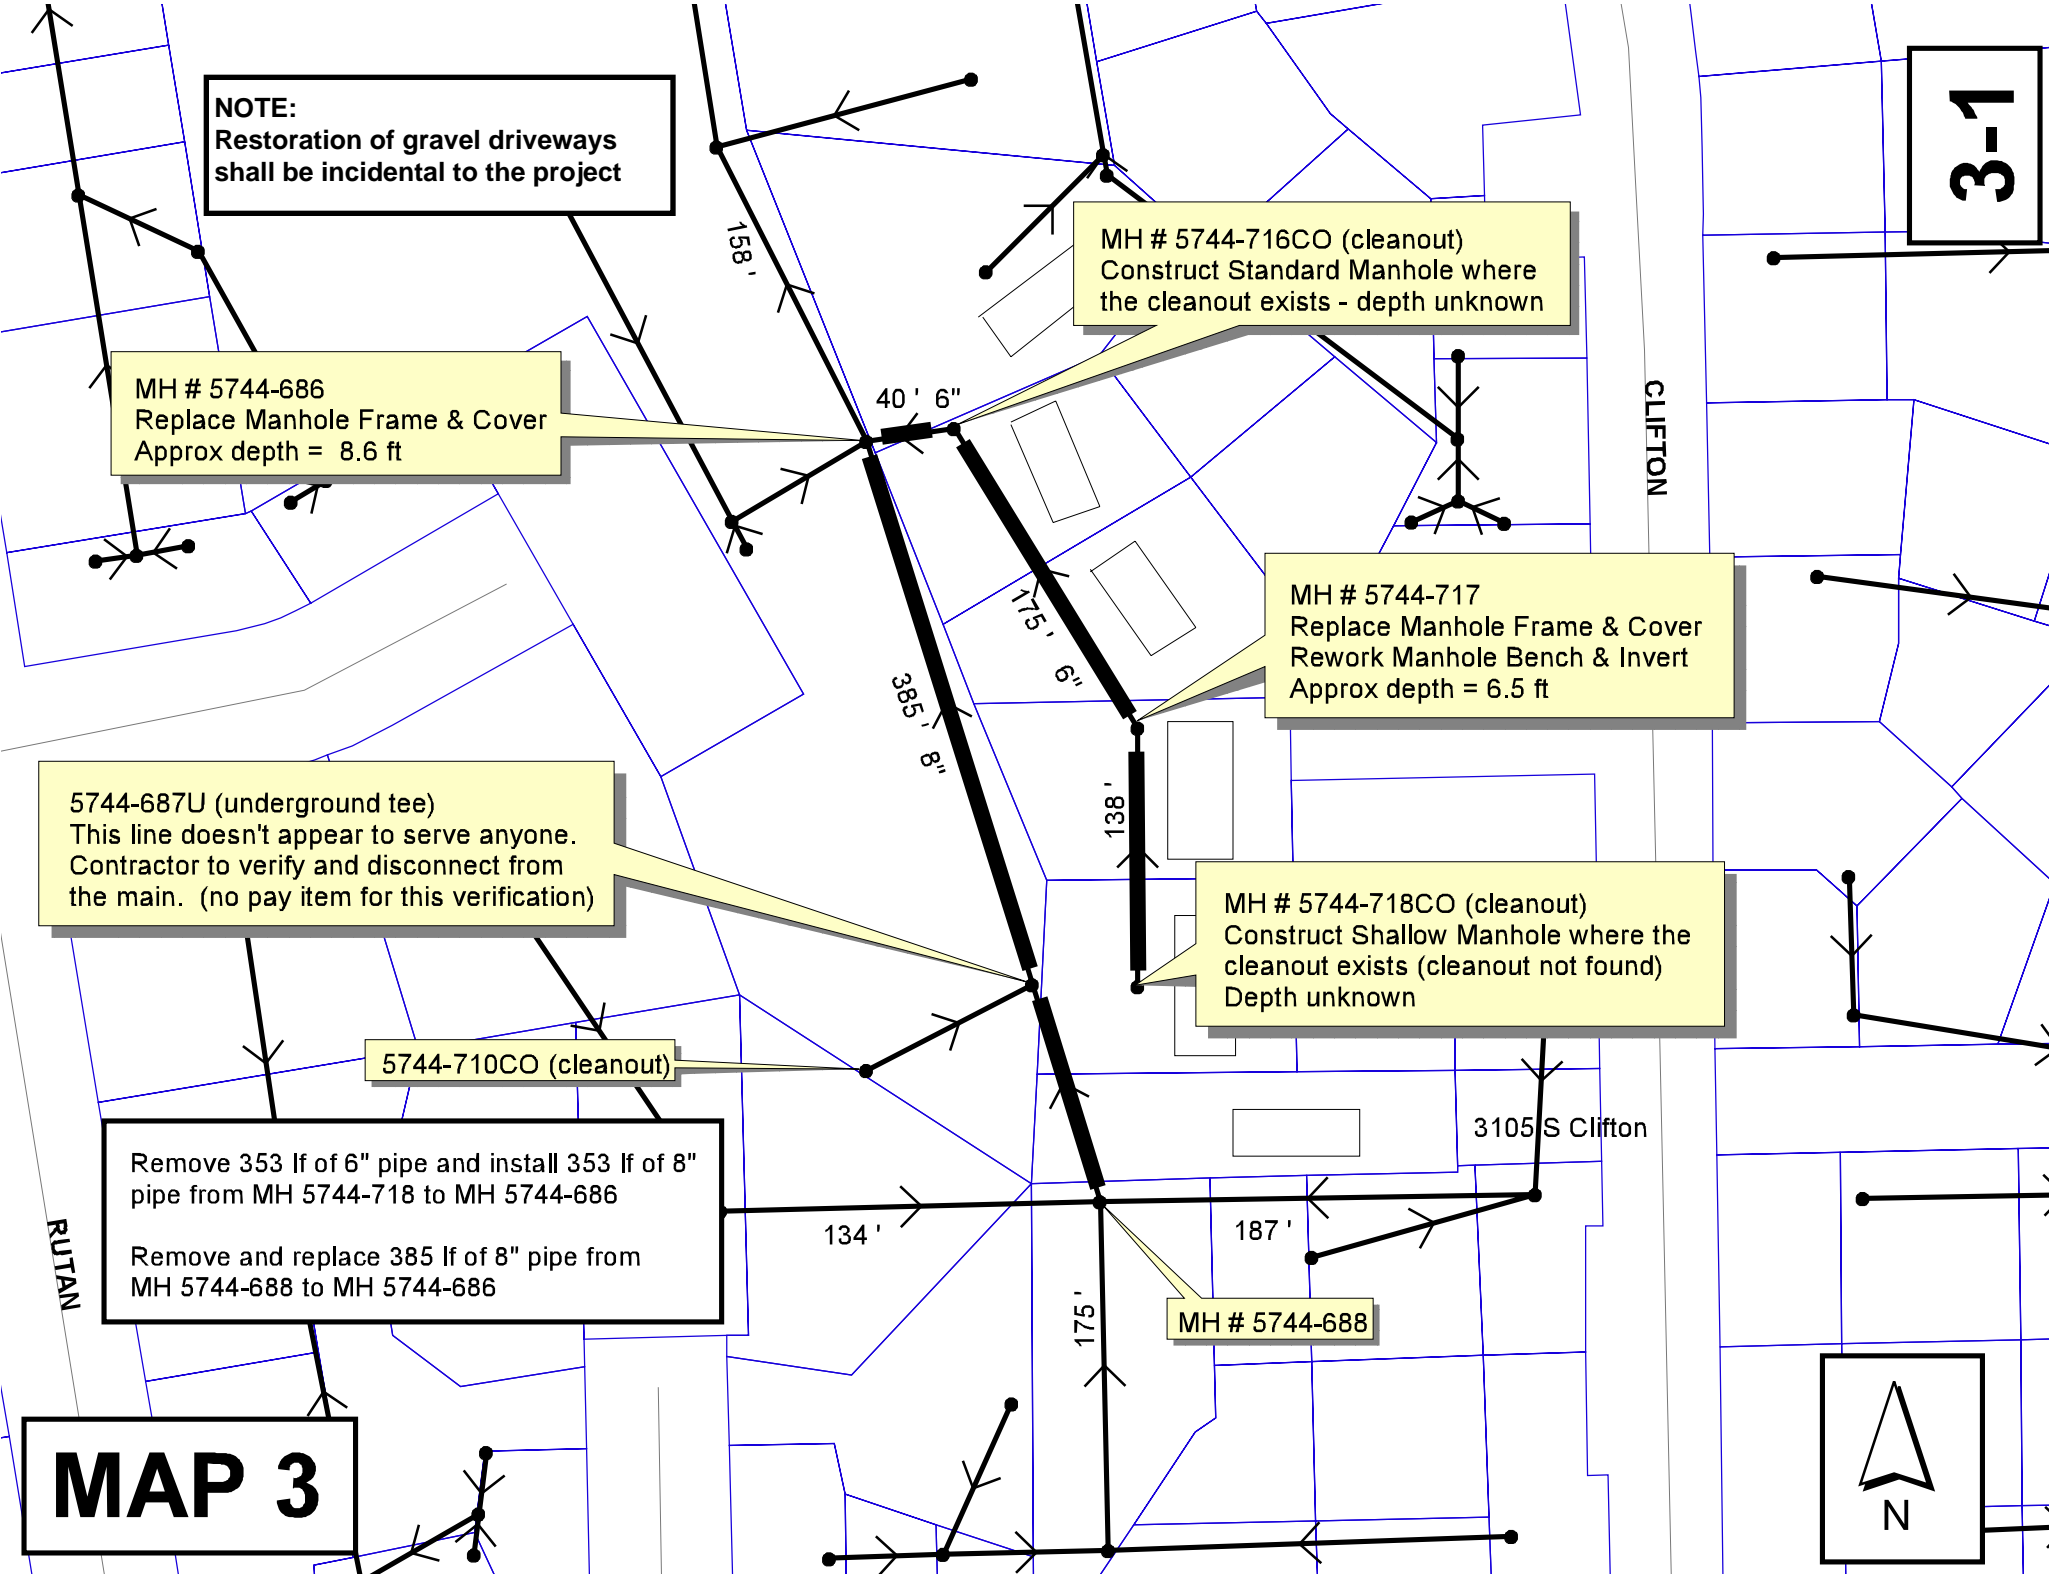
MH # 5744-686
Replace Manhole Frame & Cover
Approx depth = 8.6 ft

MH # 5744-716CO (cleanout)
Construct Standard Manhole where
the cleanout exists - depth unknown

MH # 5744-717
Replace Manhole Frame & Cover
Rework Manhole Bench & Invert
Approx depth = 6.5 ft

5744-687U (underground tee)
This line doesn't appear to serve anyone.
Contractor to verify and disconnect from
the main. (no pay item for this verification)

MH # 5744-718CO (cleanout)
Construct Shallow Manhole where the
cleanout exists (cleanout not found)
Depth unknown

Remove 353 lf of 6" pipe and install 353 lf of 8" pipe from MH 5744-718 to MH 5744-686
Remove and replace 385 lf of 8" pipe from MH 5744-688 to MH 5744-686
