Aerial View

# Television Inspection Master Report

3108 S RUTAN ST

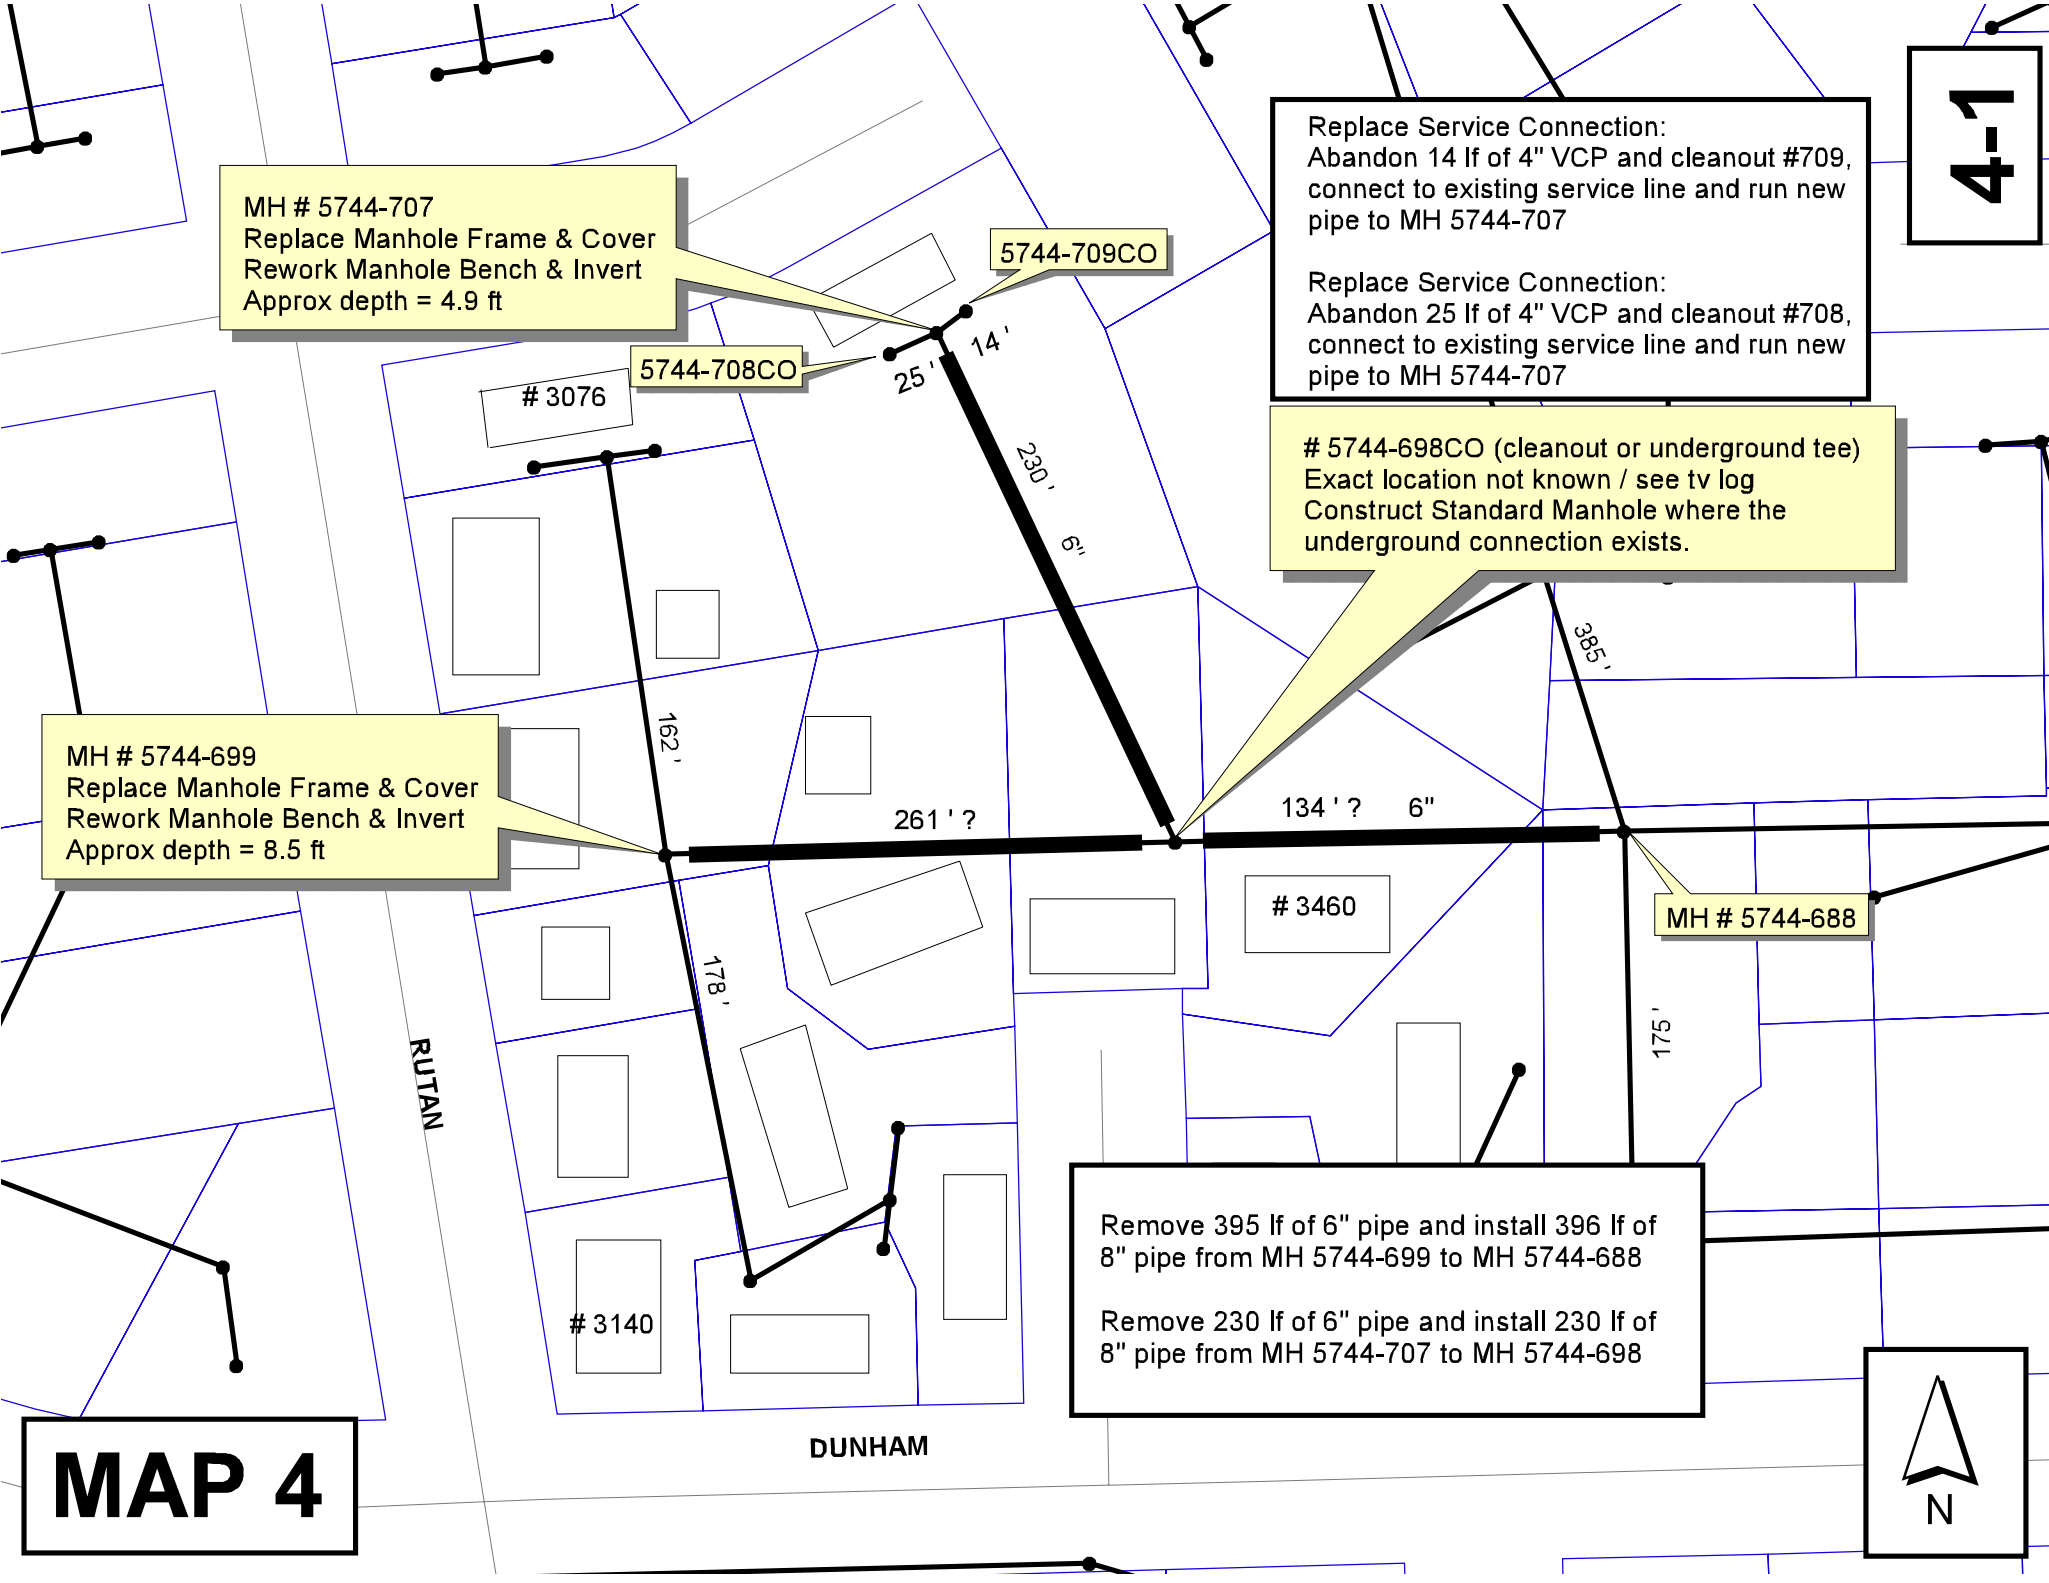
# 5744-698CO (cleanout or underground tee)  
Exact location not known / see tv log  
Construct Standard Manhole where the  
underground connection exists.

MH # 5744-707  
Replace Manhole Frame & Cover  
Rework Manhole Bench & Invert  
Approx depth = 4.9 ft

Replace Service Connection:  
Abandon 14 lf of 4" VCP and cleanout #709,  
connect to existing service line and run new  
pipe to MH 5744-707

Replace Service Connection:  
Abandon 25 lf of 4" VCP and cleanout #708,  
connect to existing service line and run new  
pipe to MH 5744-707

MH # 5744-699  
Replace Manhole Frame & Cover  
Rework Manhole Bench & Invert  
Approx depth = 8.5 ft

Remove 395 lf of 6" pipe and install 396 lf of  
8" pipe from MH 5744-699 to MH 5744-688

Remove 230 lf of 6" pipe and install 230 lf of  
8" pipe from MH 5744-707 to MH 5744-699
