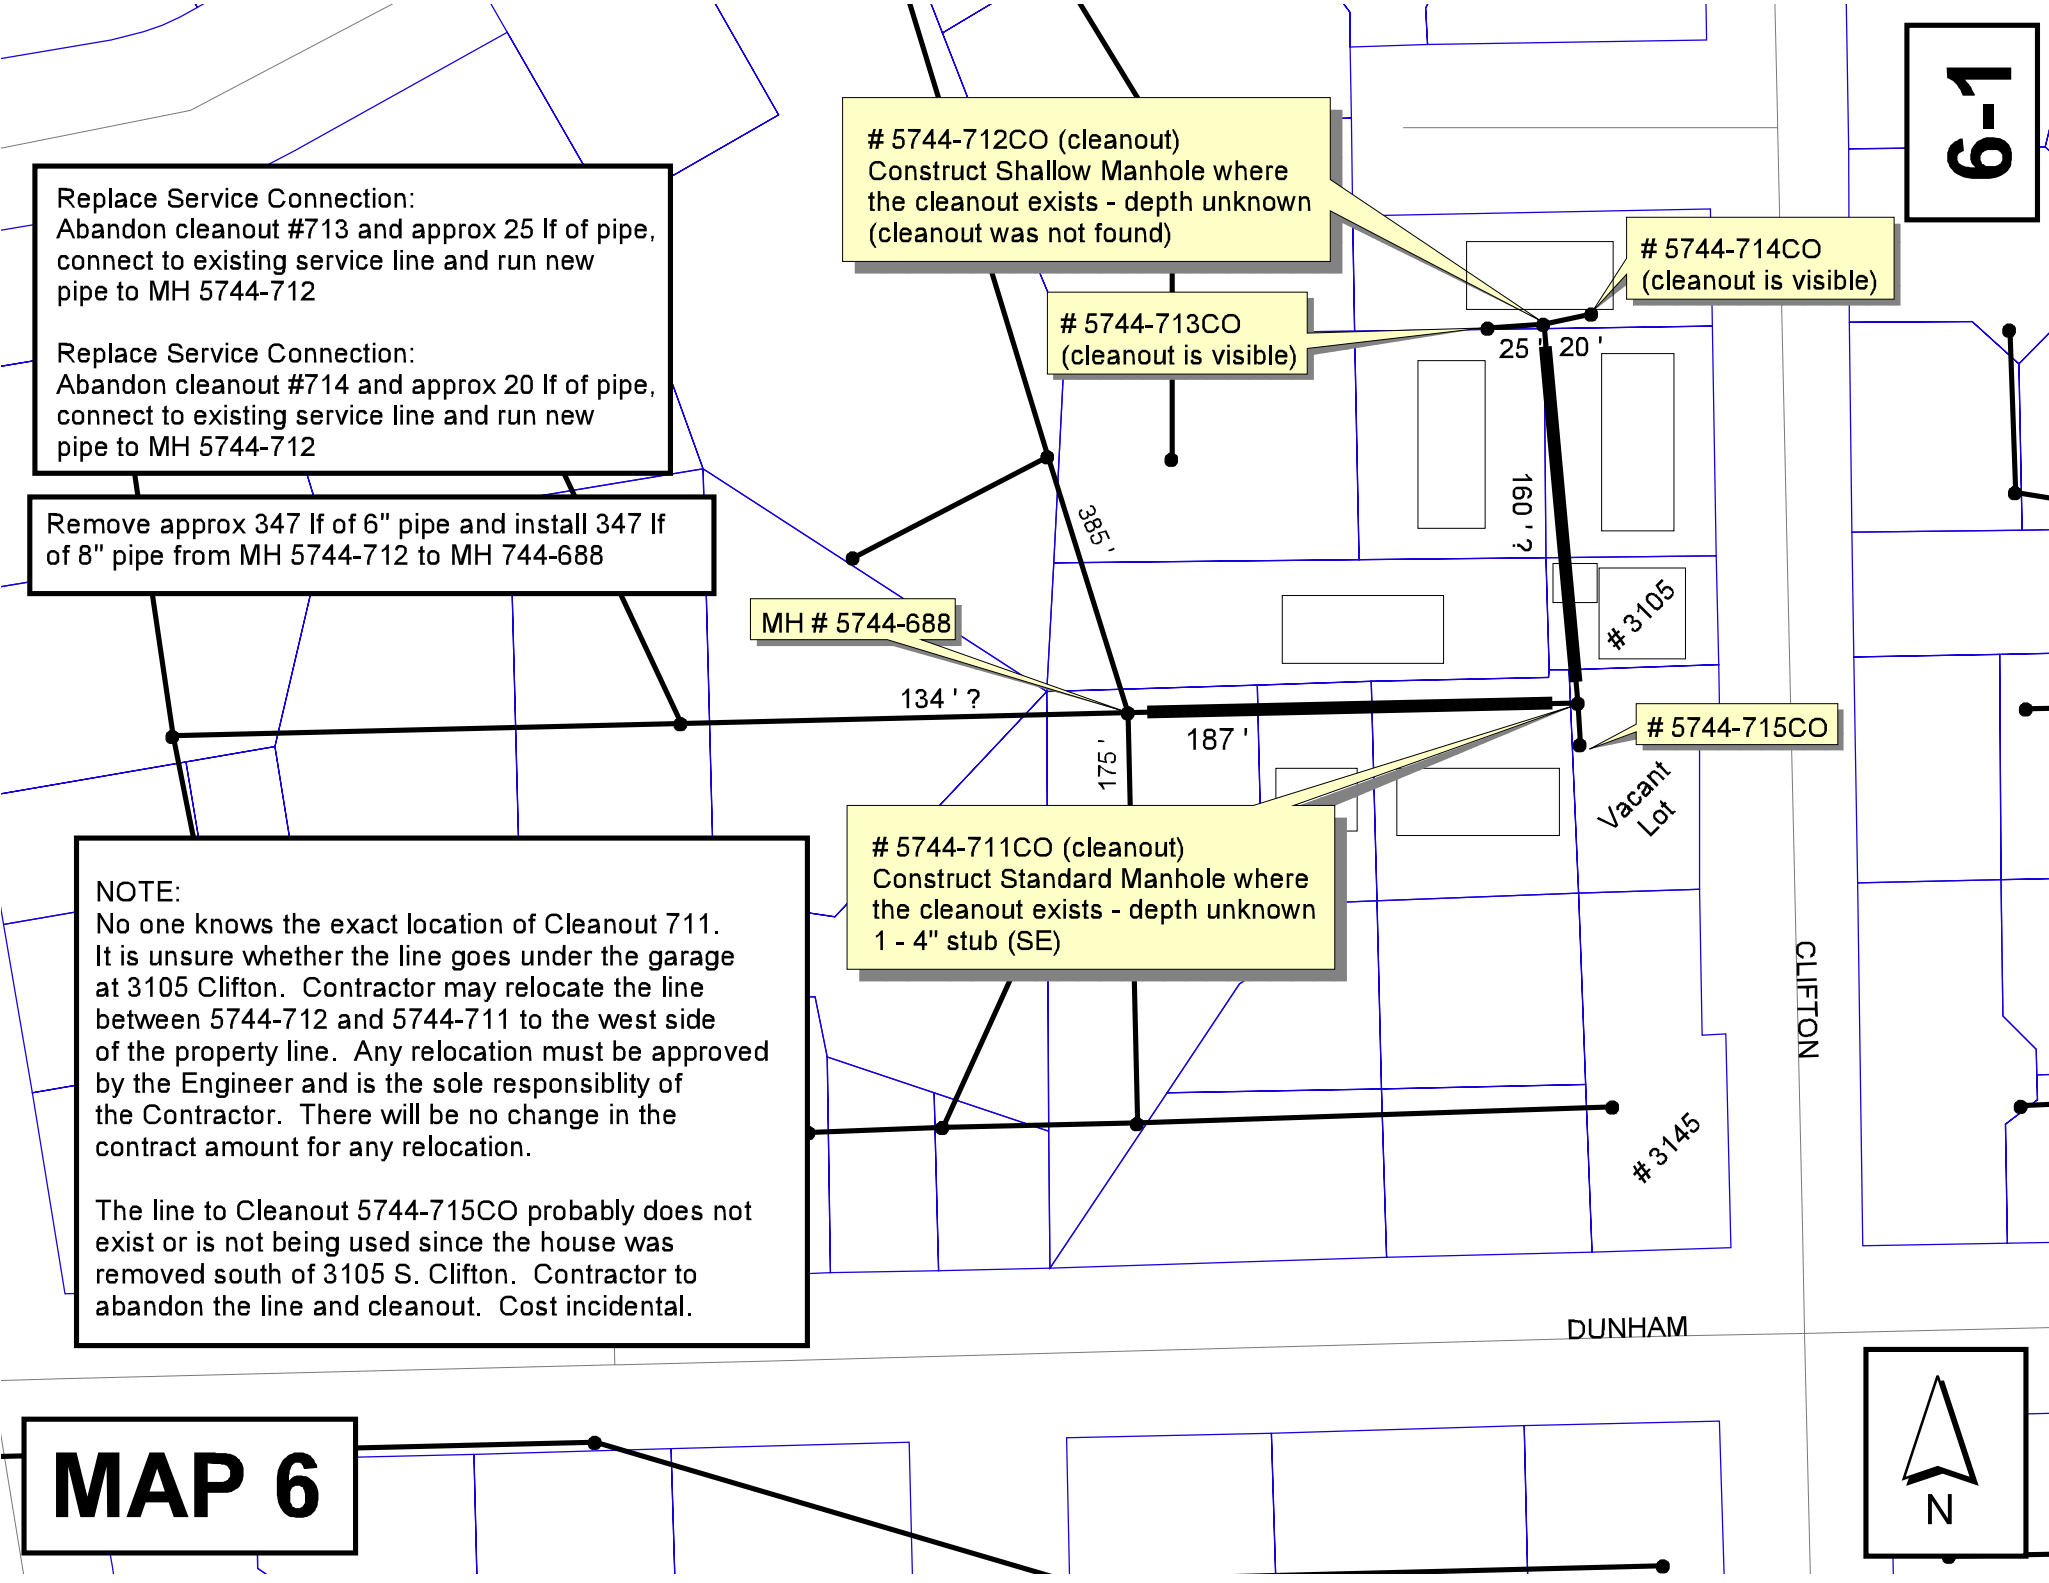
6-2

5744-712CO (cleanout)
Construct Shallow Manhole where the cleanout exists - depth unknown (cleanout was not found)

5744-713CO
(cleanout is visible)

5744-714CO
(cleanout is visible)

5744-711CO (cleanout)
Construct Standard Manhole where the cleanout exists - depth unknown 1 - 4" stub (SE)

NOTE:
No one knows the exact location of Cleanout 711. It is unsure whether the line goes under the garage at 3105 Clifton. Contractor may relocate the line between 5744-712 and 5744-711 to the west side of the property line. Any relocation must be approved by the Engineer and is the sole responsibility of the Contractor. There will be no change in the contract amount for any relocation.

The line to Cleanout 5744-715CO probably does not exist or is not being used since the house was removed south of 3105 S. Clifton. Contractor to abandon the line and cleanout. Cost incidental.

Replace Service Connection:
Abandon cleanout #713 and approx 25 lf of pipe, connect to existing service line and run new pipe to MH 5744-712

Replace Service Connection:
Abandon cleanout #714 and approx 20 lf of pipe, connect to existing service line and run new pipe to MH 5744-712

Remove approx 347 lf of 6" pipe and install 347 lf of 8" pipe from MH 5744-712 to MH 744-688
