ROSS PARKWAY

# Television Inspection Master Report

**US Manhole:** 5744-910  
**DS Manhole:** 5744-909

4005 E ROSS PKWY  
4025 E ROSS PKWY

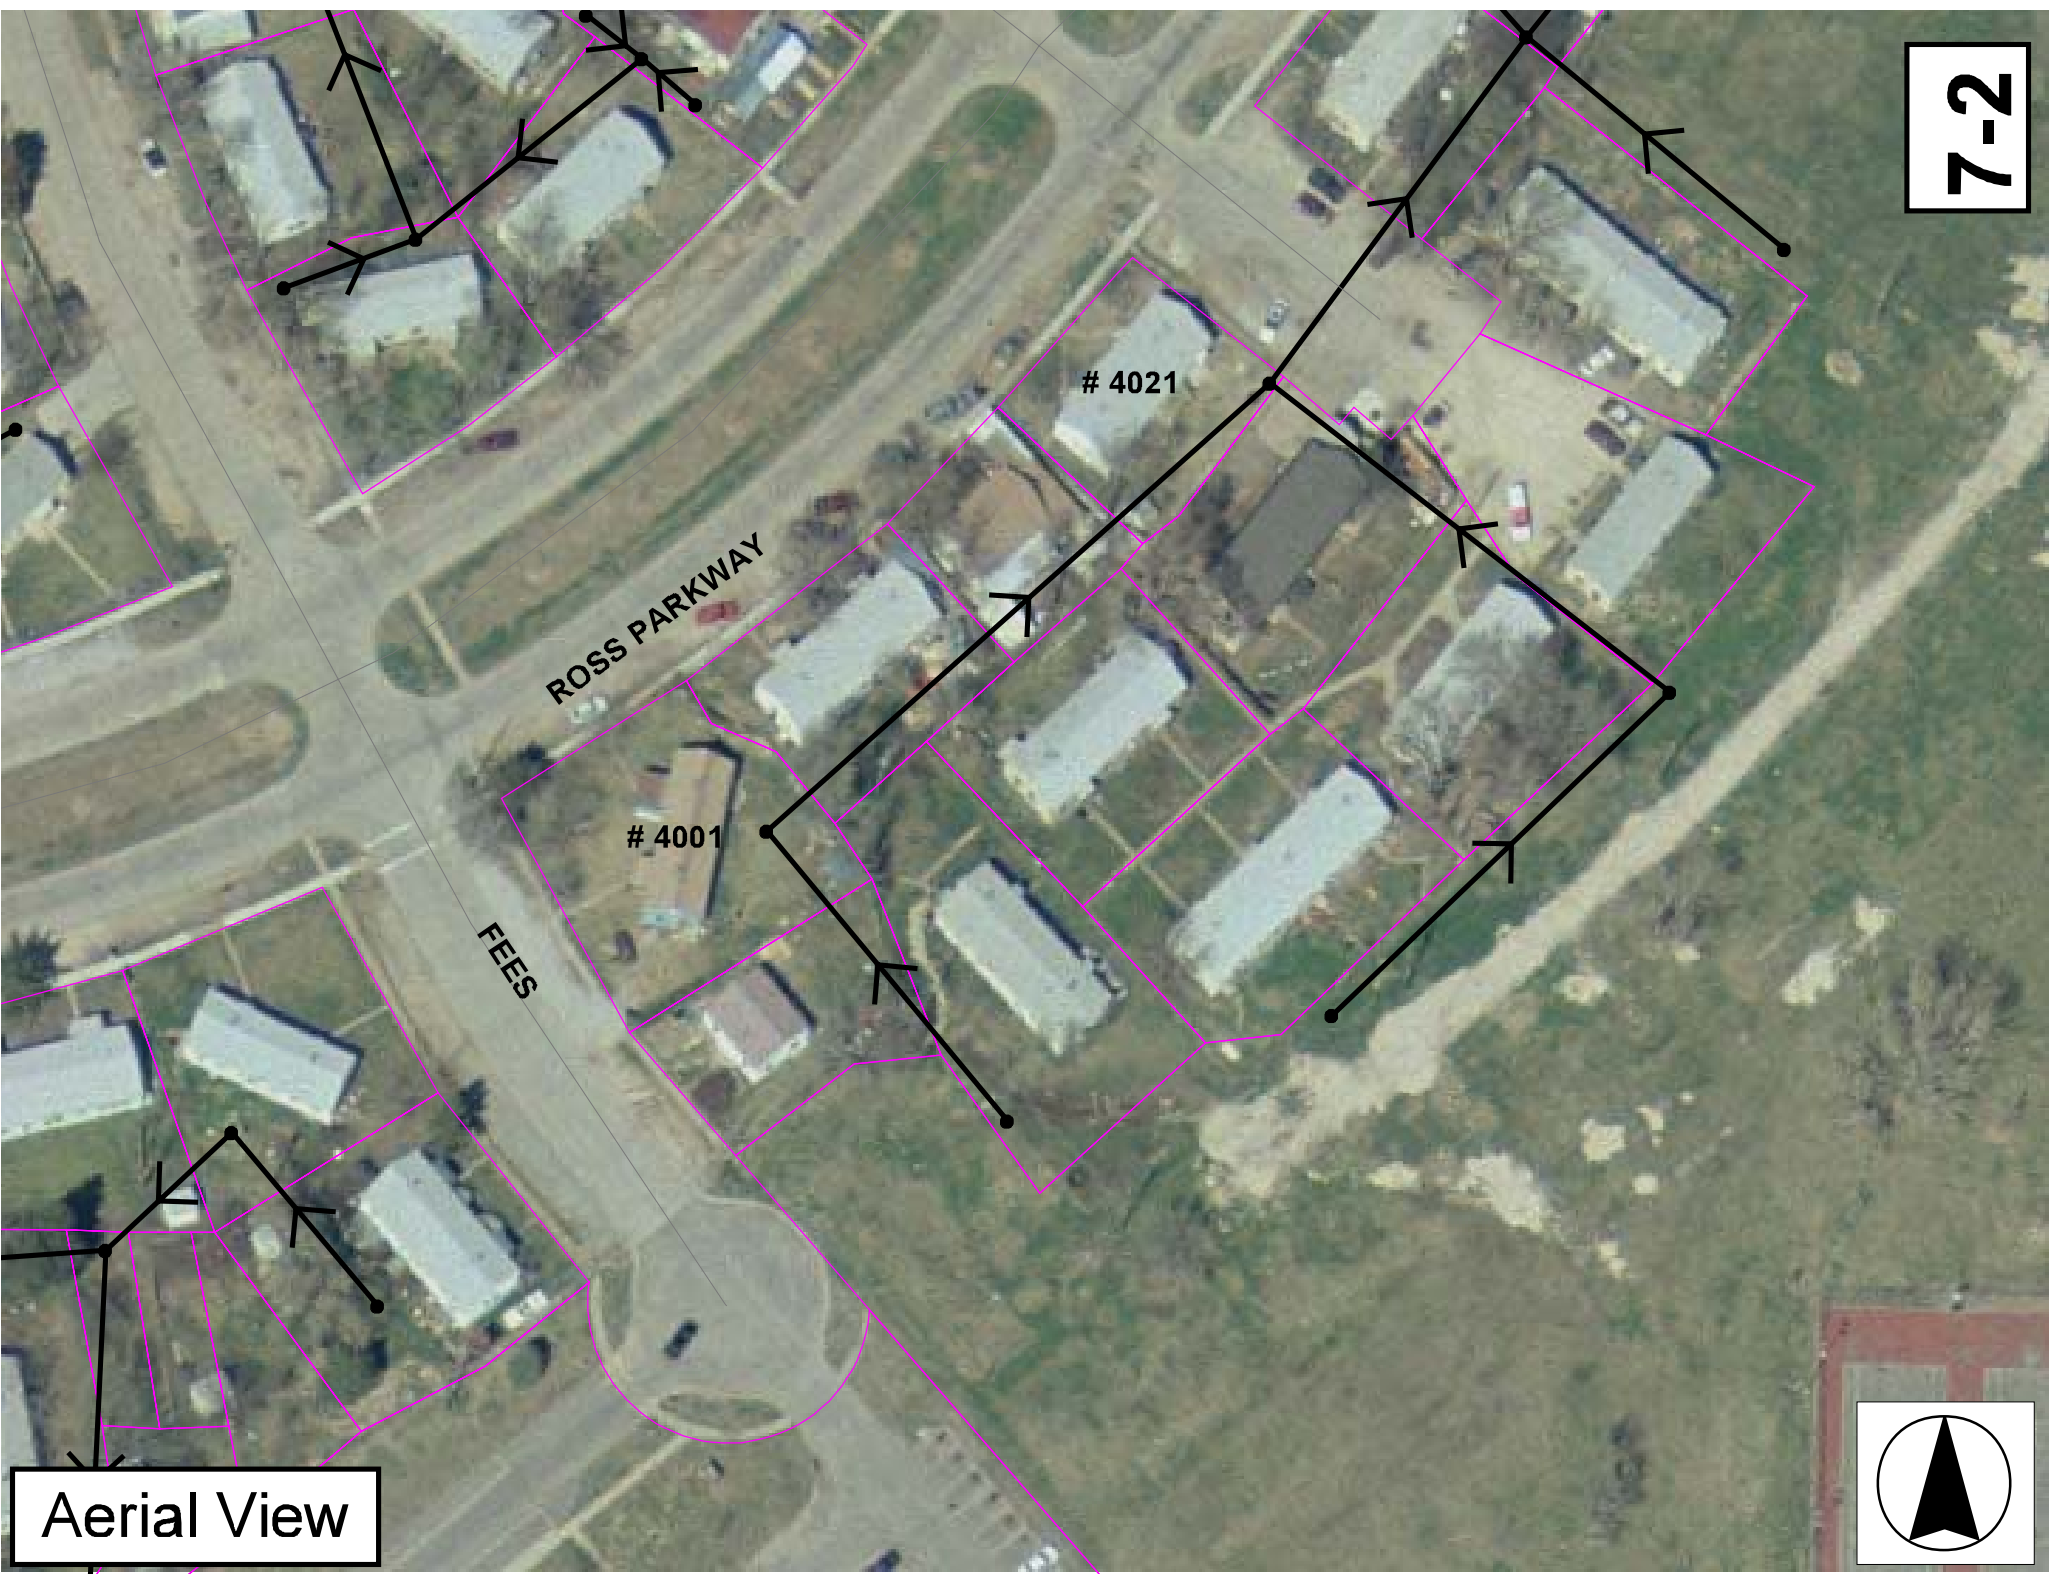
Aerial View

MH # 5744-910  
Approx depth = 9.7 ft

MH # 5744-909  
Approx depth = 4.4 ft

Remove 238 lf of 6" pipe and  
install 238 lf of 8" pipe
