**Remove and replace 151 lf of 8" pipe from MH 5744-215 to MH 5744-213**

**MAP 3**

# Television Inspection Master Report

US Manhole: 5744-215 2629 S FEES ST  
DS Manhole: 5744-214U (underground union)

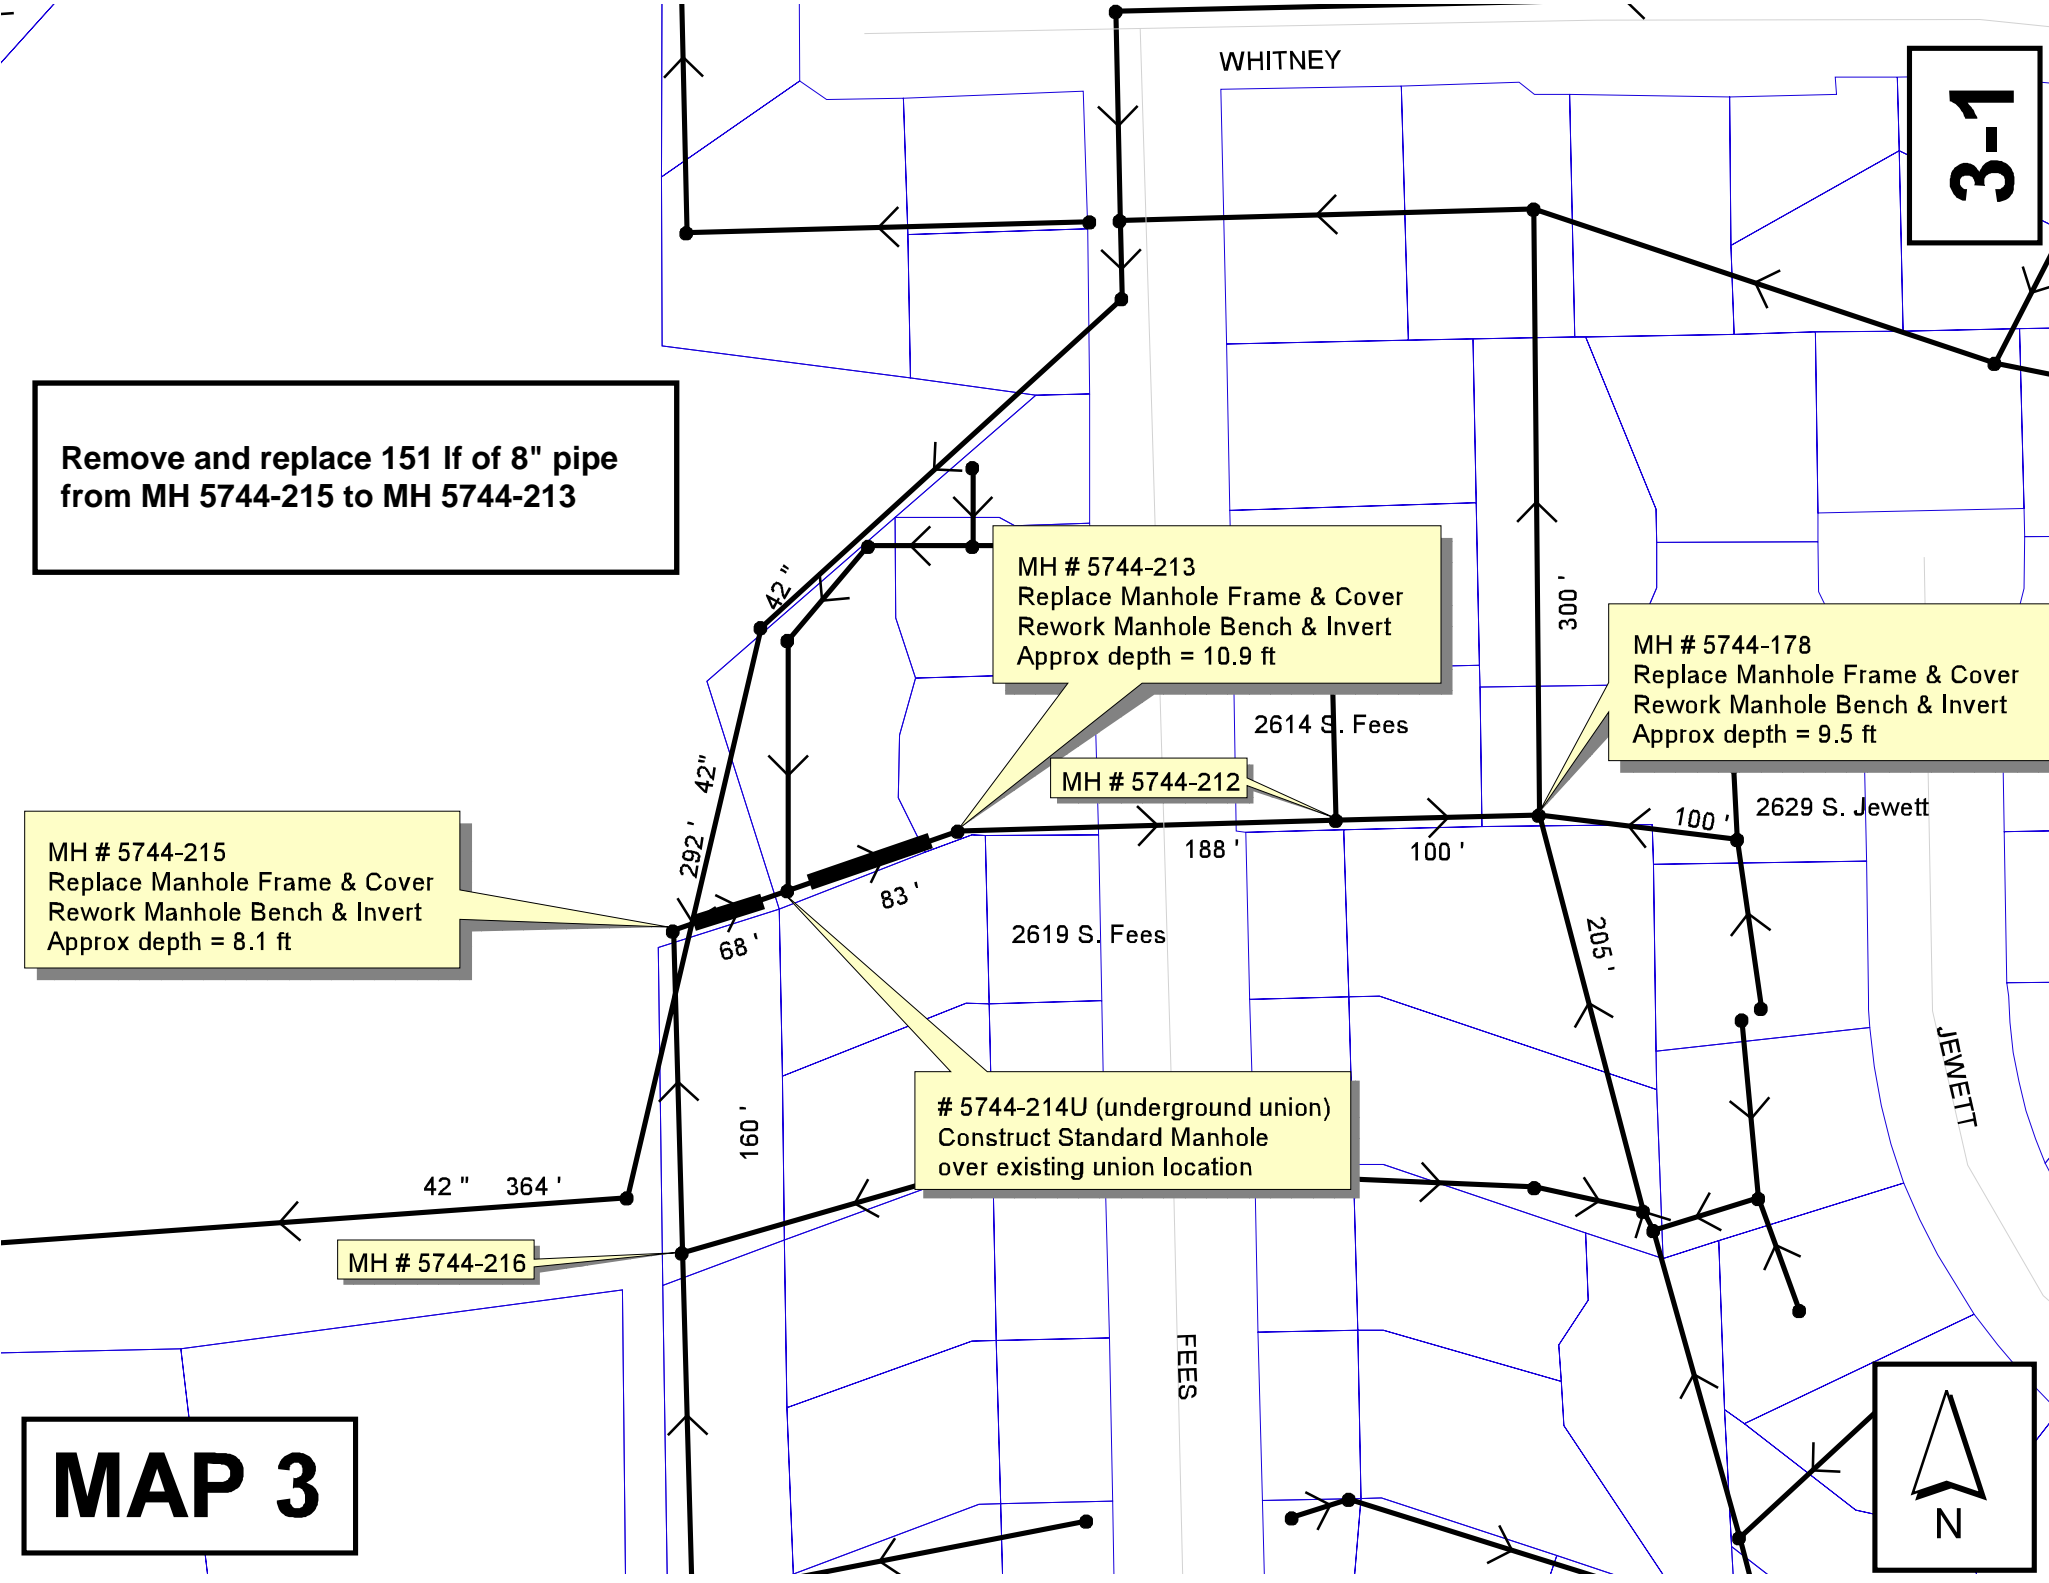
MH # 5744-213  
Replace Manhole Frame & Cover  
Rework Manhole Bench & Invert  
Approx depth = 10.9 ft

MH # 5744-178  
Replace Manhole Frame & Cover  
Rework Manhole Bench & Invert  
Approx depth = 9.5 ft

MH # 5744-215  
Replace Manhole Frame & Cover  
Rework Manhole Bench & Invert  
Approx depth = 8.1 ft

# 5744-214U (underground union)  
Construct Standard Manhole  
over existing union location
