# Television Inspection Master Report

US Manhole: 5744-724  
DS Manhole: 5744-723 3537 E SUNNYBROOK ST

US Manhole: 5744-723  
DS Manhole: 5744-684

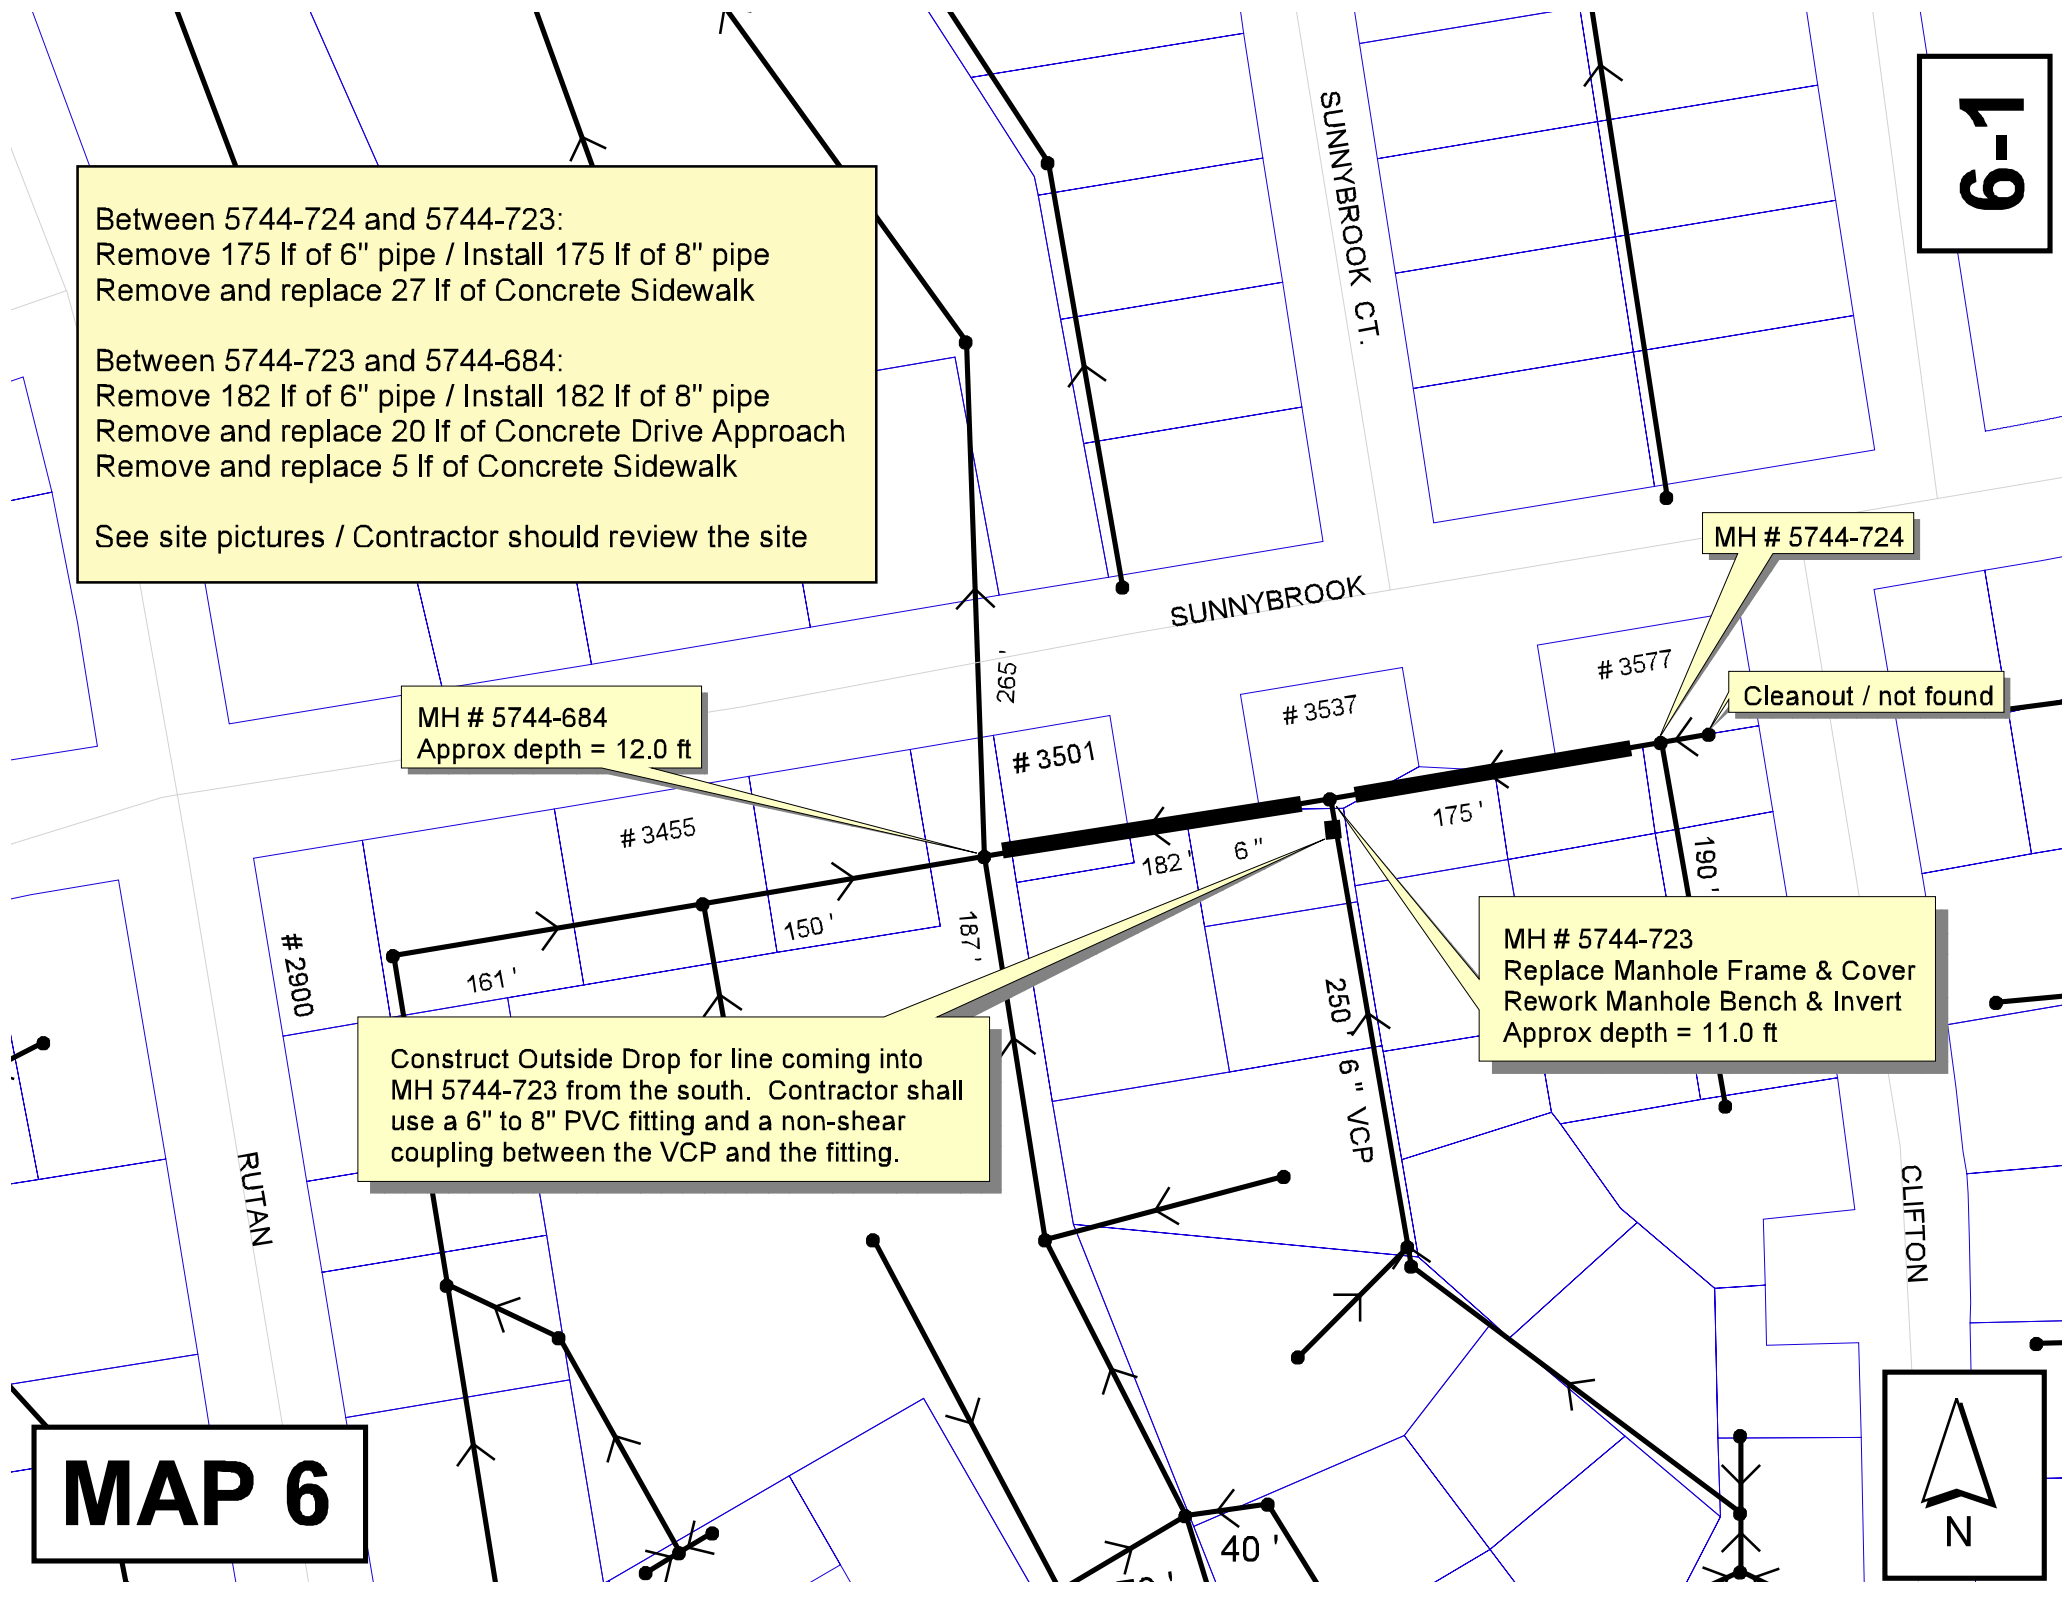
6-2

MH # 5744-684  
Approx depth = 12.0 ft

MH # 5744-723  
Replace Manhole Frame & Cover  
Rework Manhole Bench & Invert  
Approx depth = 11.0 ft

MH # 5744-724

Cleanout / not found

Between 5744-724 and 5744-723:  
Remove 175 lf of 6" pipe / Install 175 lf of 8" pipe  
Remove and replace 27 lf of Concrete Sidewalk

Between 5744-723 and 5744-684:  
Remove 182 lf of 6" pipe / Install 182 lf of 8" pipe  
Remove and replace 20 lf of Concrete Drive Approach  
Remove and replace 5 lf of Concrete Sidewalk

Construct Outside Drop for line coming into  
MH 5744-723 from the south. Contractor shall  
use a 6" to 8" PVC fitting and a non-shear  
coupling between the VCP and the fitting.

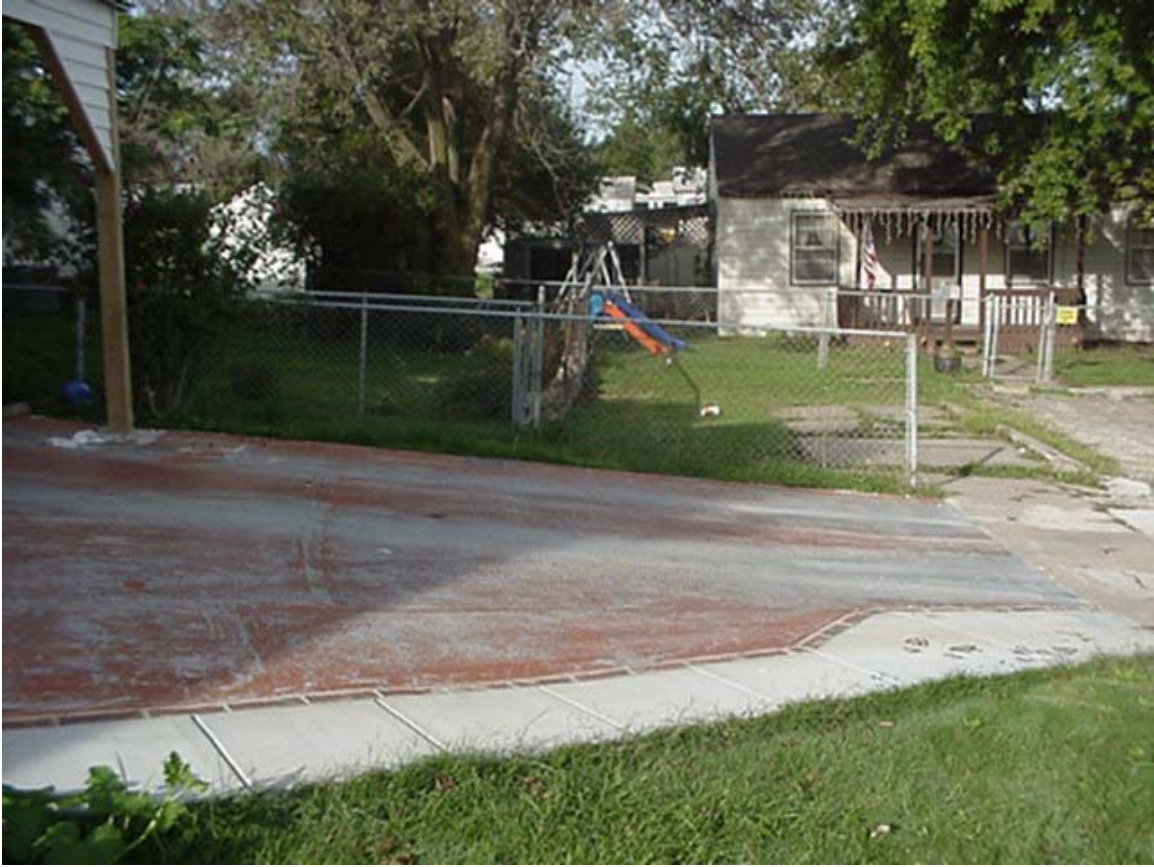
**6-5**

Standing west of MH 5744-723, looking west. There is a porch over the sewer line. Contractor needs to view the area.

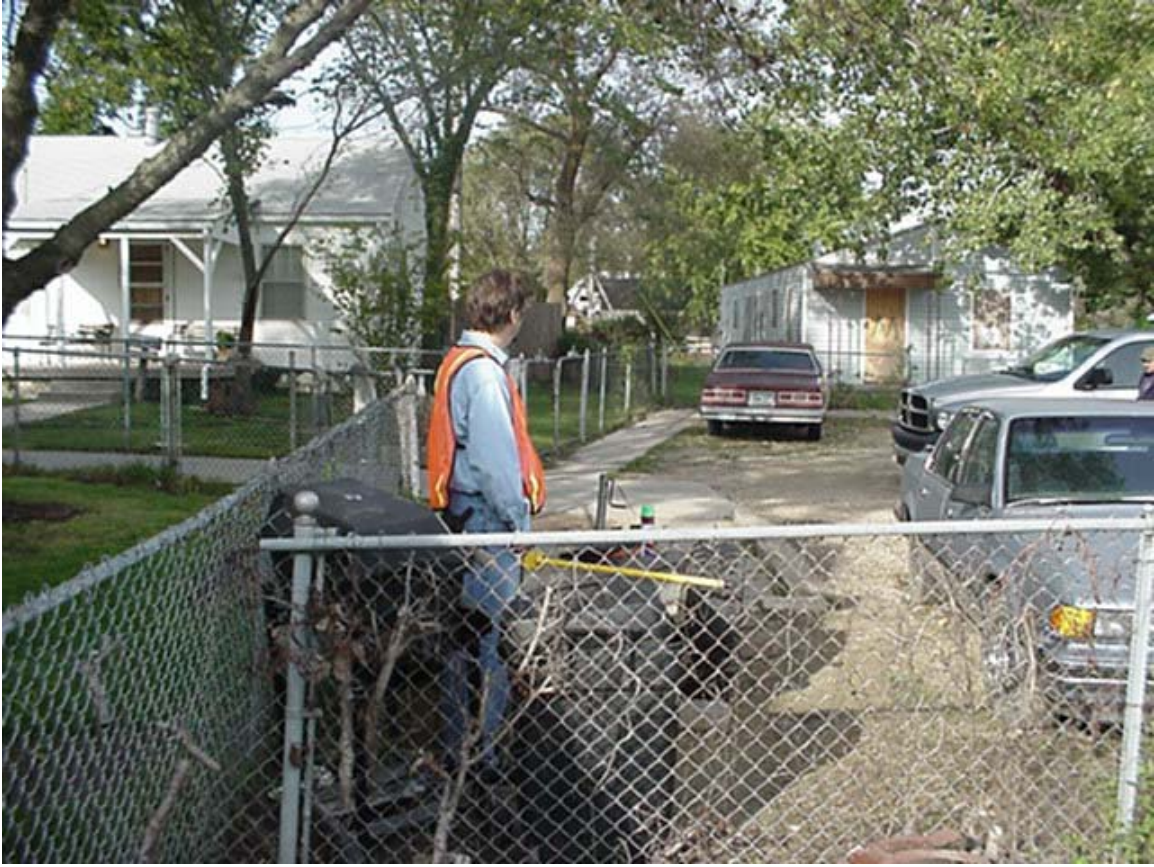
Standing west of MH 5744-724, looking west
