SITE 4

Television Inspection Master Report

US Manhole: 5845-402 2157 S GLENDALE
DS Manhole: 5845-400 2213 S GLENDALE ST

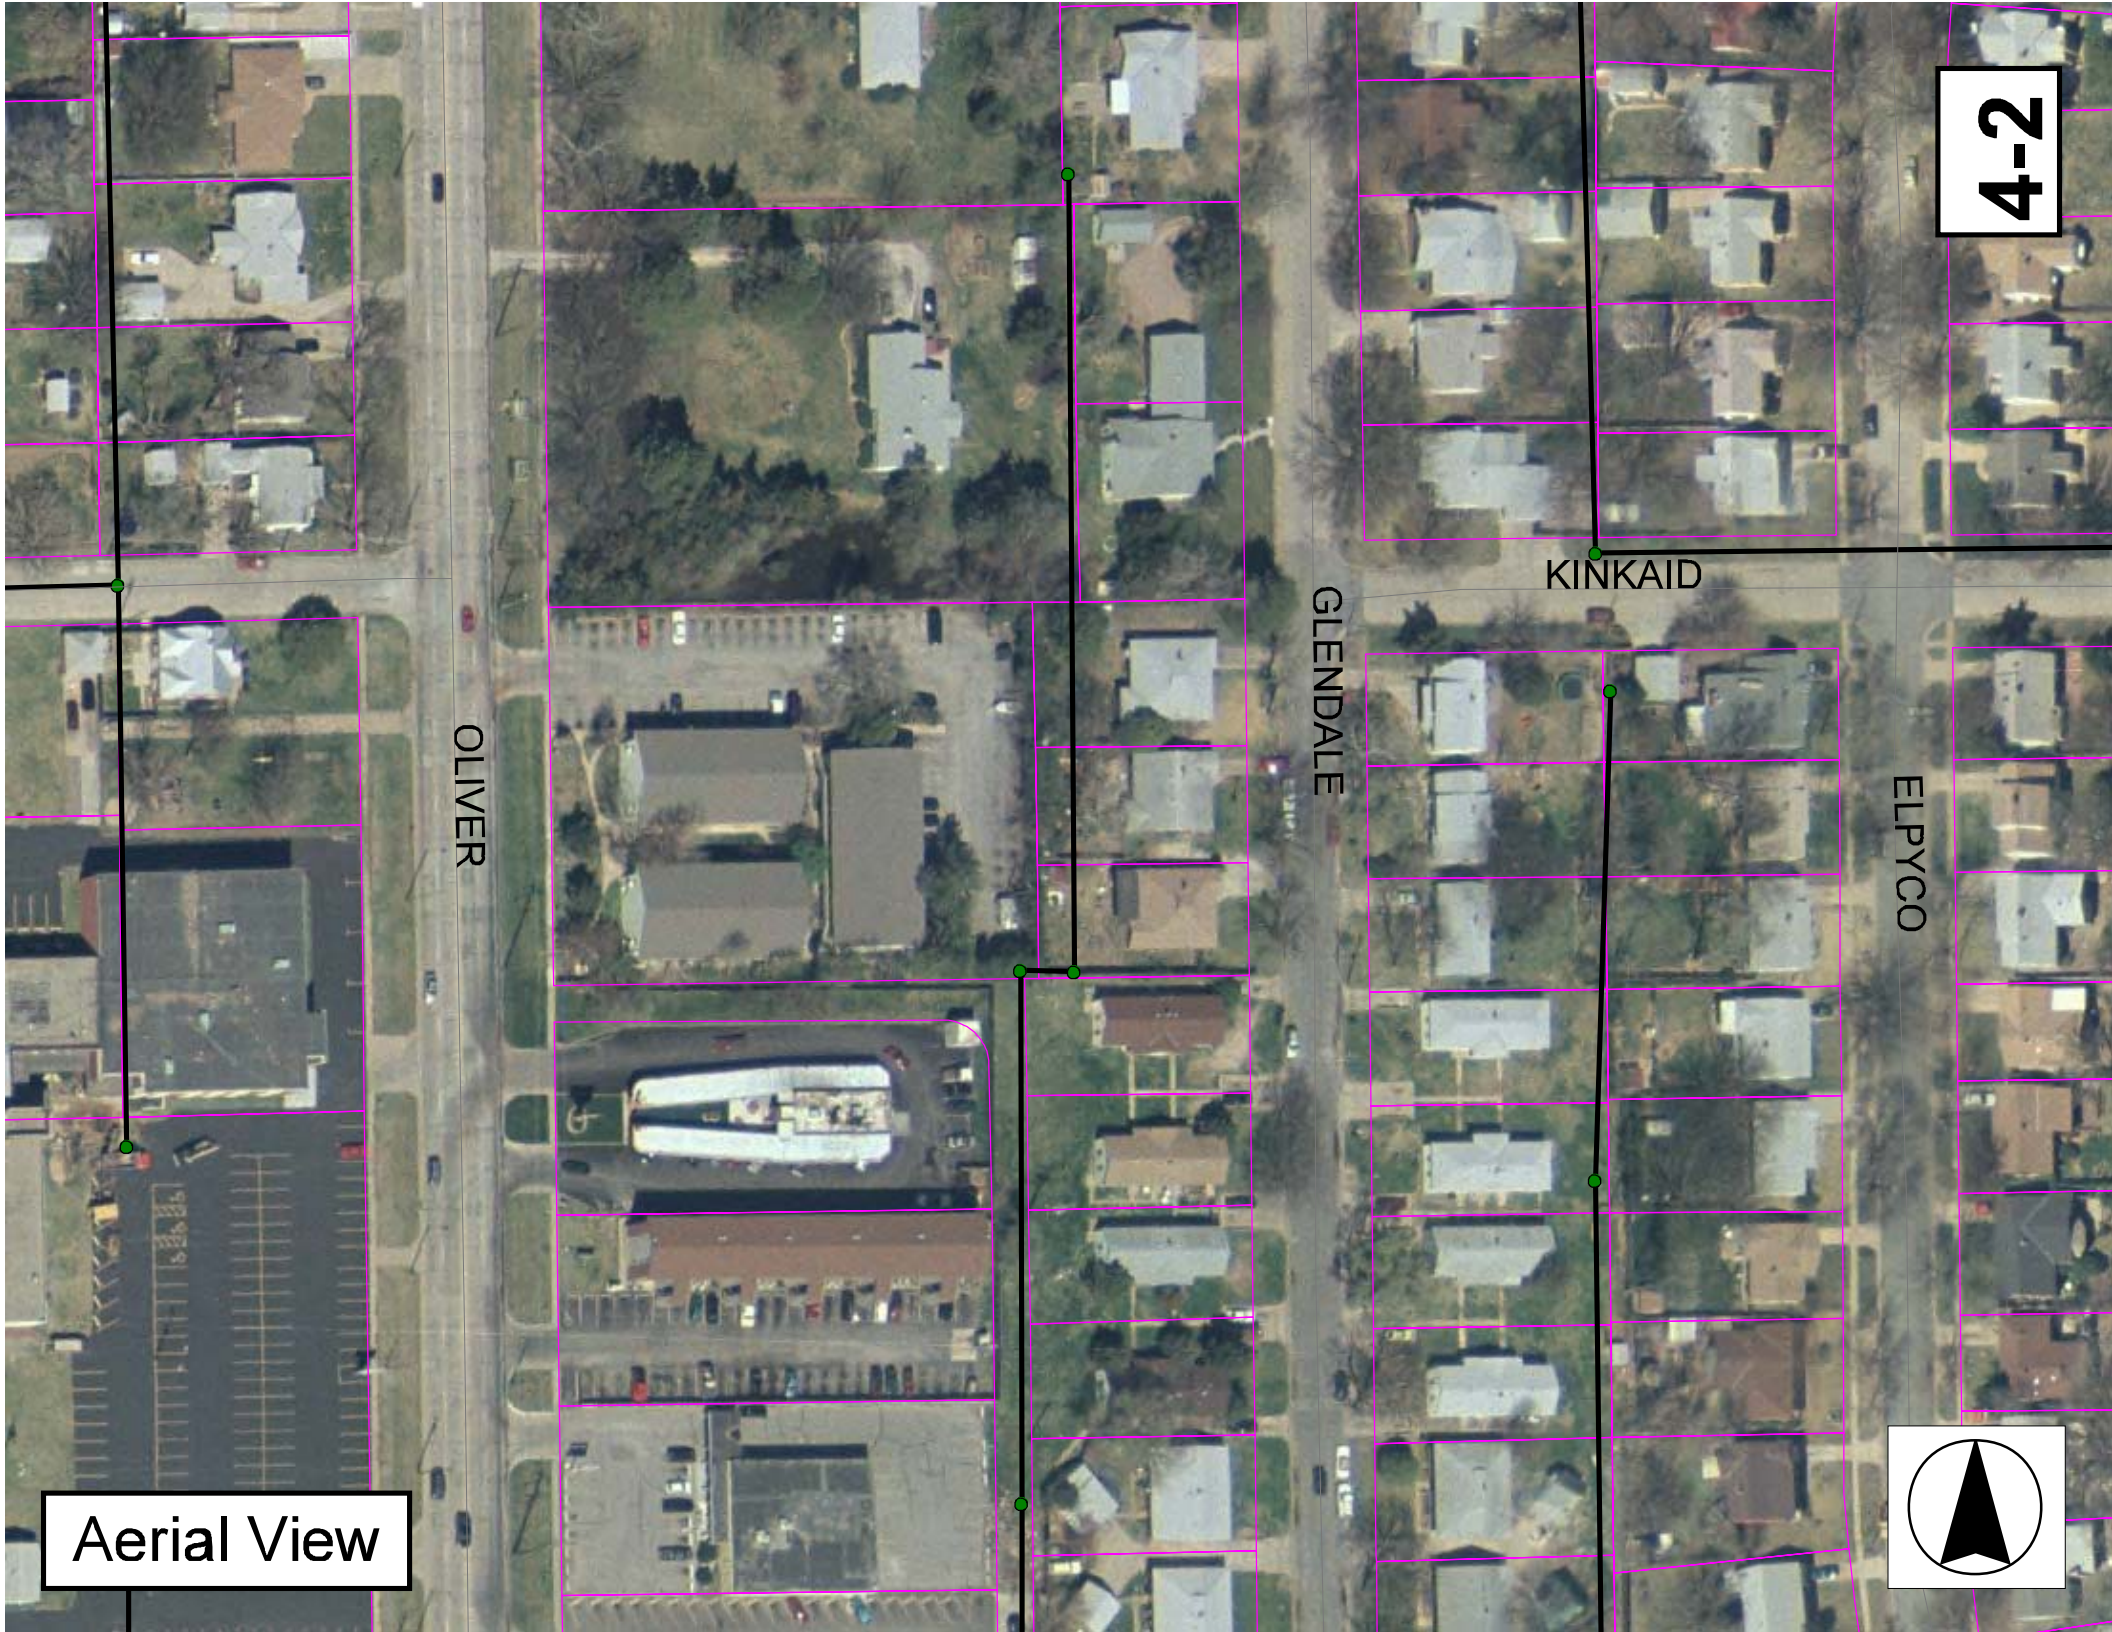
Aerial View

Records indicated a manhole at 205 lf south of MH 5845-402, but televising showed no manhole. Per Sewer Maintenance, the manhole does exist, is buried approx 18" and the pipe is not cut out from inside the manhole. The manhole is located in the yard of 2124 S. Oliver. There is a green flag on the manhole and also in the fence as a marker.

Point Repair:
Remove a manhole at 205 lf south of MH 5845-402.
Manhole is buried approx. 18".
Remove and replace 5 lf of 8" pipe from the south wall of the manhole to 5 lf south.
Remove and replace 20 lf of 8" pipe from the north wall of the manhole to 20 lf north.

Point Repair:
Remove and replace 10 lf of 8" pipe from the north wall of MH 5845-400 to 10 lf north.

MH # 5845-400
Replace Manhole Frame & Cover
Approx depth = 8.8 ft
