SITE 6

Remove and replace 546 lf of 8" pipe from MH 5445-311 to MH 5445-308

Television Inspection Master Report

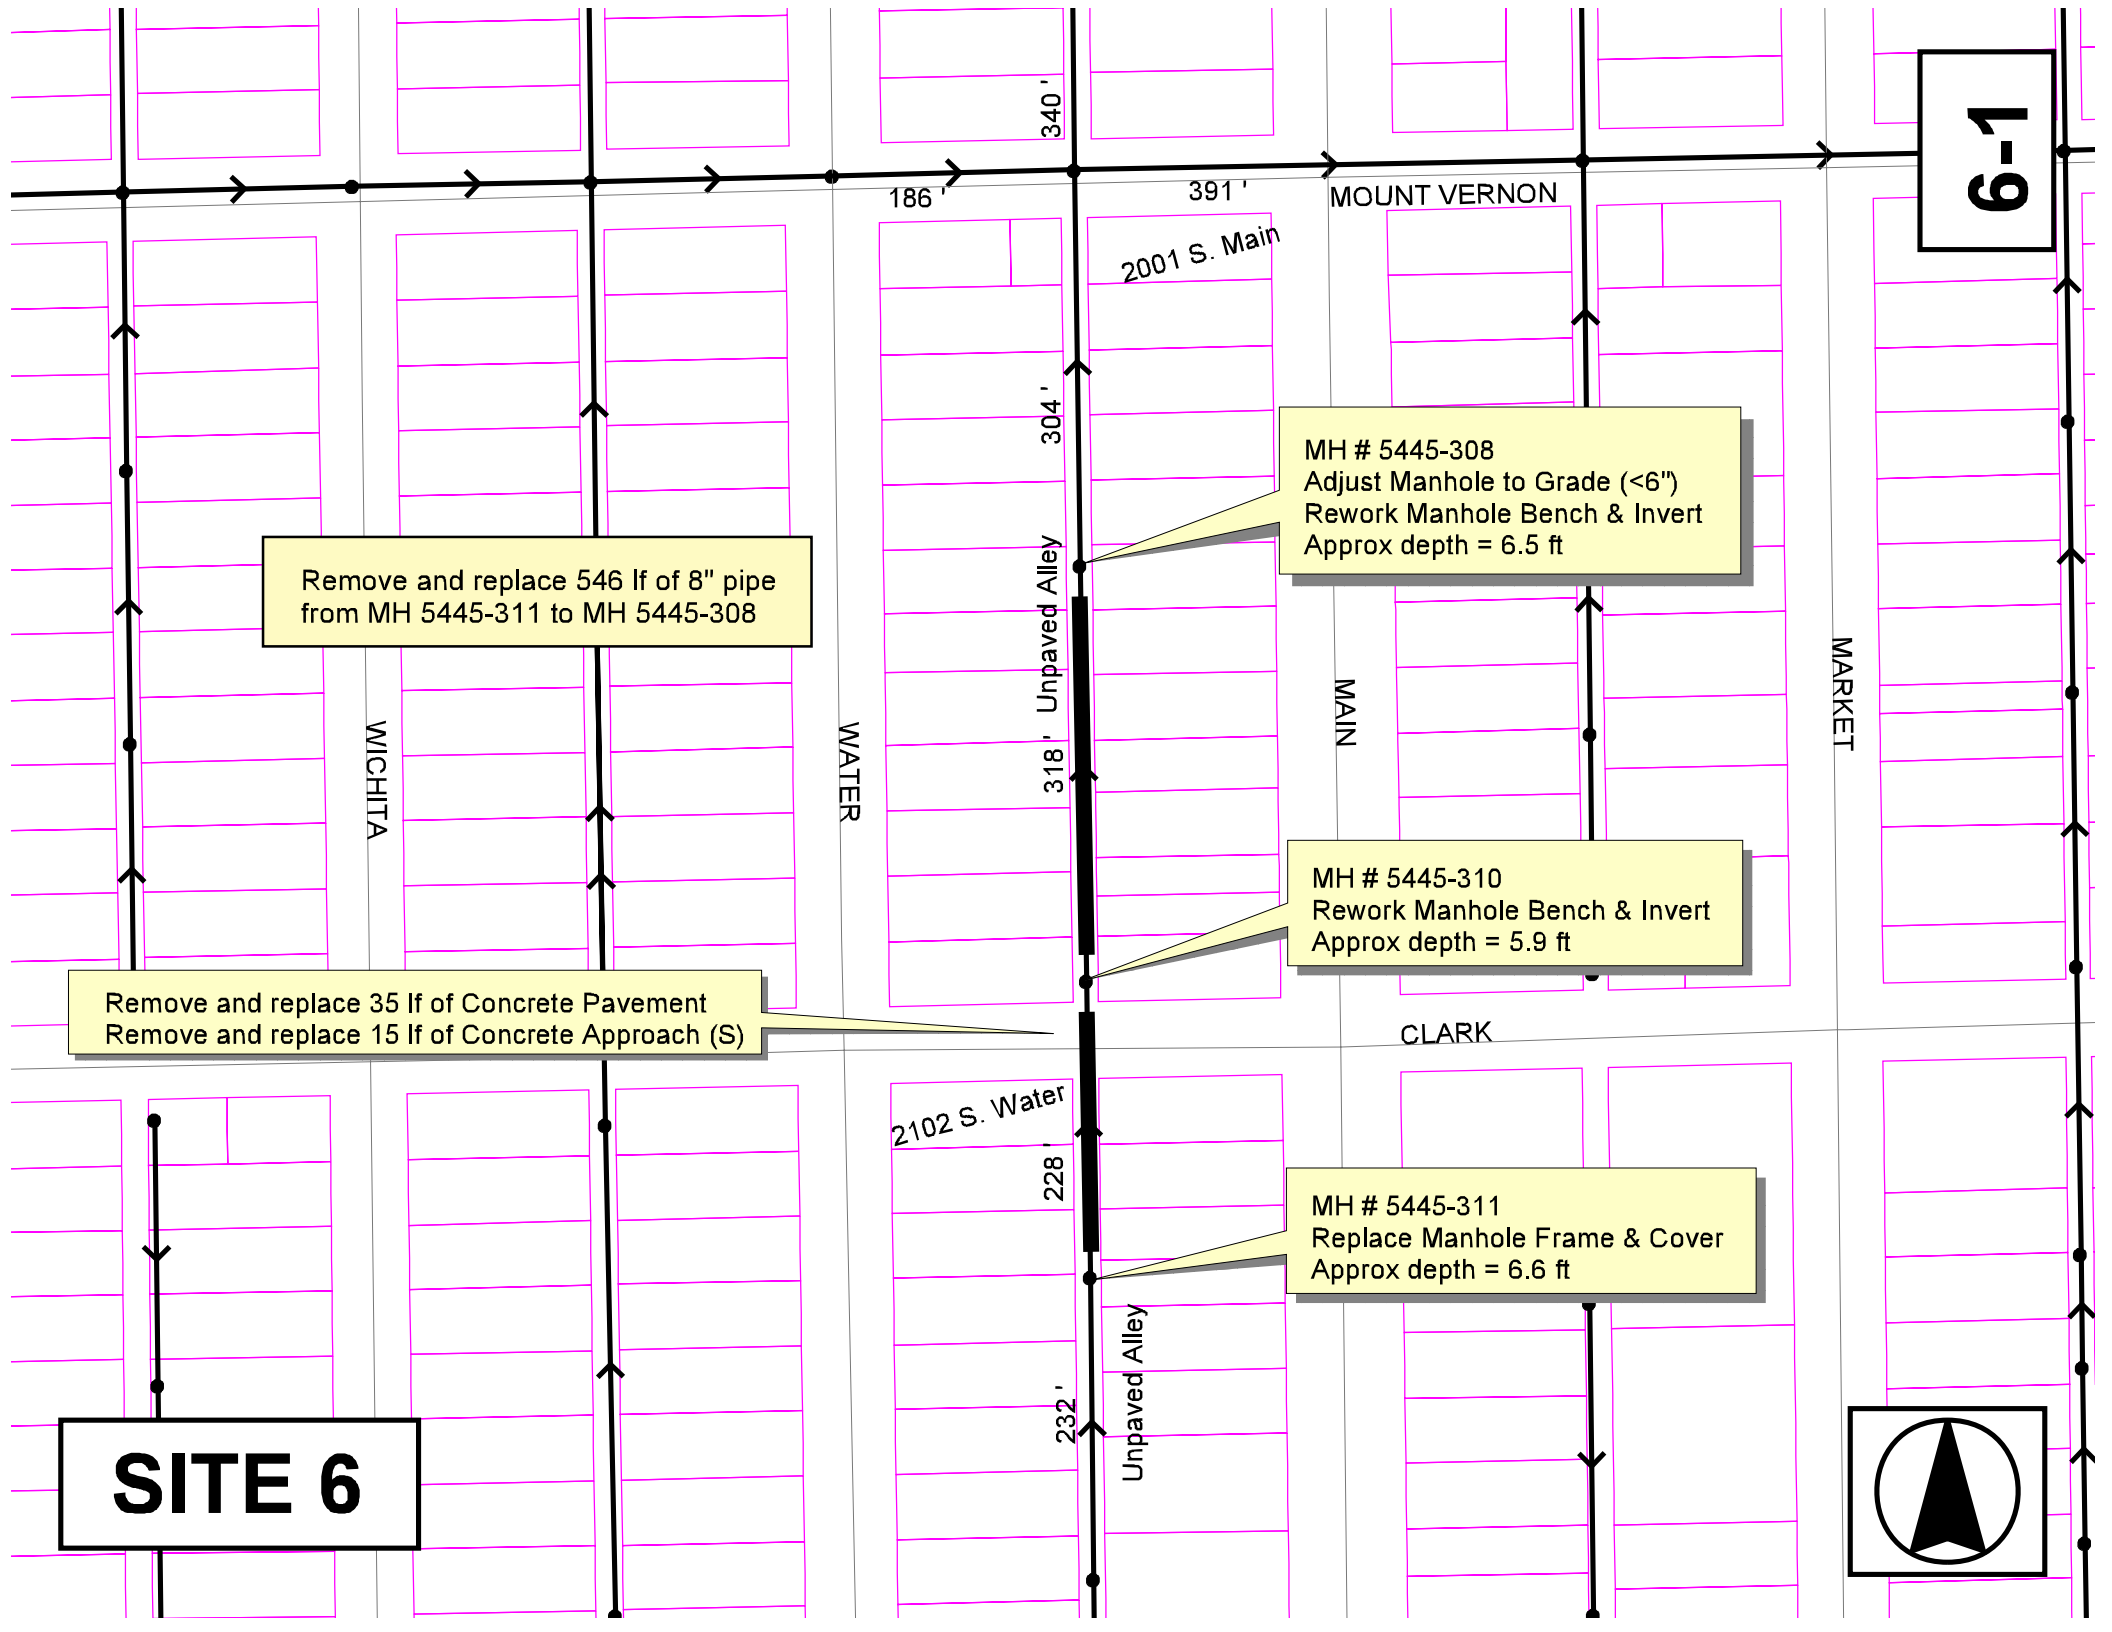
6-1

Remove and replace 35 lf of Concrete Pavement
Remove and replace 15 lf of Concrete Approach (S)

MH # 5445-308
Adjust Manhole to Grade (<6")
Rework Manhole Bench & Invert
Approx depth = 6.5 ft

MH # 5445-310
Rework Manhole Bench & Invert
Approx depth = 5.9 ft

MH # 5445-311
Replace Manhole Frame & Cover
Approx depth = 6.6 ft
