9-1

SITE 9

Television Inspection Master Report

US Manhole: 5548-419
DS Manhole: 5548-415

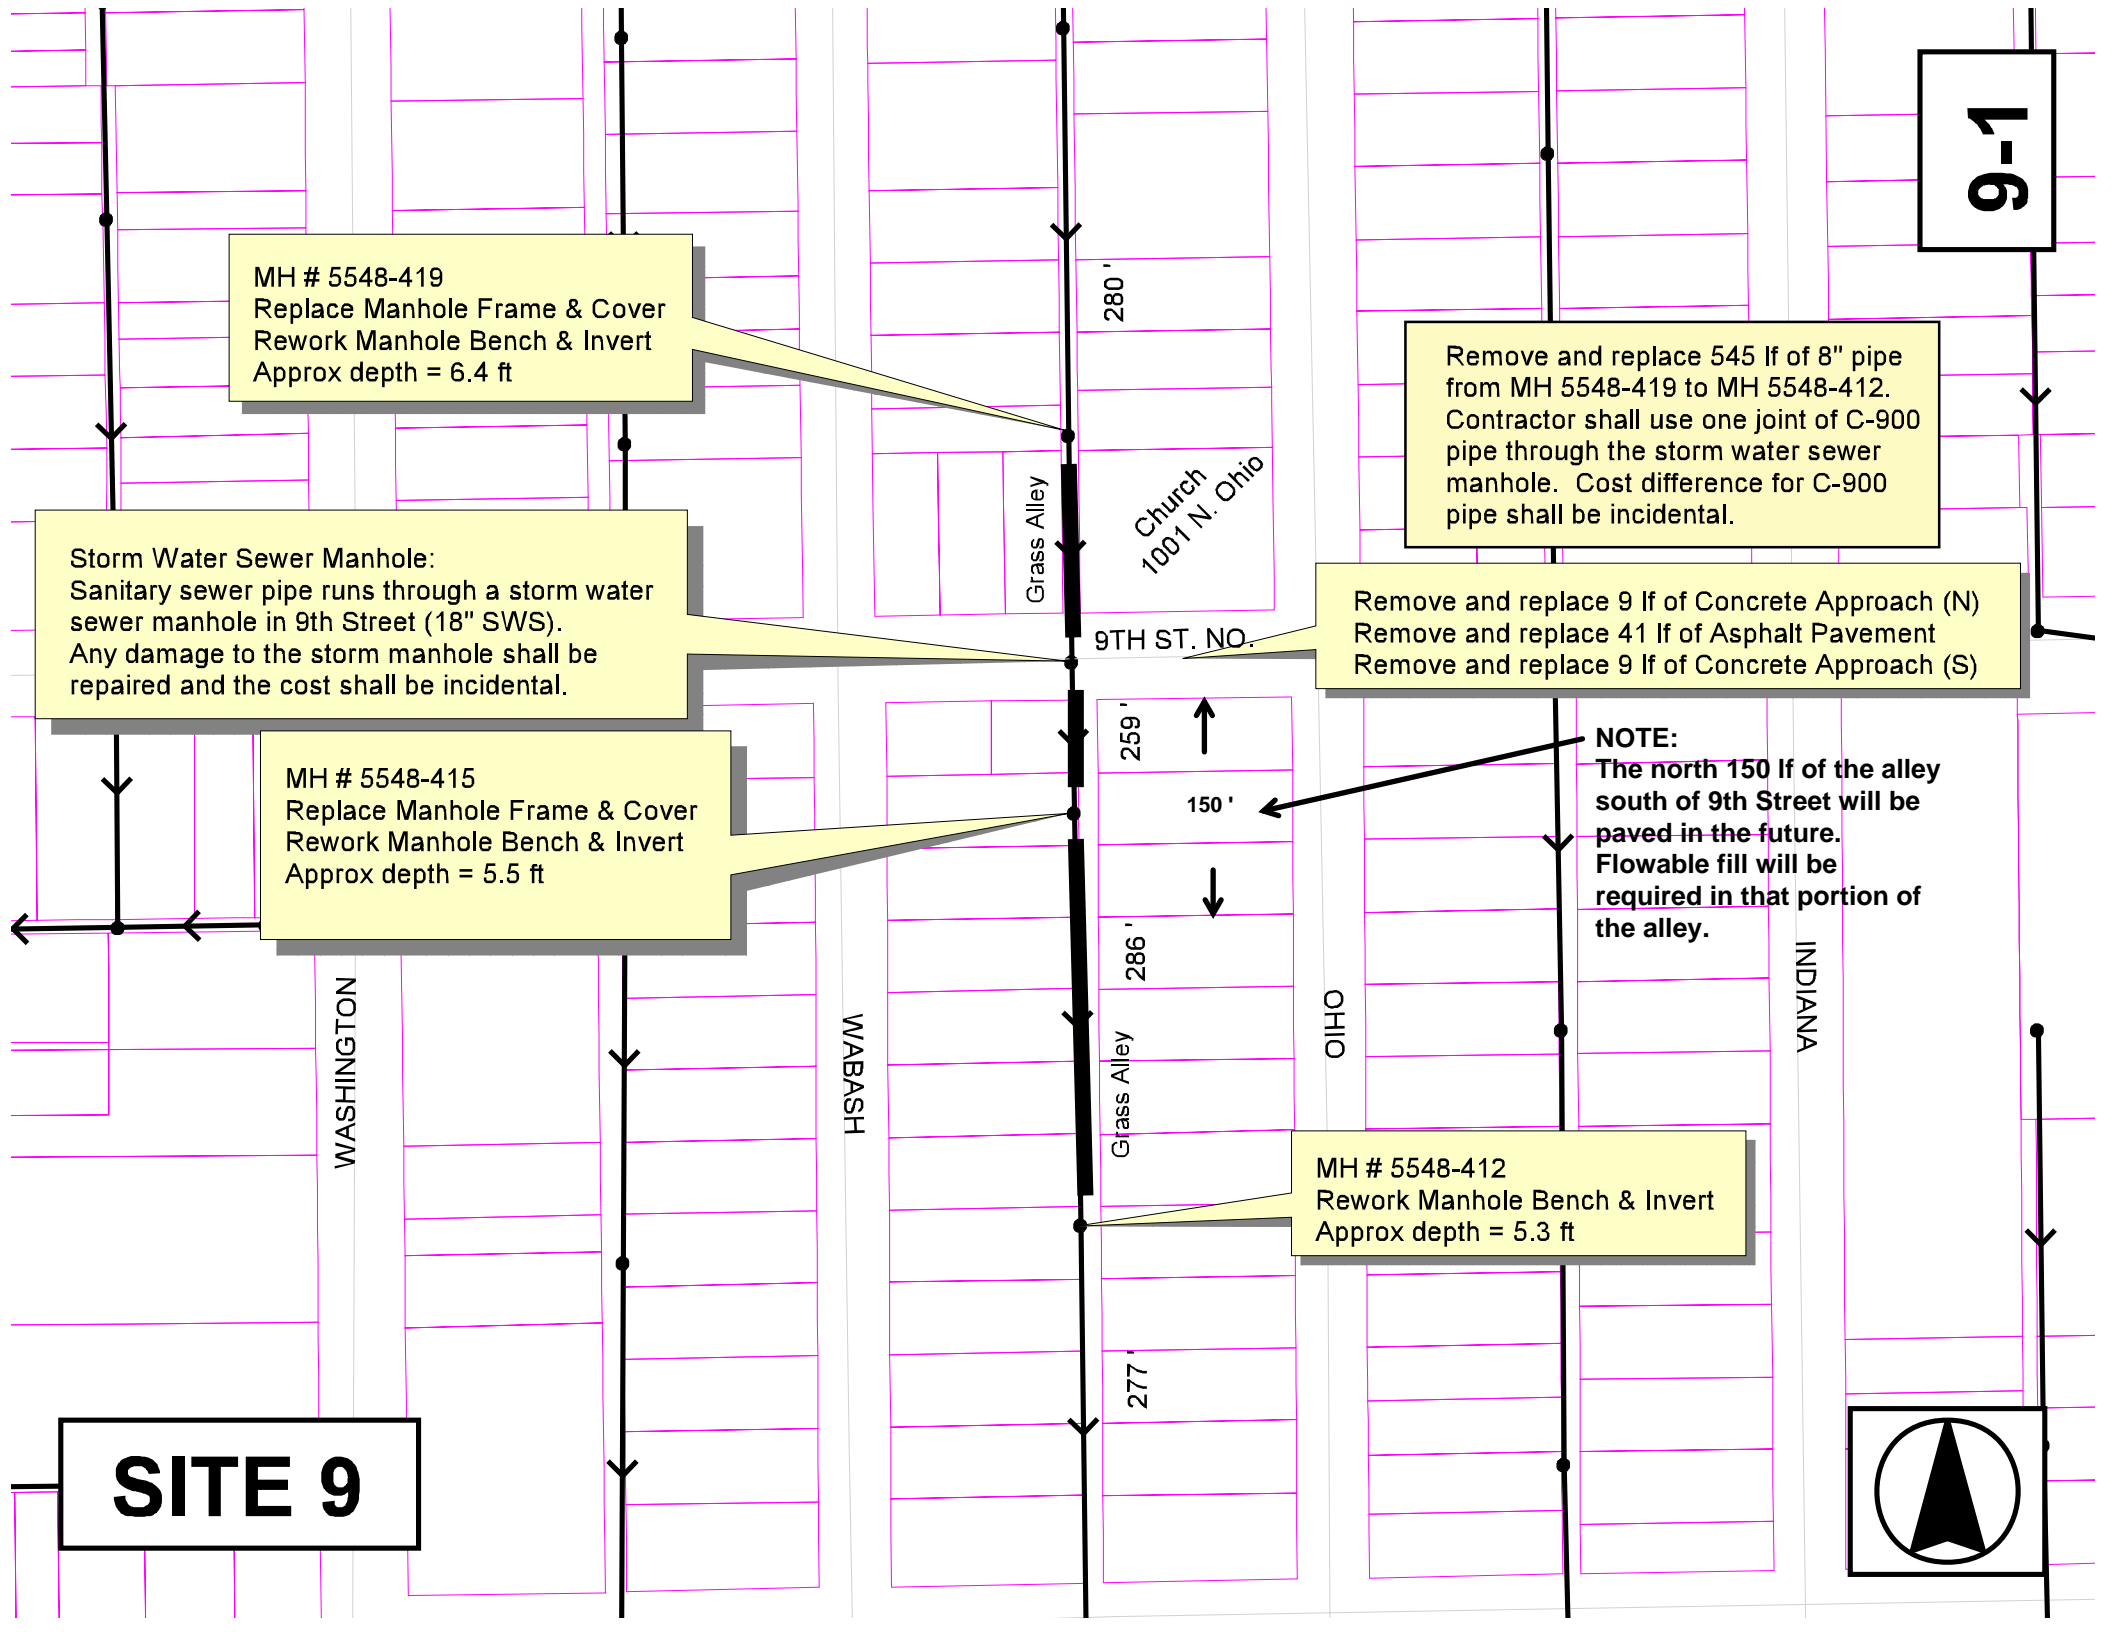
MH # 5548-419
Replace Manhole Frame & Cover
Rework Manhole Bench & Invert
Approx depth = 6.4 ft

Storm Water Sewer Manhole:
Sanitary sewer pipe runs through a storm water sewer manhole in 9th Street (18" SWS).
Any damage to the storm manhole shall be repaired and the cost shall be incidental.

MH # 5548-415
Replace Manhole Frame & Cover
Rework Manhole Bench & Invert
Approx depth = 5.5 ft

MH # 5548-412
Rework Manhole Bench & Invert
Approx depth = 5.3 ft

Remove and replace 545 lf of 8" pipe from MH 5548-419 to MH 5548-412.
Contractor shall use one joint of C-900 pipe through the storm water sewer manhole. Cost difference for C-900 pipe shall be incidental.

Remove and replace 9 lf of Concrete Approach (N)
Remove and replace 41 lf of Asphalt Pavement
Remove and replace 9 lf of Concrete Approach (S)

NOTE:
The north 150 lf of the alley south of 9th Street will be paved in the future.
Flowable fill will be required in that portion of the alley.
