# Television Inspection Master Report

US Manhole: 5947-121  
DS Manhole: 5947-120

20 E WILLOWBROOK ST  
15 E PEACH TREE ST

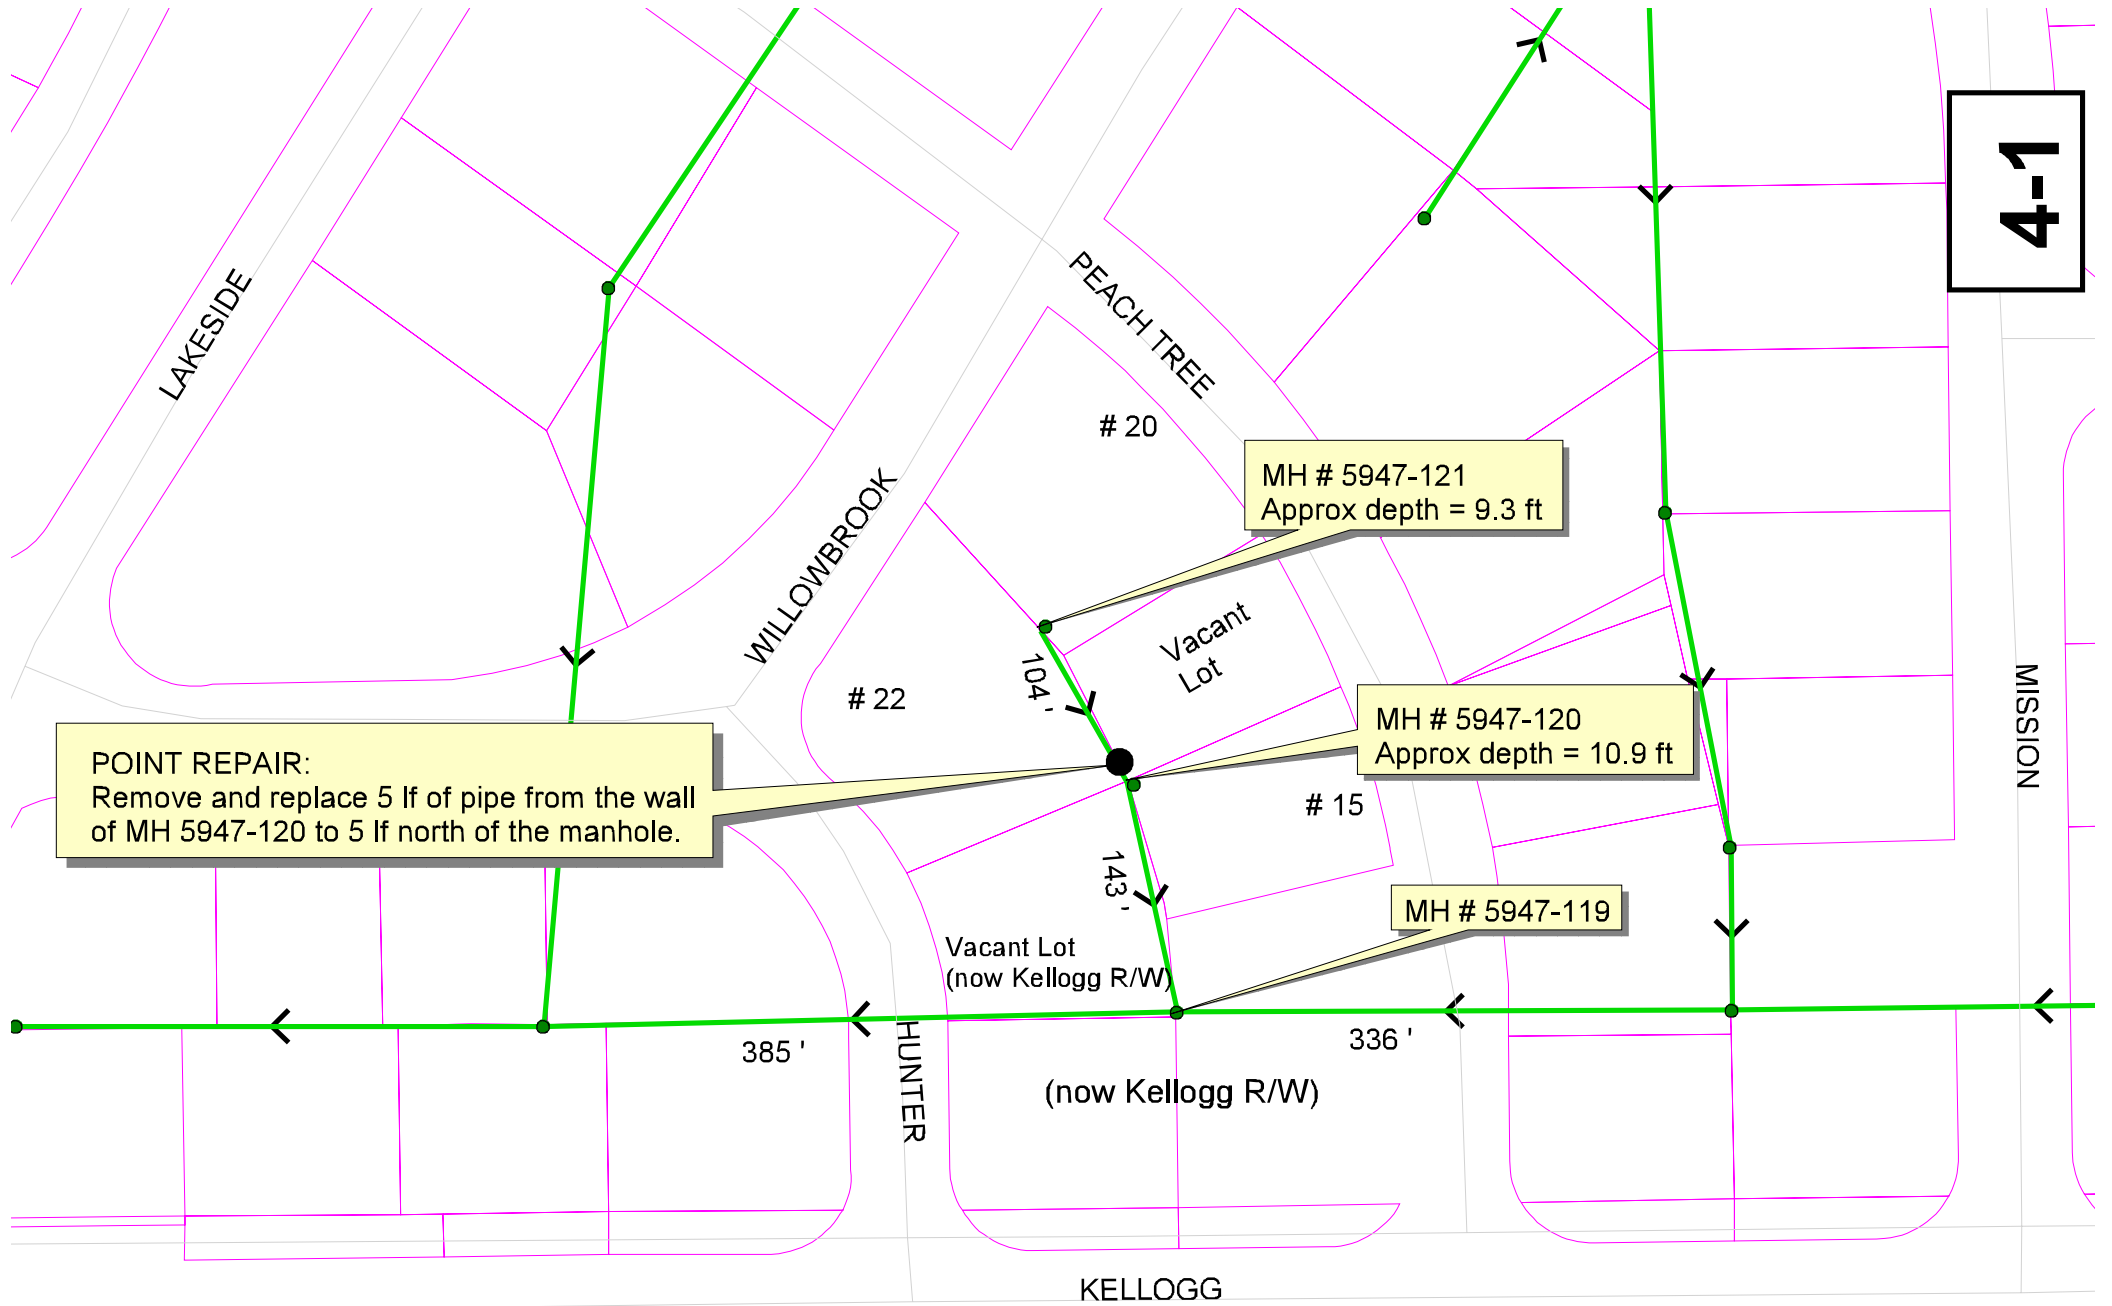
MH # 5947-121  
Approx depth = 9.3 ft

MH # 5947-120  
Approx depth = 10.9 ft

MH # 5947-119

**POINT REPAIR:**  
Remove and replace 5 lf of pipe from the wall of MH 5947-120 to 5 lf north of the manhole.

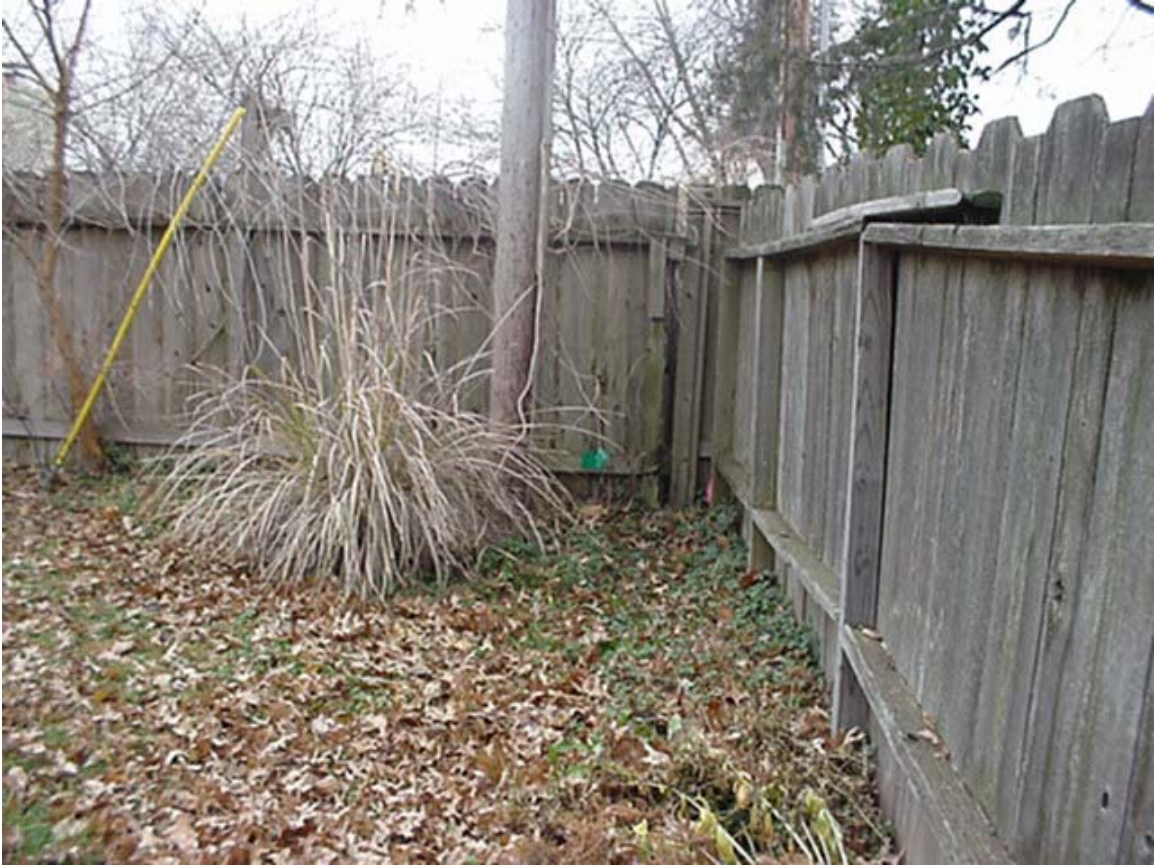
Manhole 5947-120 is located in the very northwest corner of 15 Peachtree.

I'm standing in the vacant lot north of the manhole, looking south. The green flag indicates the location of the pipe. The utility pole is very close to the sewer pipe. The offset joint here needs to be fixed in order to line the pipe in the future.
