SITE 5

Television Inspection Master Report

US Manhole: 5748-375
DS Manhole: 5748-374

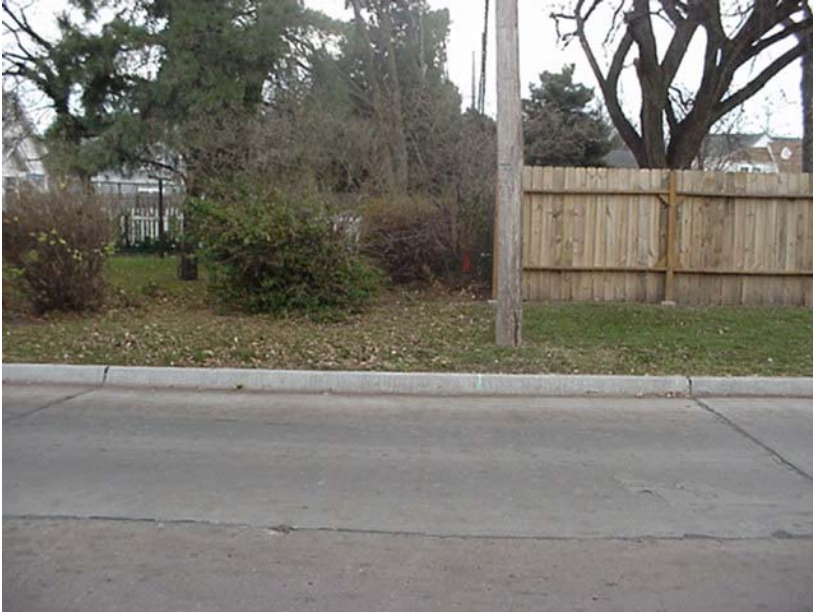
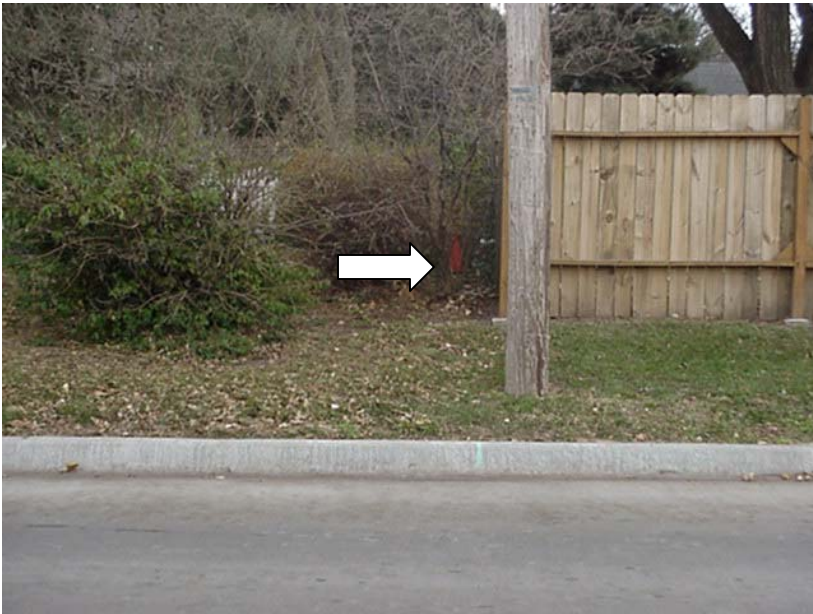
5-4

24	186.0	Joint	Gapped Joint	2	0.000	0	0	0.000
25	190.0	Invert	Sag					0.000
35% FLOW								
26	191.0	Invert	Sag					
45% FLOW WE WILL USE A CLEANER TO PULL DOWN WATER.								
27	193.0	Crown	Broken Pipe	3	0.010	60	0	0.010
29	193.0	Camera Lens Submerge	Sag					
WITHOUT THE CLEANER								
32	198.0	Camera Lens Emerged	Sag					
34	204.0	Camera Lens Emerged	Sag					
30	209.0	Camera Lens Emerged	Sag					
33	211.0	Camera Lens Submerge	Sag					
35	215.0	Camera Lens Emerged	Sag					
28	221.0	DS Manhole 5748-374						0.000

**Need to replace the downstream 36 lf
From 185' south of MH 5748-375 to the downstream manhole.**

The orange cone is sitting on MH 5748-374 (arrow pointing to it).
I'm standing in Murdock, looking south.
The manhole is in the property of 657 N. Terrace.

POINT REPAIR:
Remove and replace 36 lf of 8" pipe
from MH 5748-374 to 36 lf north of
the manhole. Pavement removal and
replacement shall be included in the
price of the point repair.
