Install 227 lf of 8" Cured-in-Place Liner from MH 5346-145 to 5346-143

SITE 2

# Television Inspection Master Report

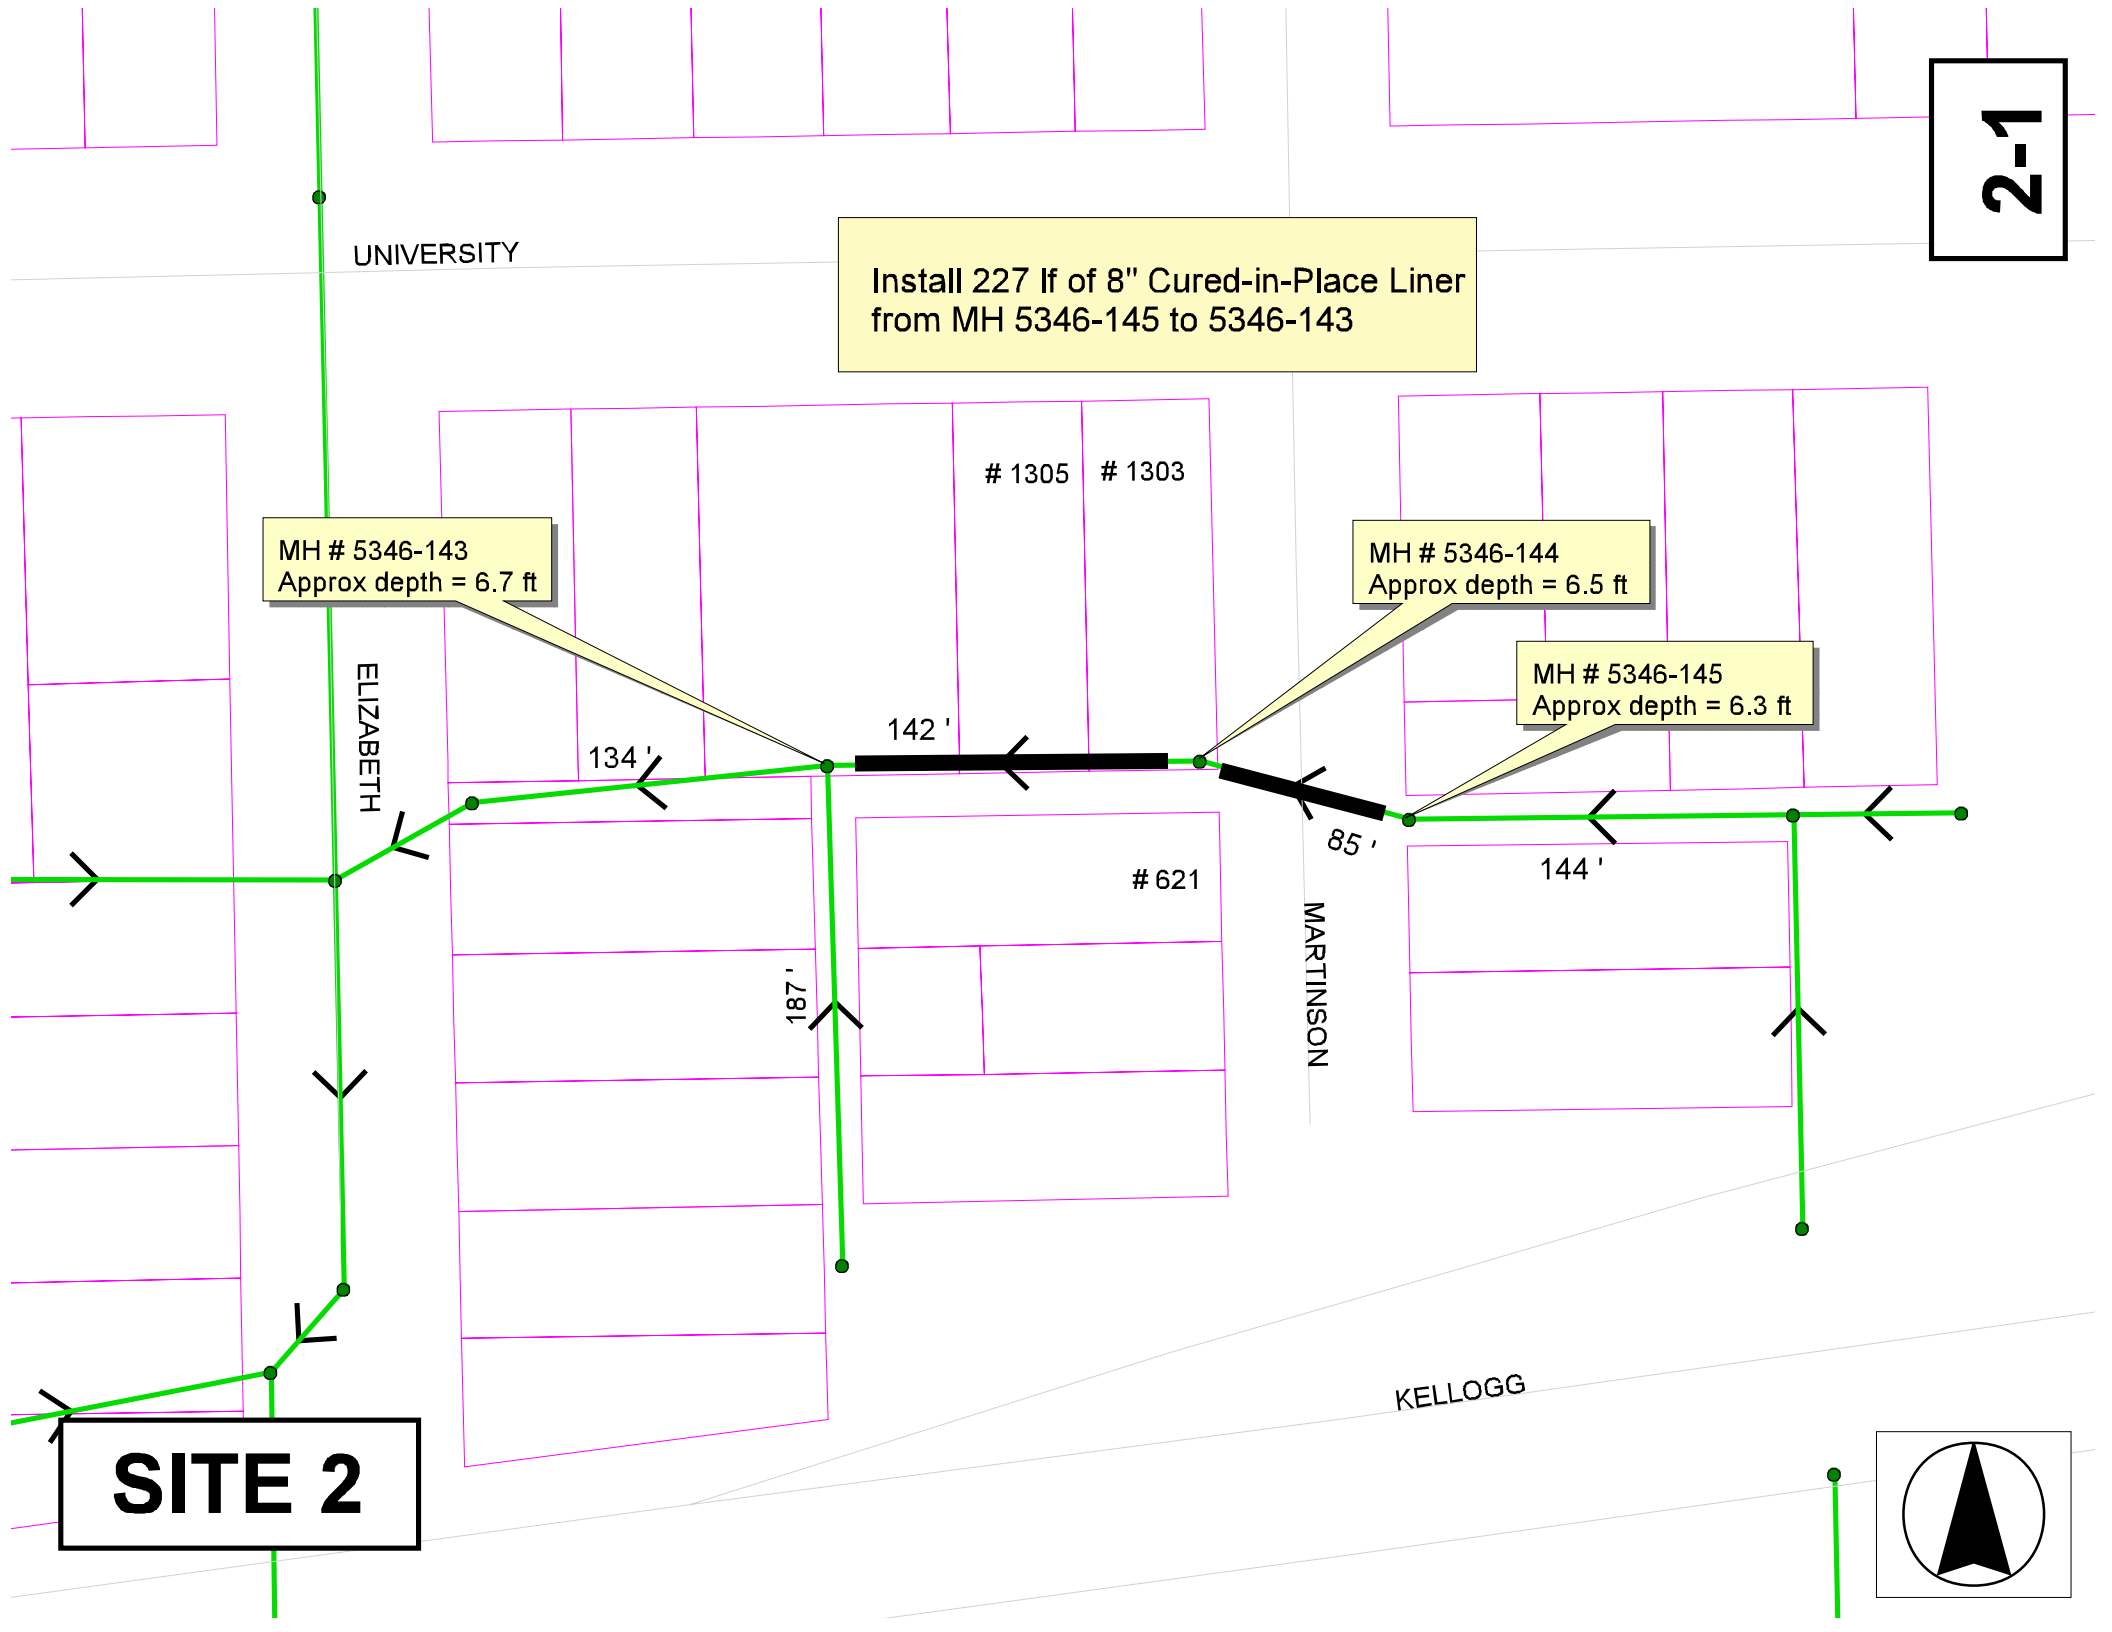
MH # 5346-143  
Approx depth = 6.7 ft

MH # 5346-144  
Approx depth = 6.5 ft

MH # 5346-145  
Approx depth = 6.3 ft
