Television Inspection Master Report

US Manhole: 5545-257
DS Manhole: 5545-208

Project No.: B-101

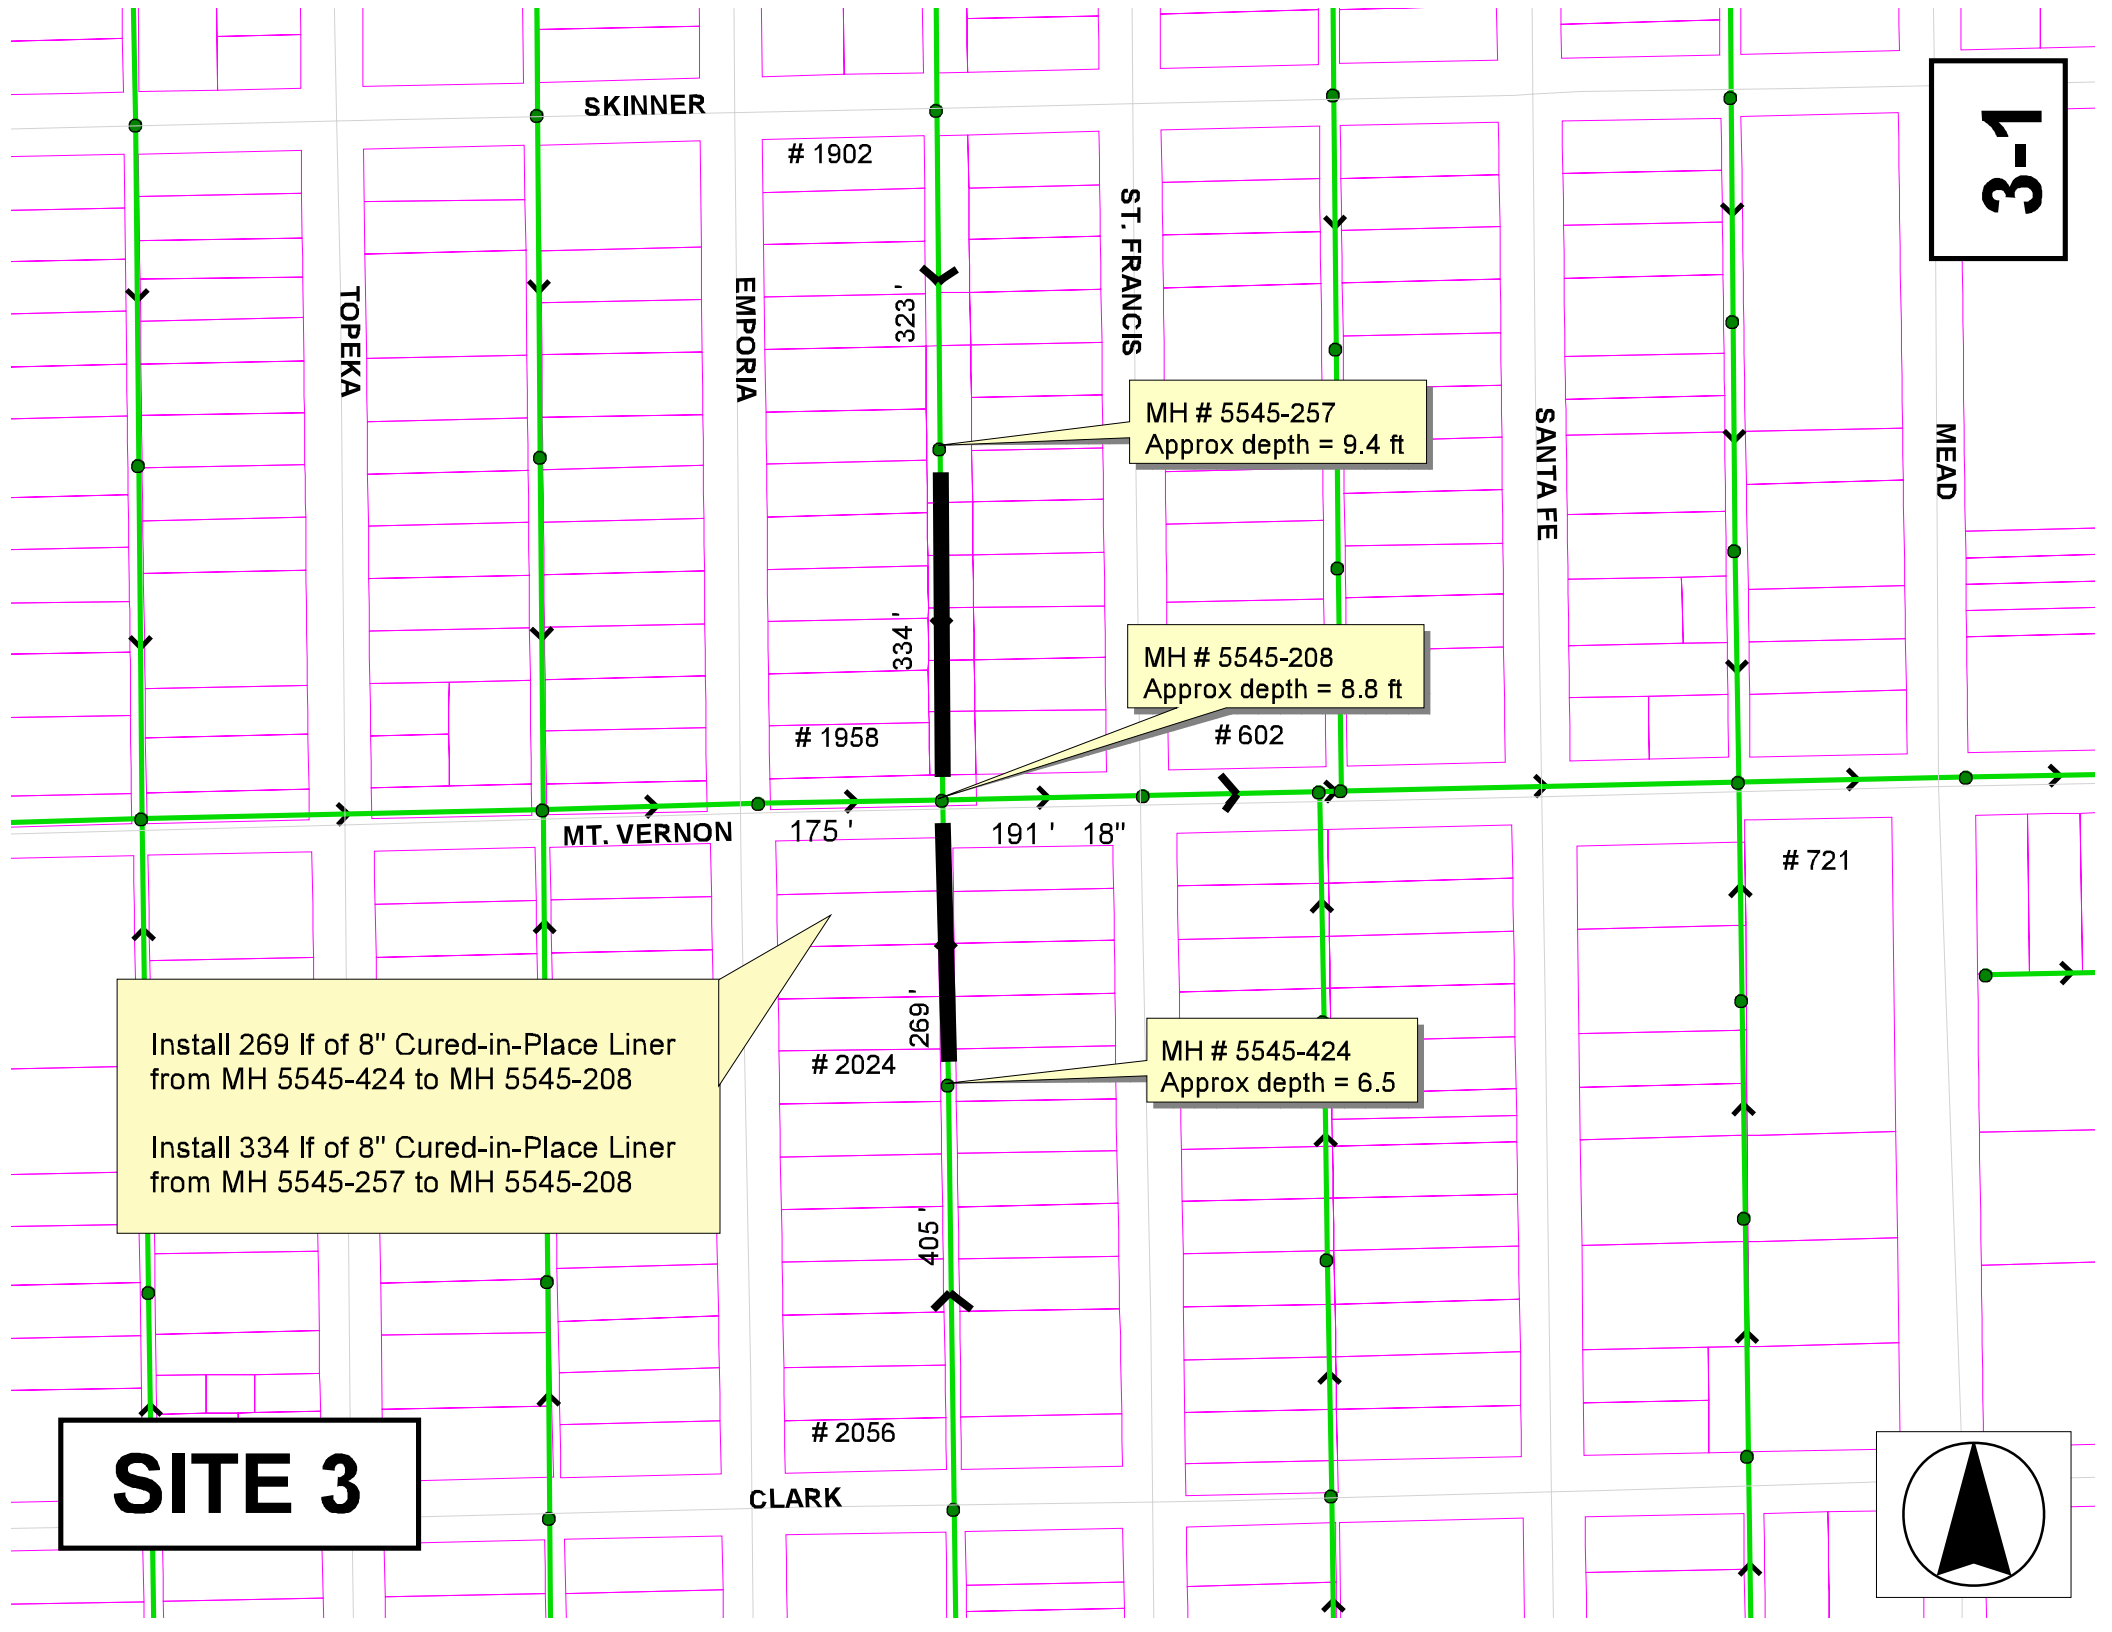
Install 269 lf of 8" Cured-in-Place Liner from MH 5545-424 to MH 5545-208

Install 334 lf of 8" Cured-in-Place Liner from MH 5545-257 to MH 5545-208

MH # 5545-257
Approx depth = 9.4 ft

MH # 5545-208
Approx depth = 8.8 ft

MH # 5545-424
Approx depth = 6.5
