Install 541 lf of 8" Cured-in-Place Liner
from MH 6046-239 to MH 6046-229

Install 528 lf of 8" Cured-in-Place Liner
from MH 6046-230 to MH 6046-020

SITE 9

Television Inspection Master Report

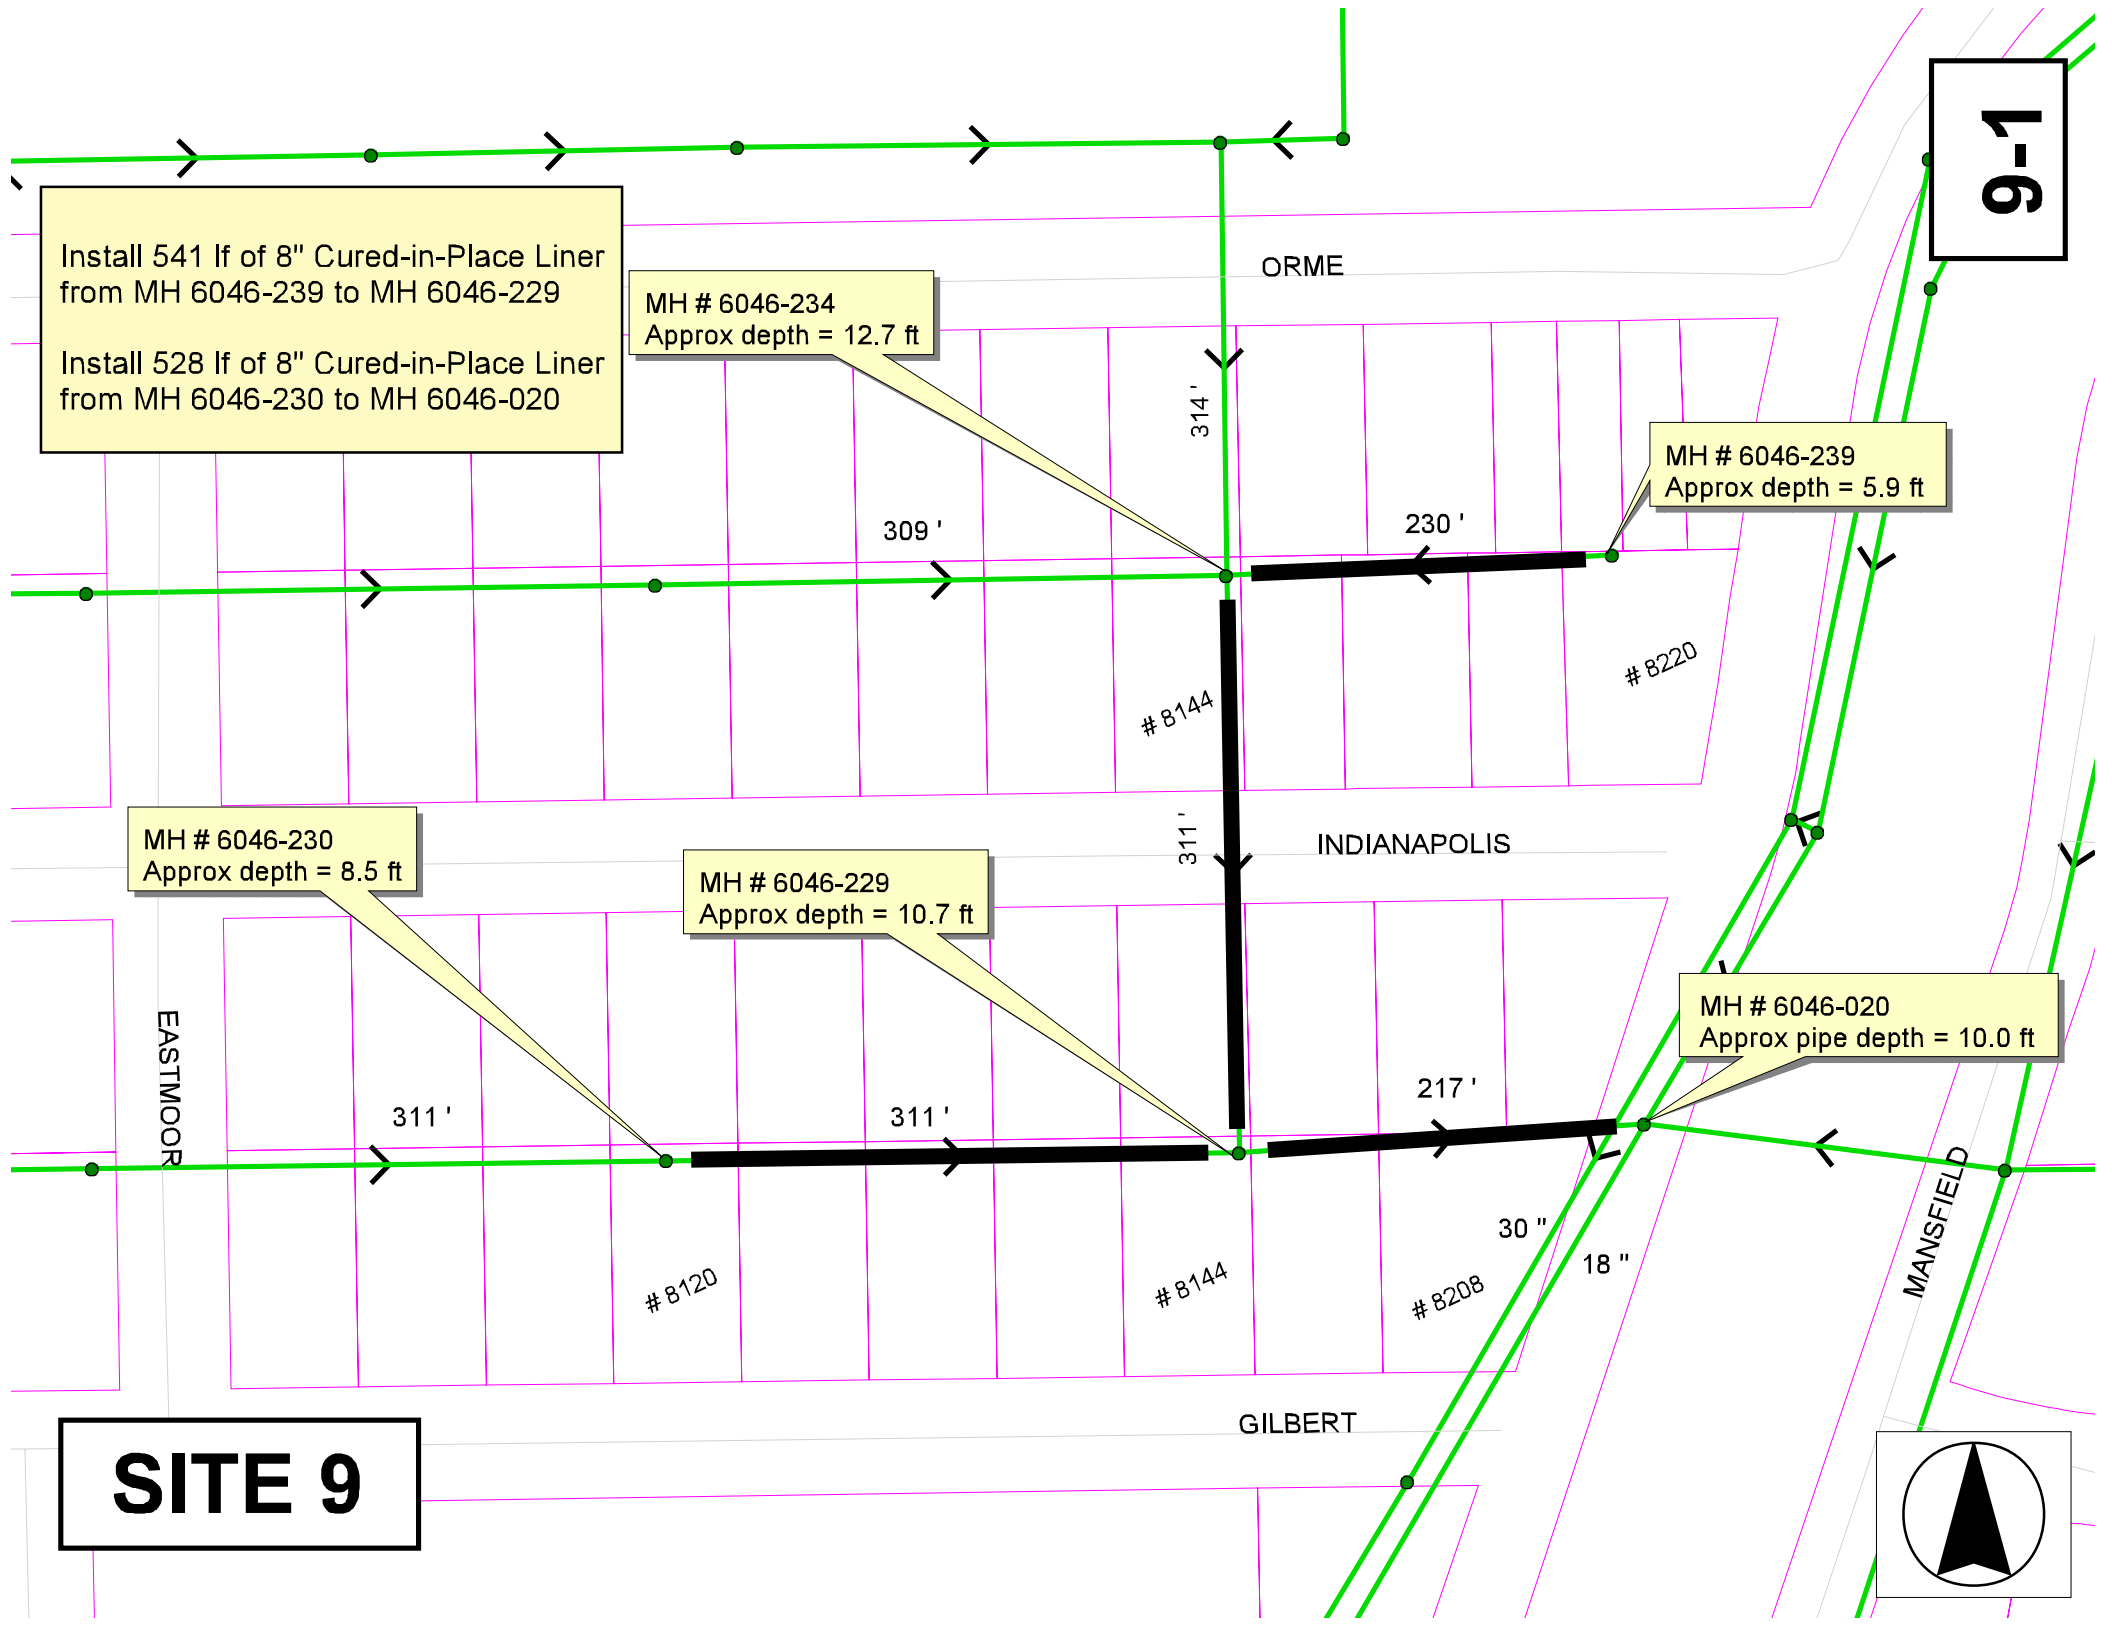
9-1

MH # 6046-234
Approx depth = 12.7 ft

MH # 6046-239
Approx depth = 5.9 ft

MH # 6046-230
Approx depth = 8.5 ft

MH # 6046-229
Approx depth = 10.7 ft

MH # 6046-020
Approx pipe depth = 10.0 ft
