Install 1019 lf of 12"
Cured-in-Place Liner
from MH 4848-036
to MH 4848-032

SITE 5

Television Inspection Master Report

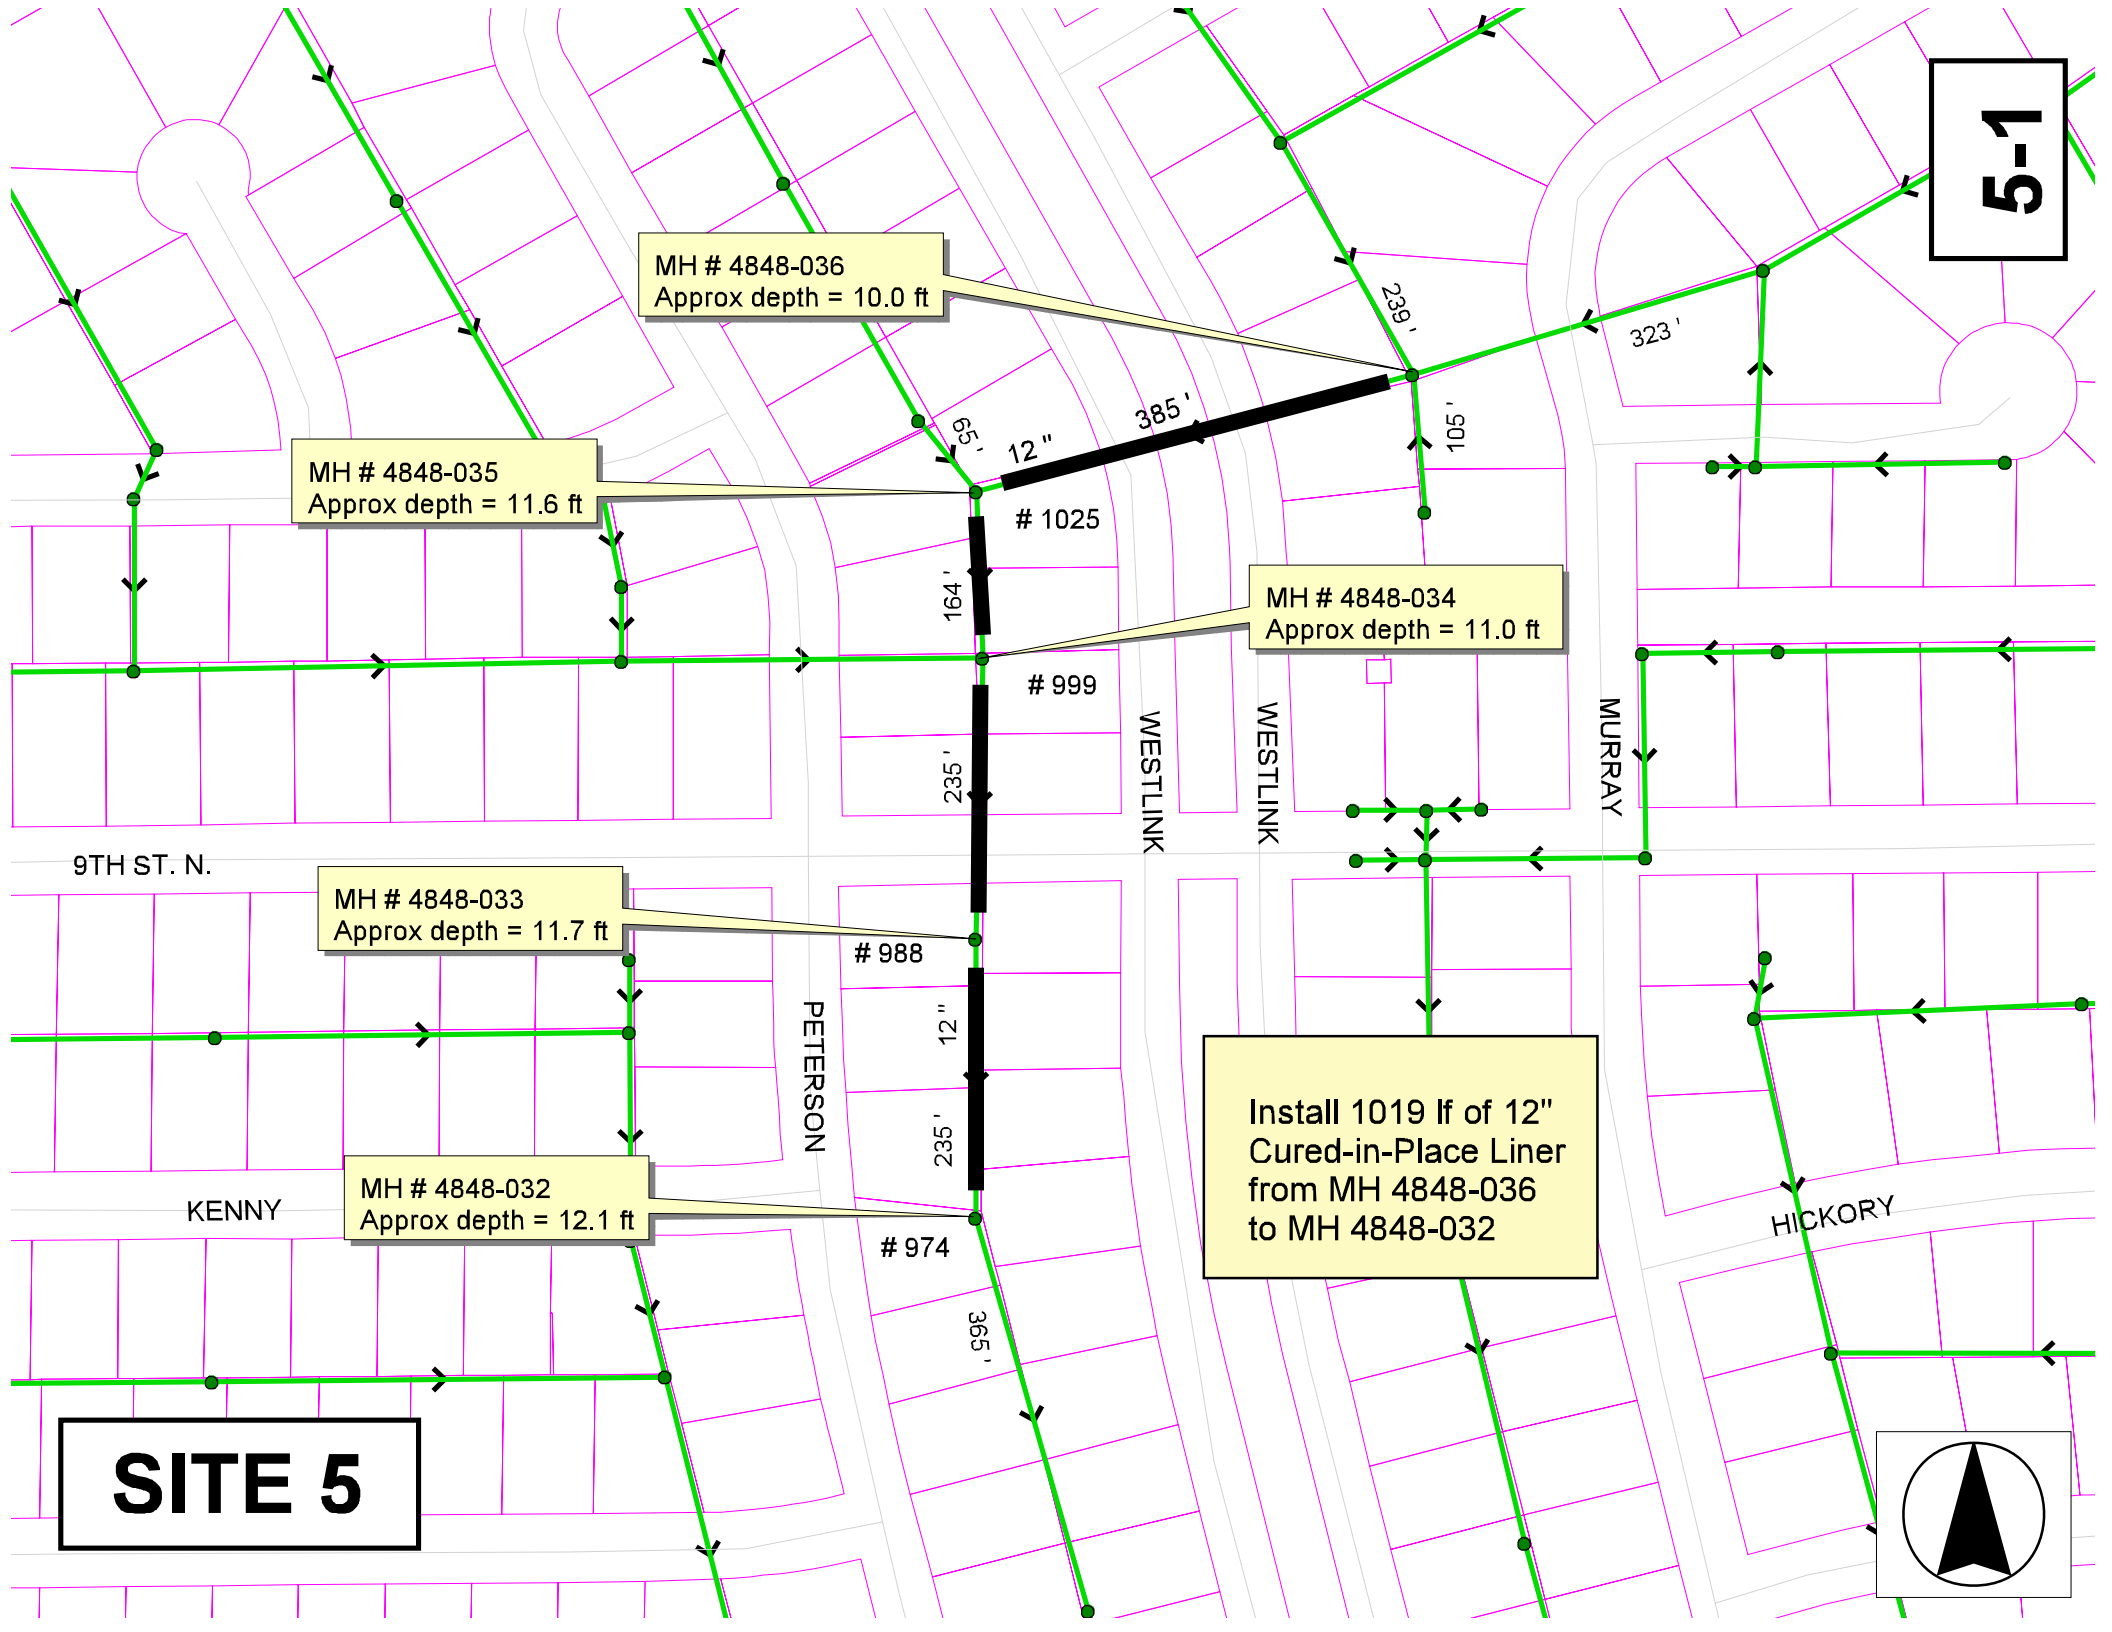
MH # 4848-036
Approx depth = 10.0 ft

MH # 4848-035
Approx depth = 11.6 ft

MH # 4848-034
Approx depth = 11.0 ft

MH # 4848-033
Approx depth = 11.7 ft

MH # 4848-032
Approx depth = 12.1 ft
