Install 500 lf of 8" Cured-in-Place Liner from MH 5847-187 to MH 5847-154

SITE 8

Television Inspection Master Report

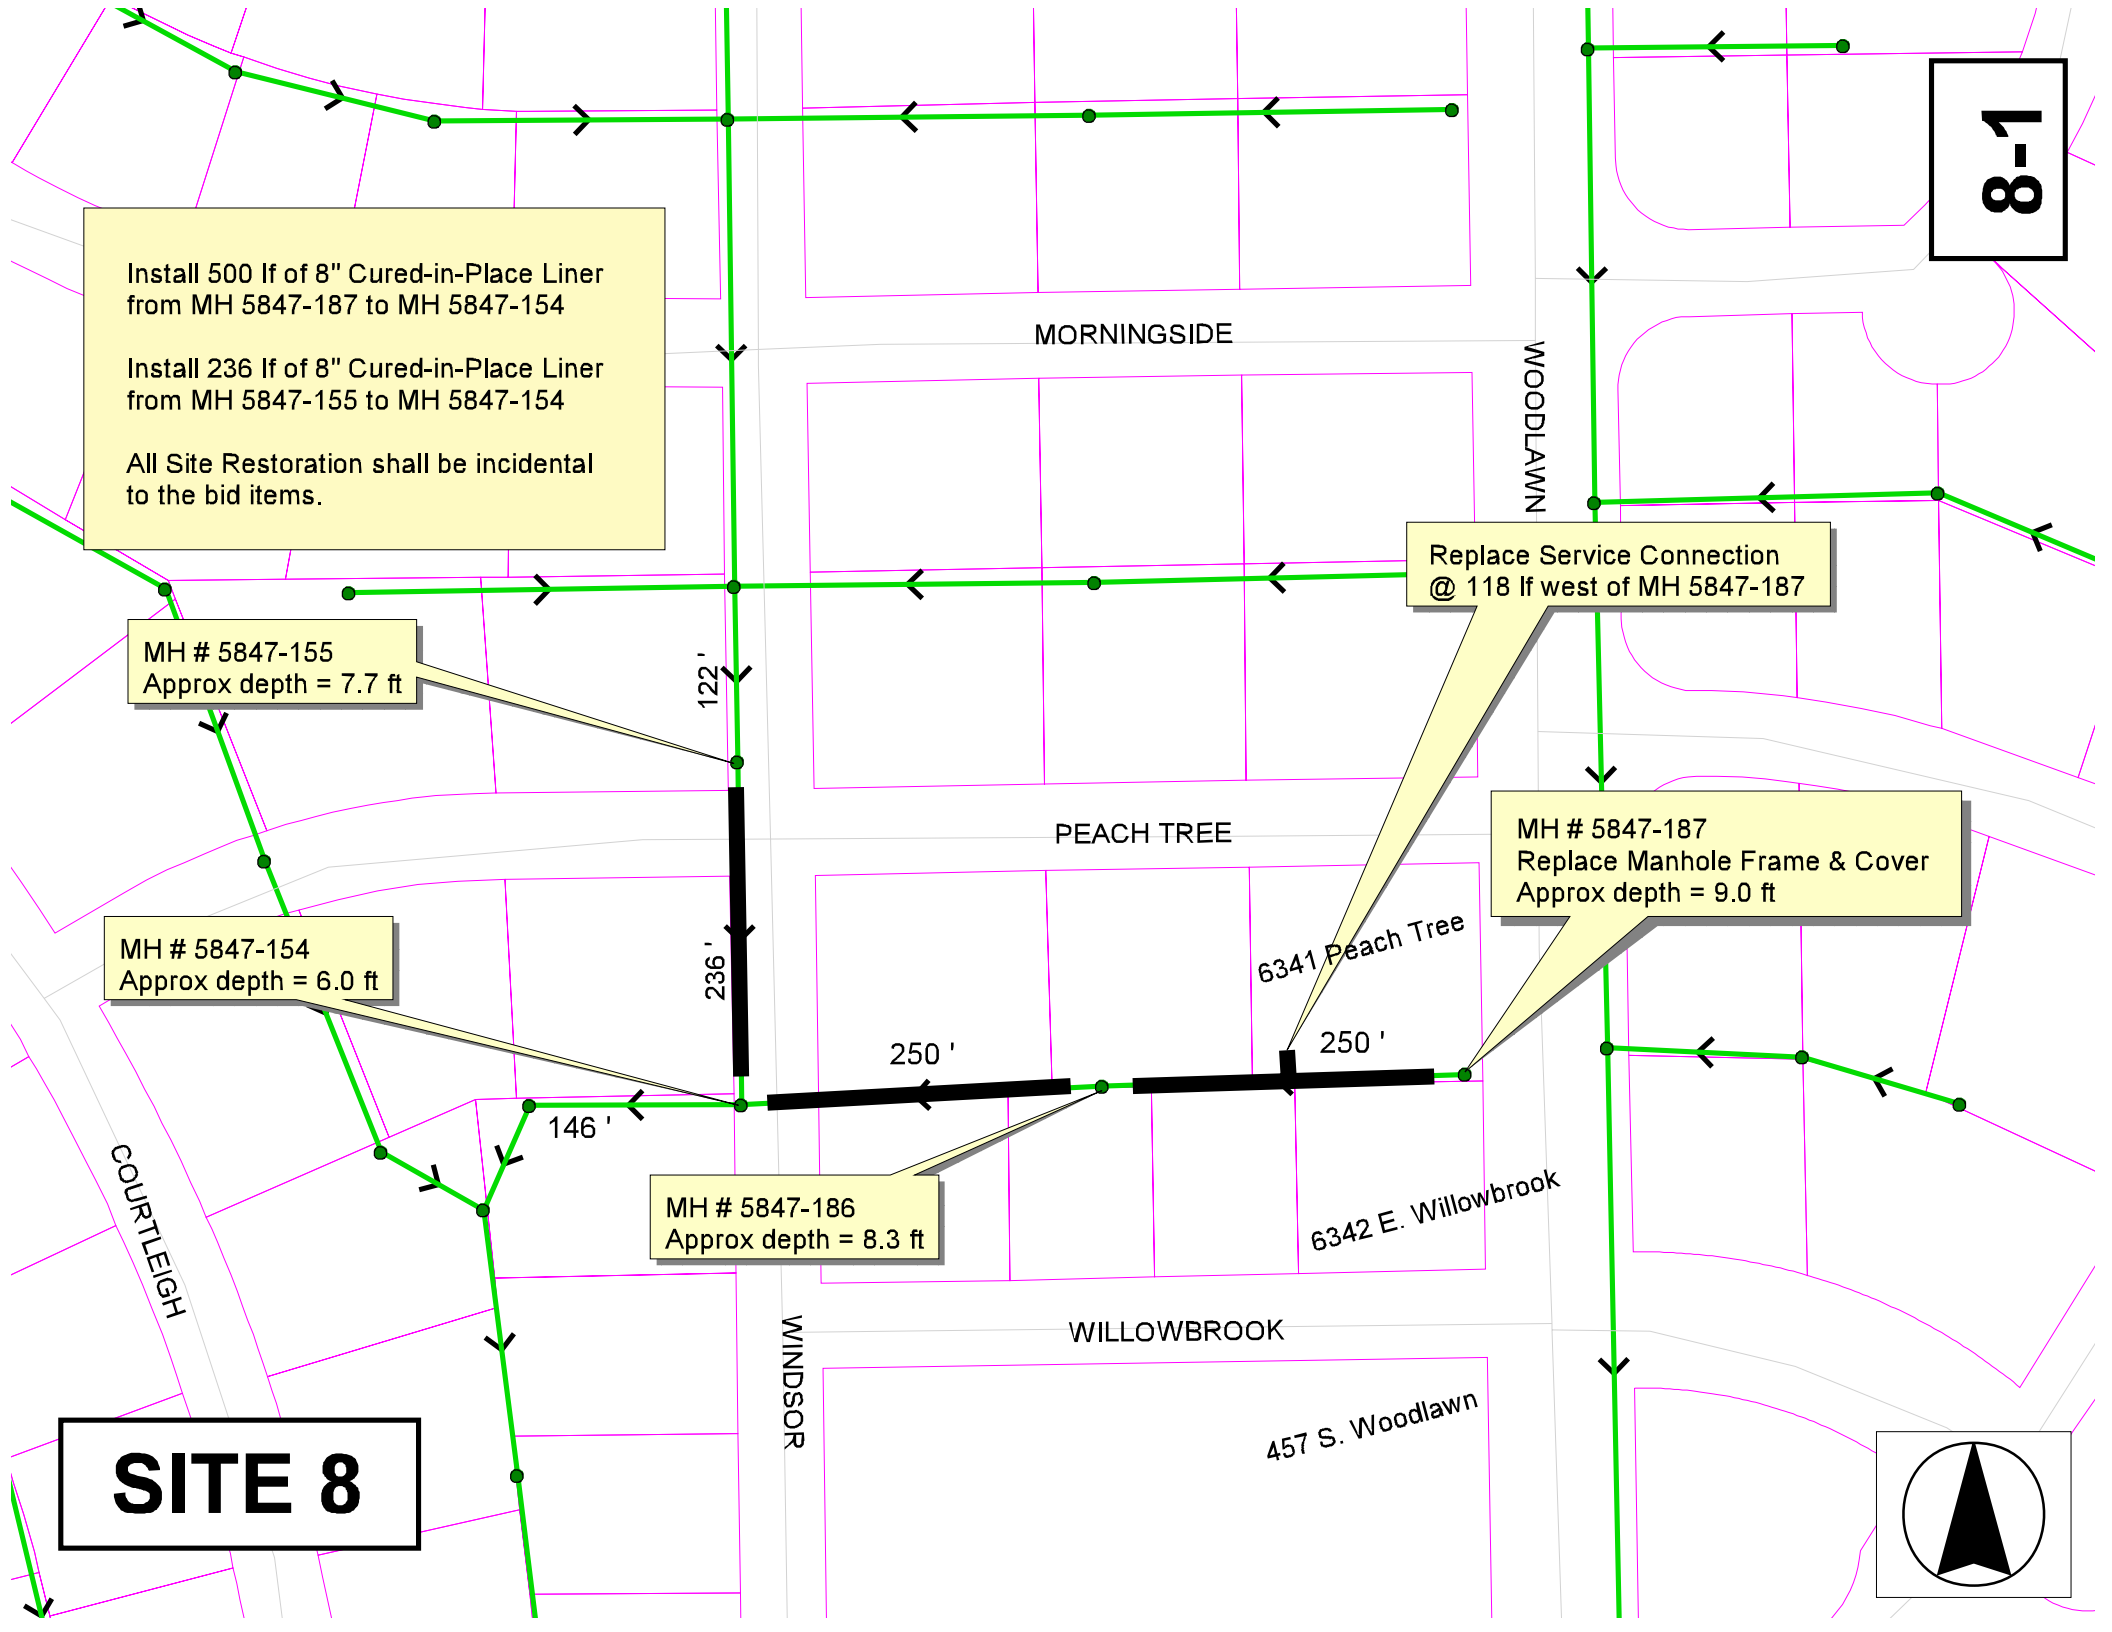
Aerial View

Replace Service Connection @ 118 lf west of MH 5847-187

MH # 5847-155
Approx depth = 7.7 ft

MH # 5847-187
Replace Manhole Frame & Cover
Approx depth = 9.0 ft

MH # 5847-154
Approx depth = 6.0 ft

MH # 5847-186
Approx depth = 8.3 ft

Install 236 lf of 8" Cured-in-Place Liner from MH 5847-155 to MH 5847-154
