POINT REPAIR:  
Remove and replace 63 lf of 8" pipe  
from MH 5248-349 to 63 lf west of  
MH 5248-349. Removal and replacement  
of concrete parking lot shall be incidental  
to the repair.

SITE 9

# Television Inspection Master Report

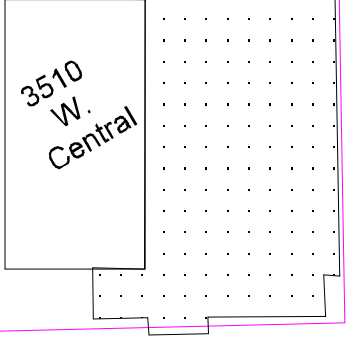
MH # 5248-349  
Approx depth = 10.1 ft

MH # 5248-350

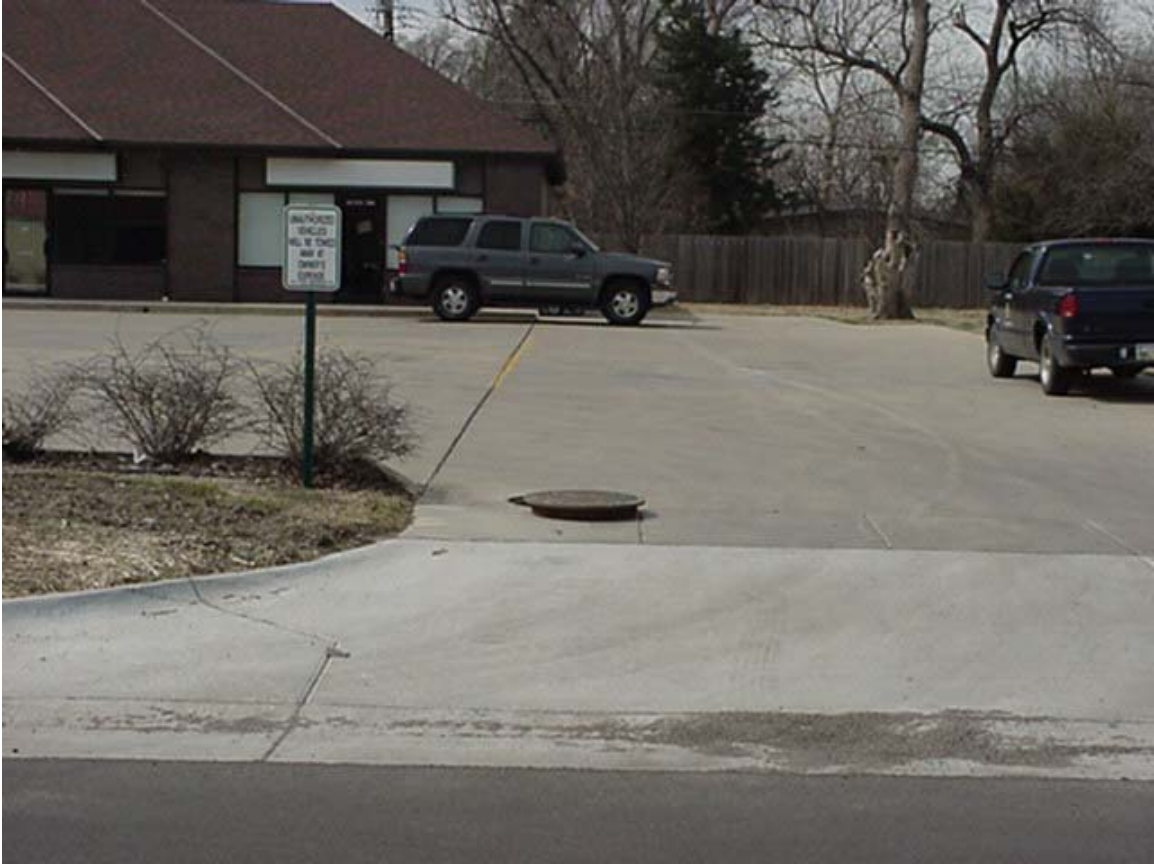
WE HAD TO PULL OUT CAMERA TO RECLEAN DUE TO GREASE AND DEBRIS IN LINE. AT 85 FT MARK. ALSO PULLED DOWN WATER. THIS LINE HAS BAD SAG FROM ABOUT 90 FT TO 120 FT MARK.

Standing in Joann Street, east of MH 5248-349, looking west.  
The entire point repair is within the concrete parking lot.

**POINT REPAIR:** Remove and replace the downstream 63 lf to correct the grade. Sag is causing excessive maintenance and stoppages.
