SITE 1

Television Inspection Master Report

US Structure: 5945-039 1737 S MISSION RD Date Insp: 9/14/2006 Basin: E01B1
DS Structure: 5945-016 1813 S MISSION RD Dir Televised: Upstream To Downstream

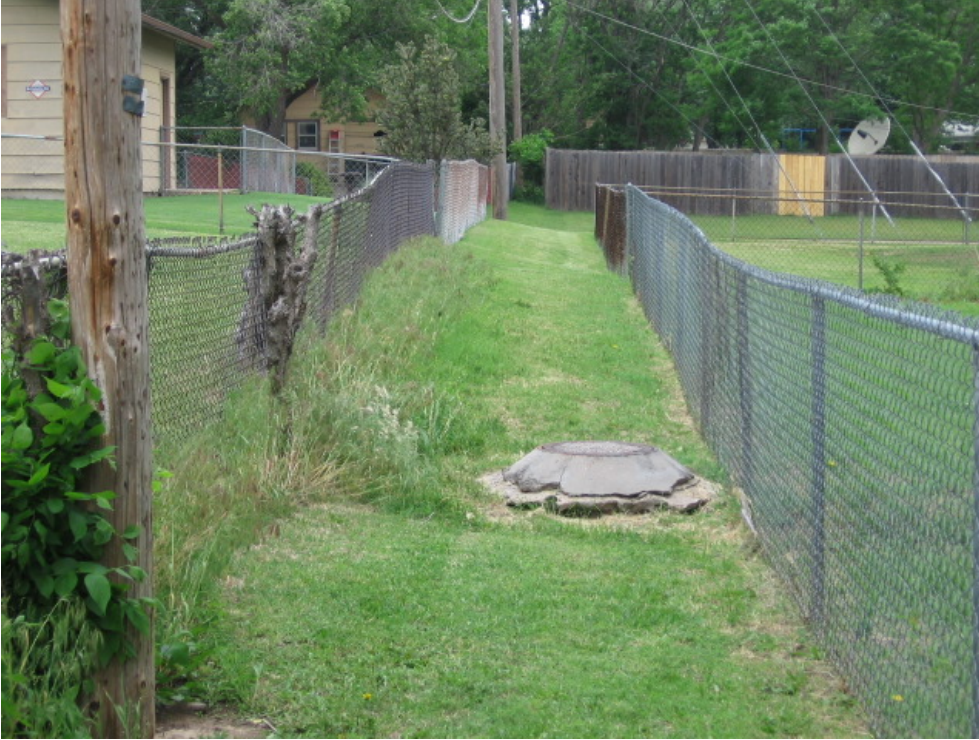
1-3

CAMERA WON'T PASS. THIS IS AT THE DROP MANHOLE. LINE HAS LOTS OF HORIZONTAL CRACKS.

The pipe has fallen vertically at a joint near the outside drop hole. There is a cavity and a lot of pipe missing. Need to replace the downstream 10 lf of pipe and probably the outside drop as well.

Standing south of MH 5945-016, looking north.

Replace Manhole Frame & Cover:

Contractor shall rework the stack/cone, per City Spec and put a concrete seal around the outside of the manhole stack, extending concrete seal to a minimum of 12" below ground level.
