SITE 2

Television Inspection Master Report

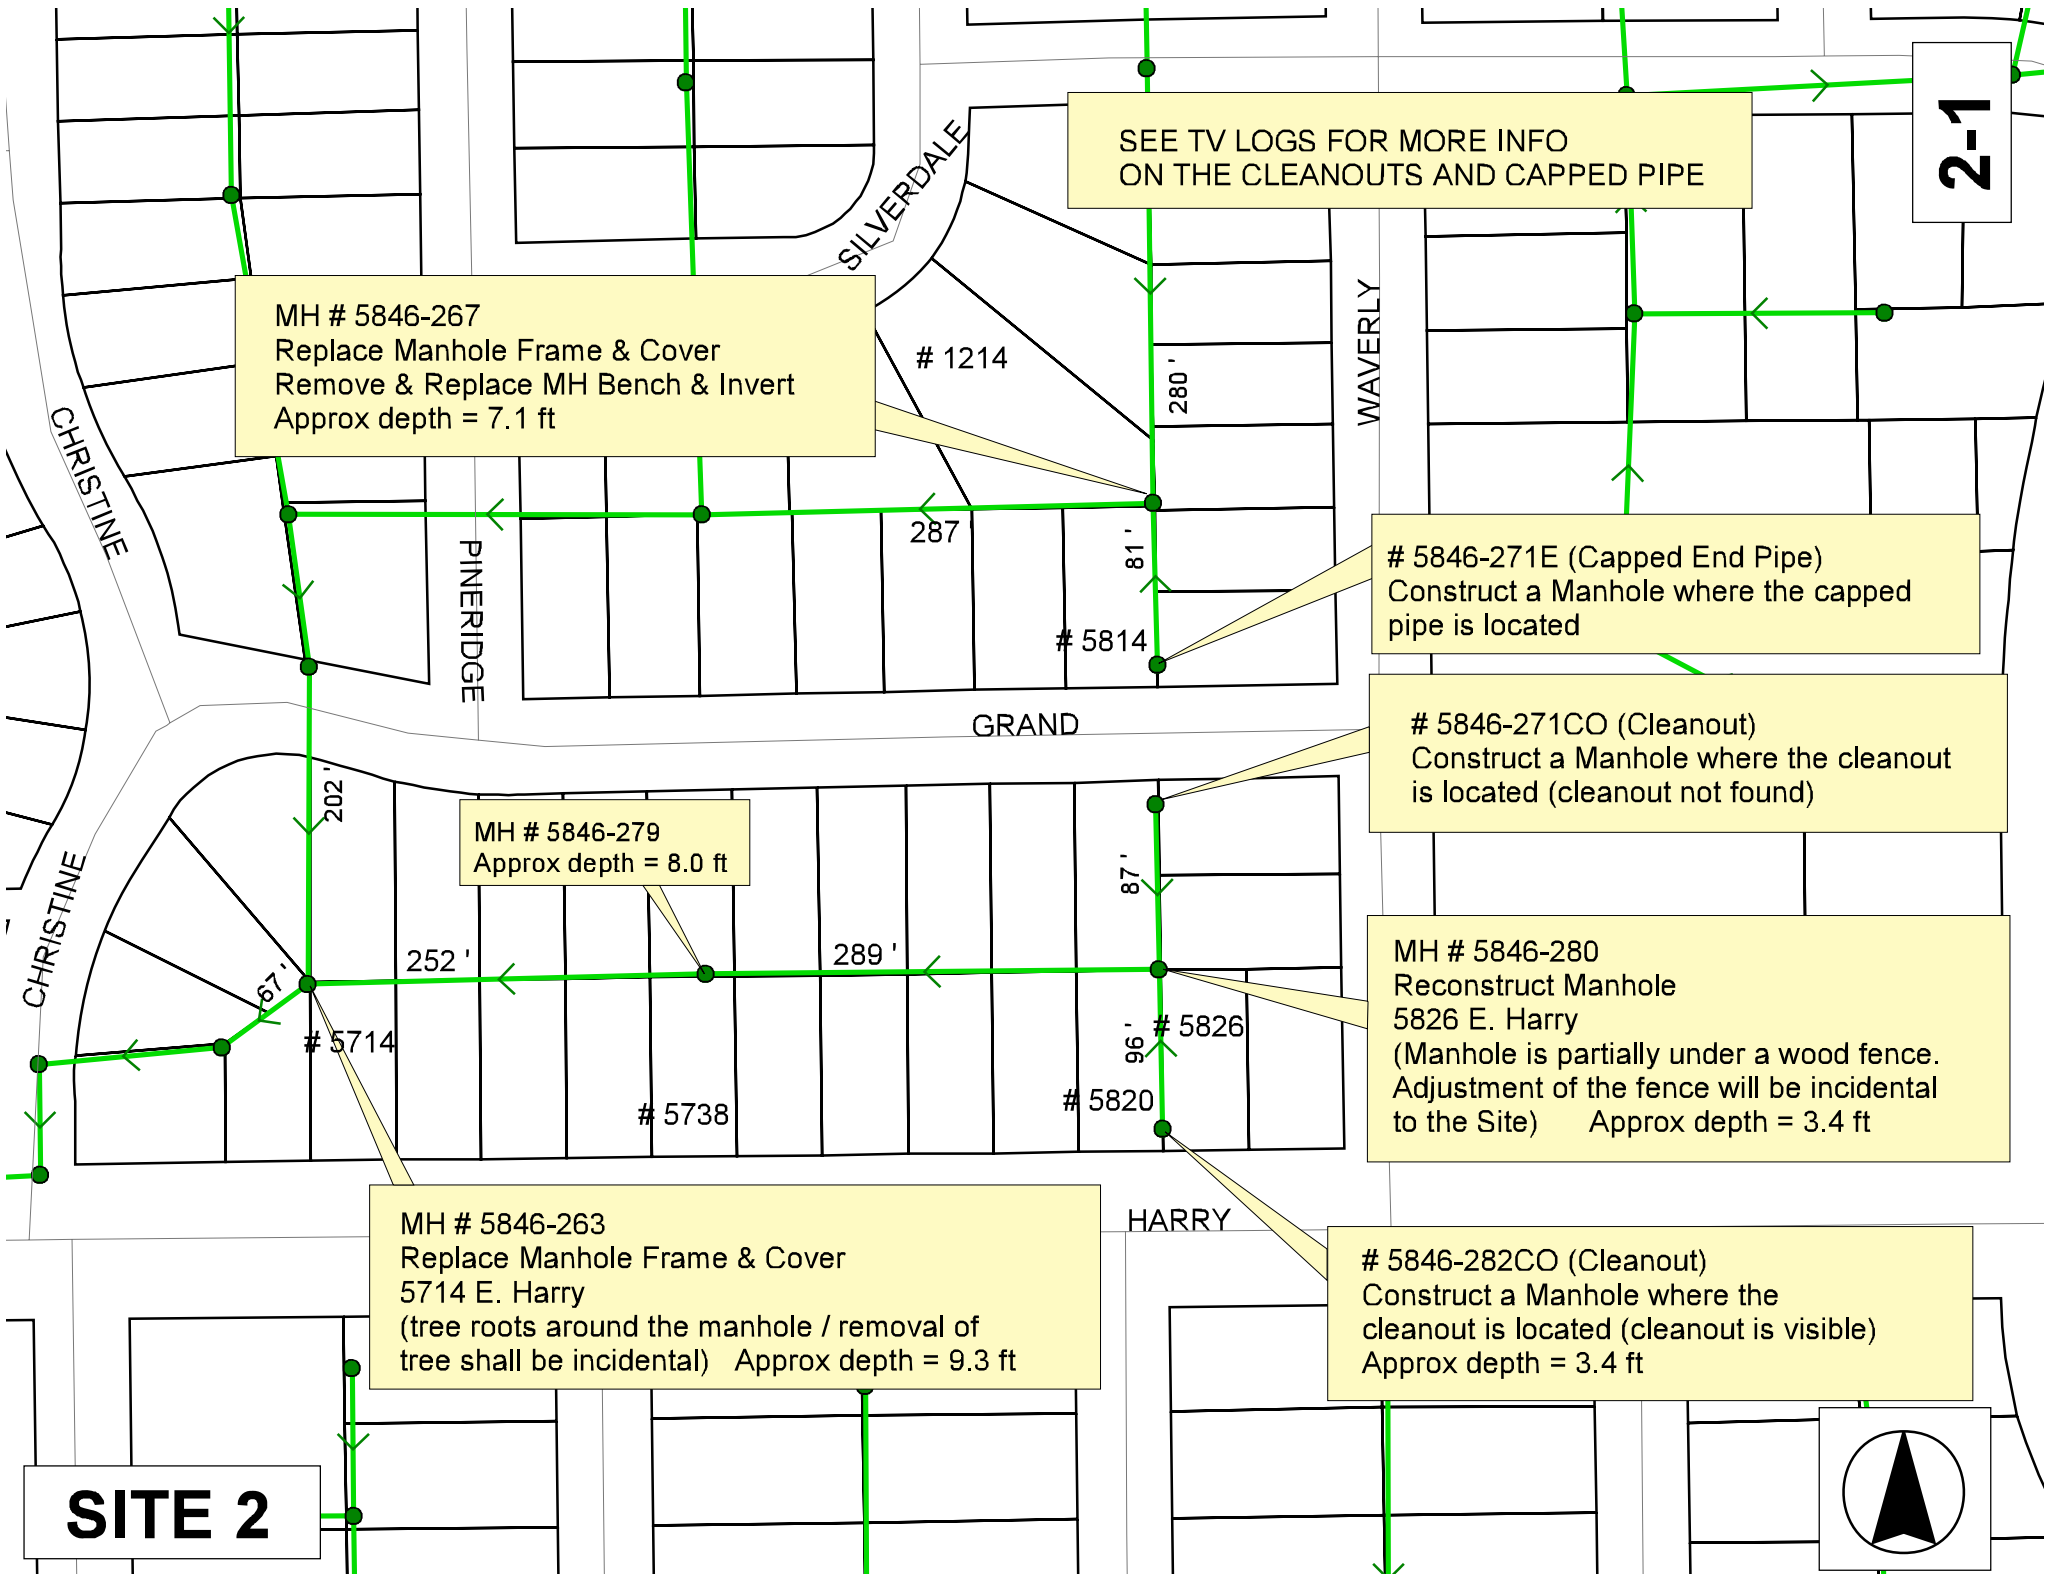
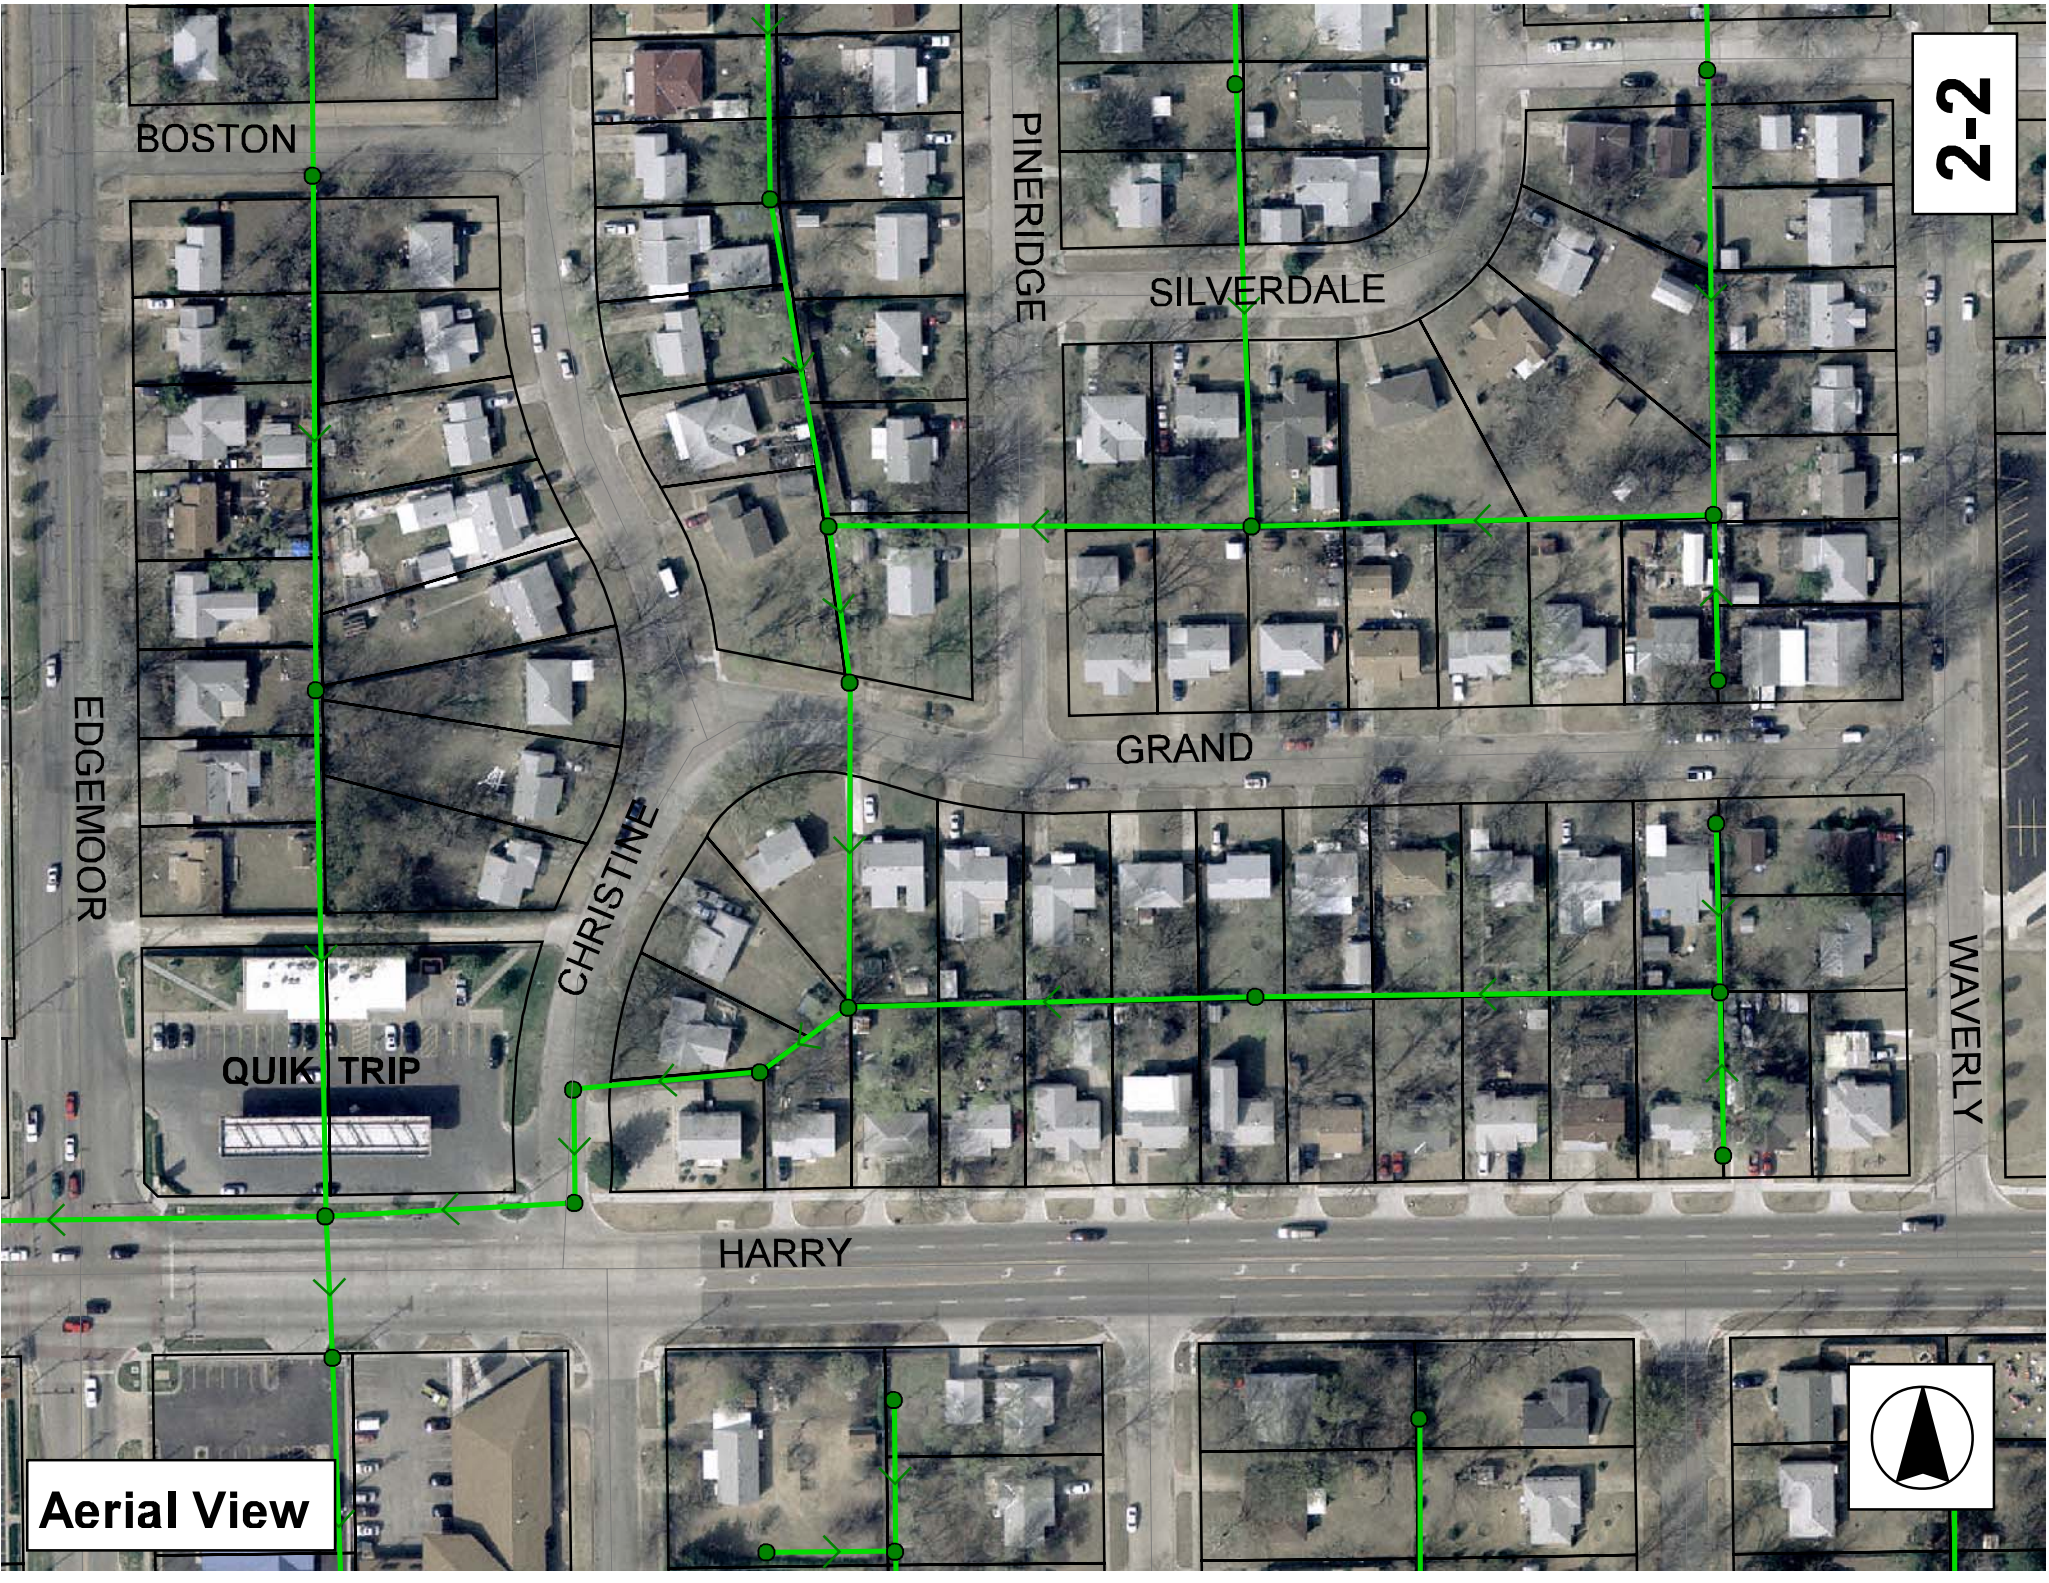
Aerial View

MH # 5846-267
Replace Manhole Frame & Cover
Remove & Replace MH Bench & Invert
Approx depth = 7.1 ft

5846-271E (Capped End Pipe)
Construct a Manhole where the capped
pipe is located

5846-271CO (Cleanout)
Construct a Manhole where the cleanout
is located (cleanout not found)

MH # 5846-279
Approx depth = 8.0 ft

MH # 5846-280
Reconstruct Manhole
5826 E. Harry
(Manhole is partially under a wood fence.
Adjustment of the fence will be incidental
to the Site) Approx depth = 3.4 ft

MH # 5846-263
Replace Manhole Frame & Cover
5714 E. Harry
(tree roots around the manhole / removal of
tree shall be incidental) Approx depth = 9.3 ft

5846-282CO (Cleanout)
Construct a Manhole where the
cleanout is located (cleanout is visible)
Approx depth = 3.4 ft
