Install 584 lf of 8" Cured-in-Place Liner from MH 5847-205 to MH 5847-002

SITE 11

Television Inspection Master Report

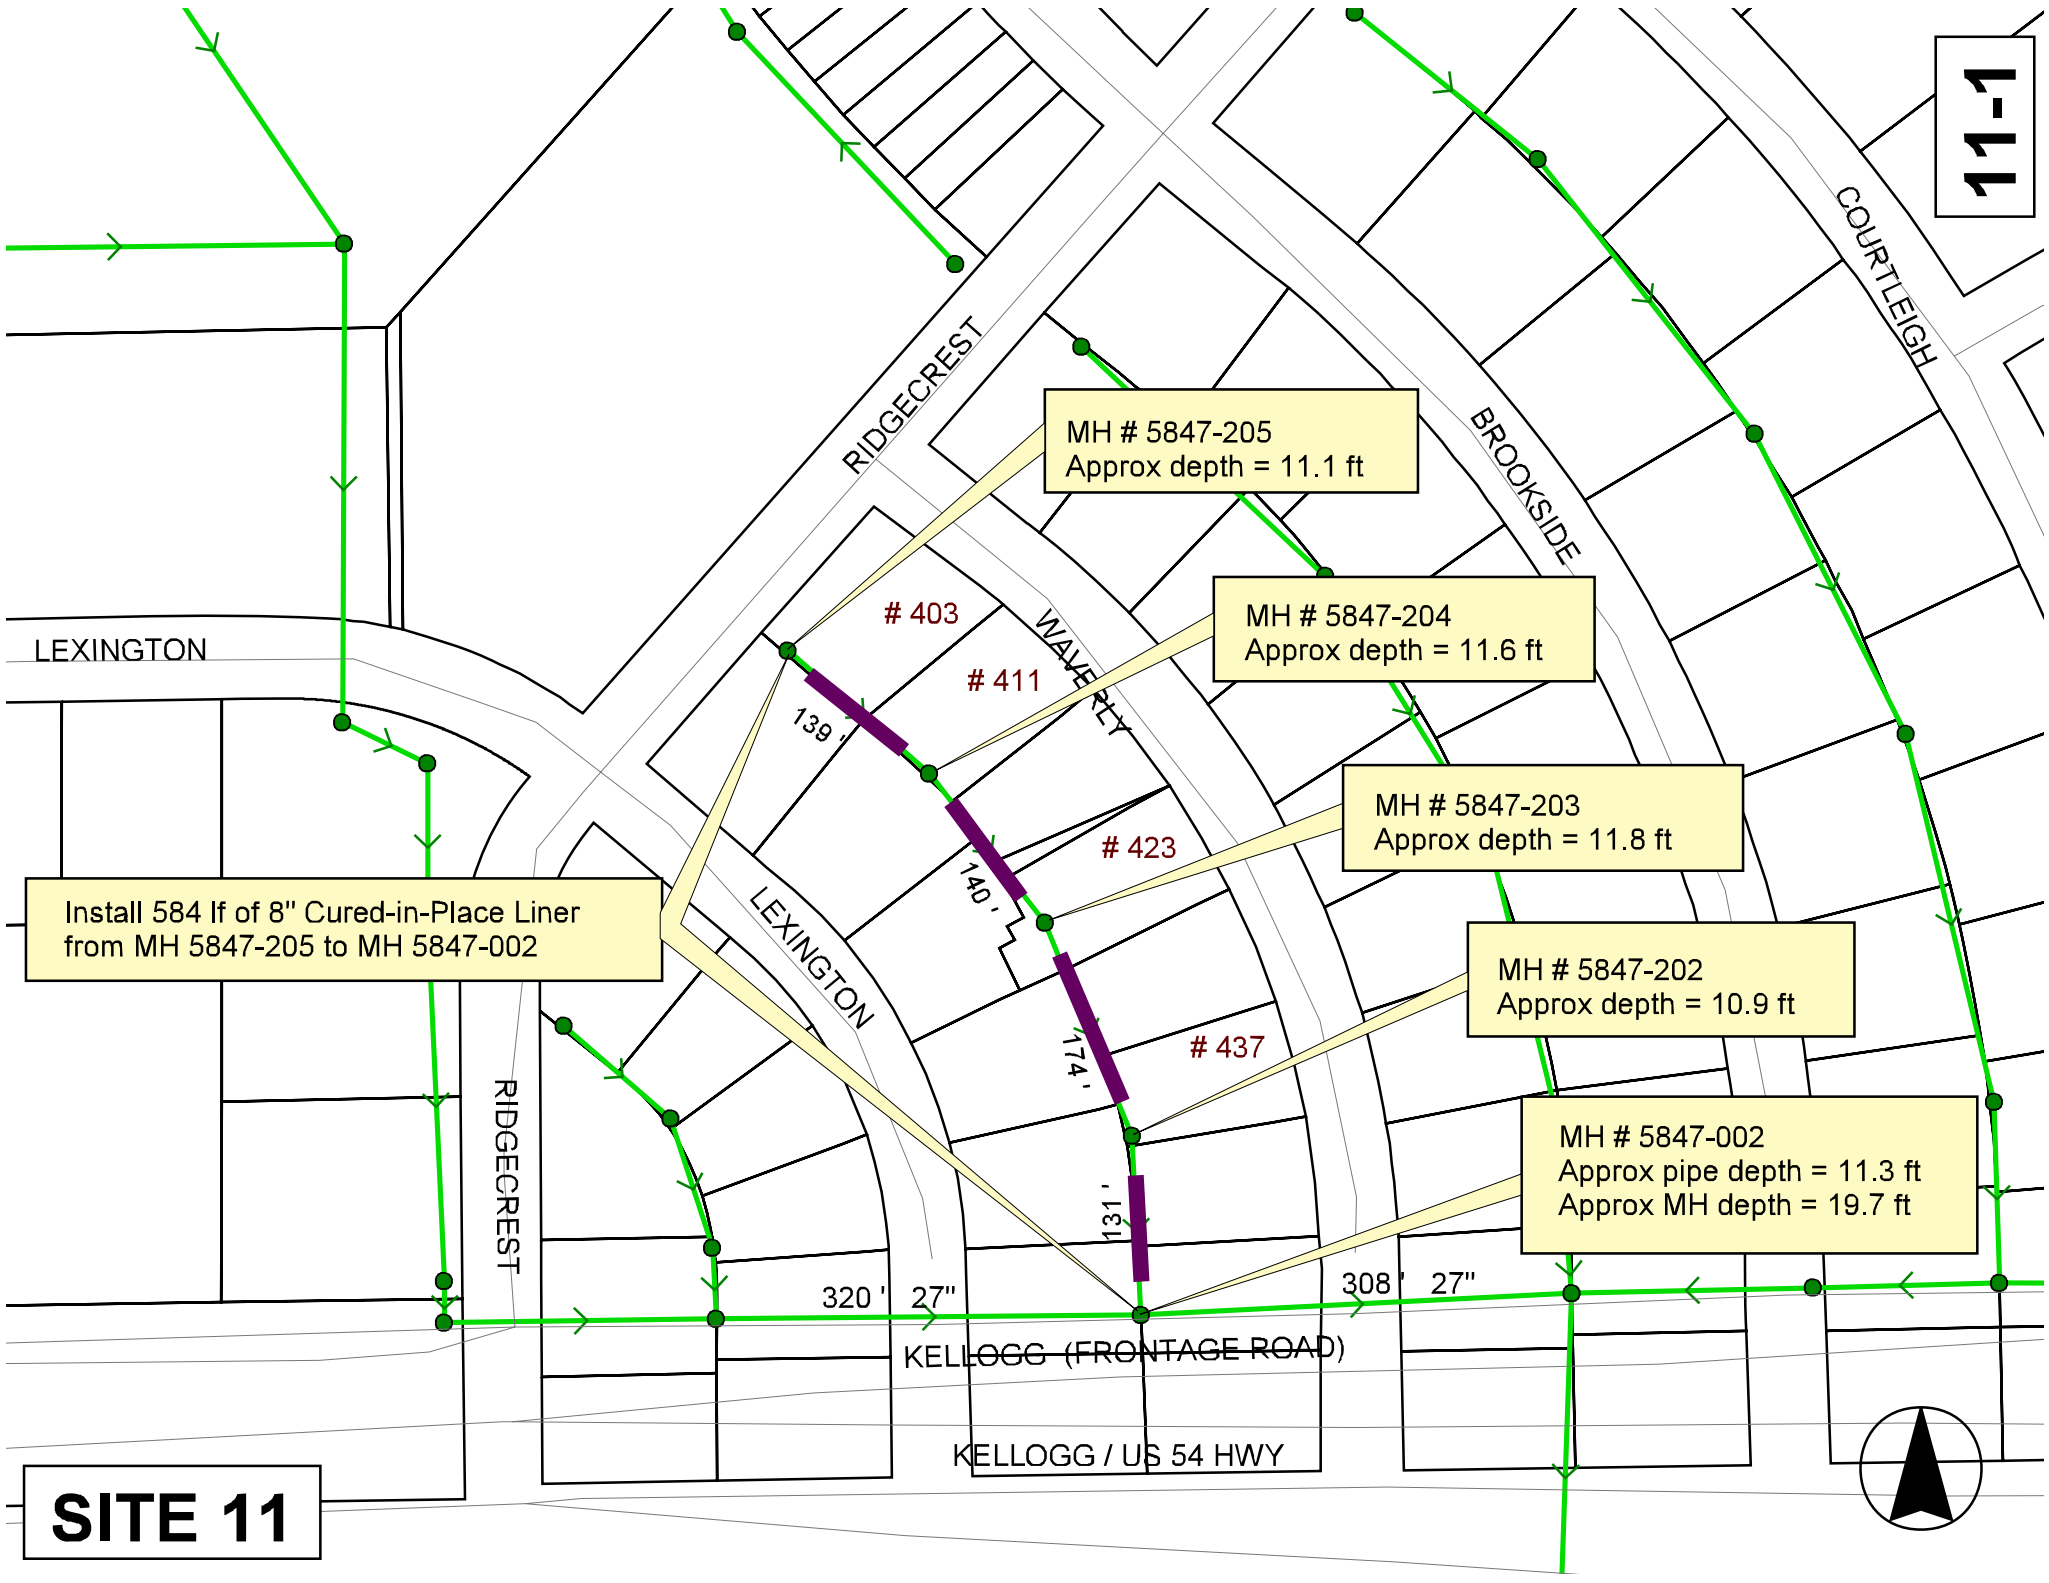
MH # 5847-205
Approx depth = 11.1 ft

MH # 5847-204
Approx depth = 11.6 ft

MH # 5847-203
Approx depth = 11.8 ft

MH # 5847-202
Approx depth = 10.9 ft

MH # 5847-002
Approx pipe depth = 11.3 ft
Approx MH depth = 19.7 ft
