Install 1111 lf of 8" Cured-in-Place Liner
from MH 5847-197 to MH 5847-485

SITE 12

Television Inspection Master Report

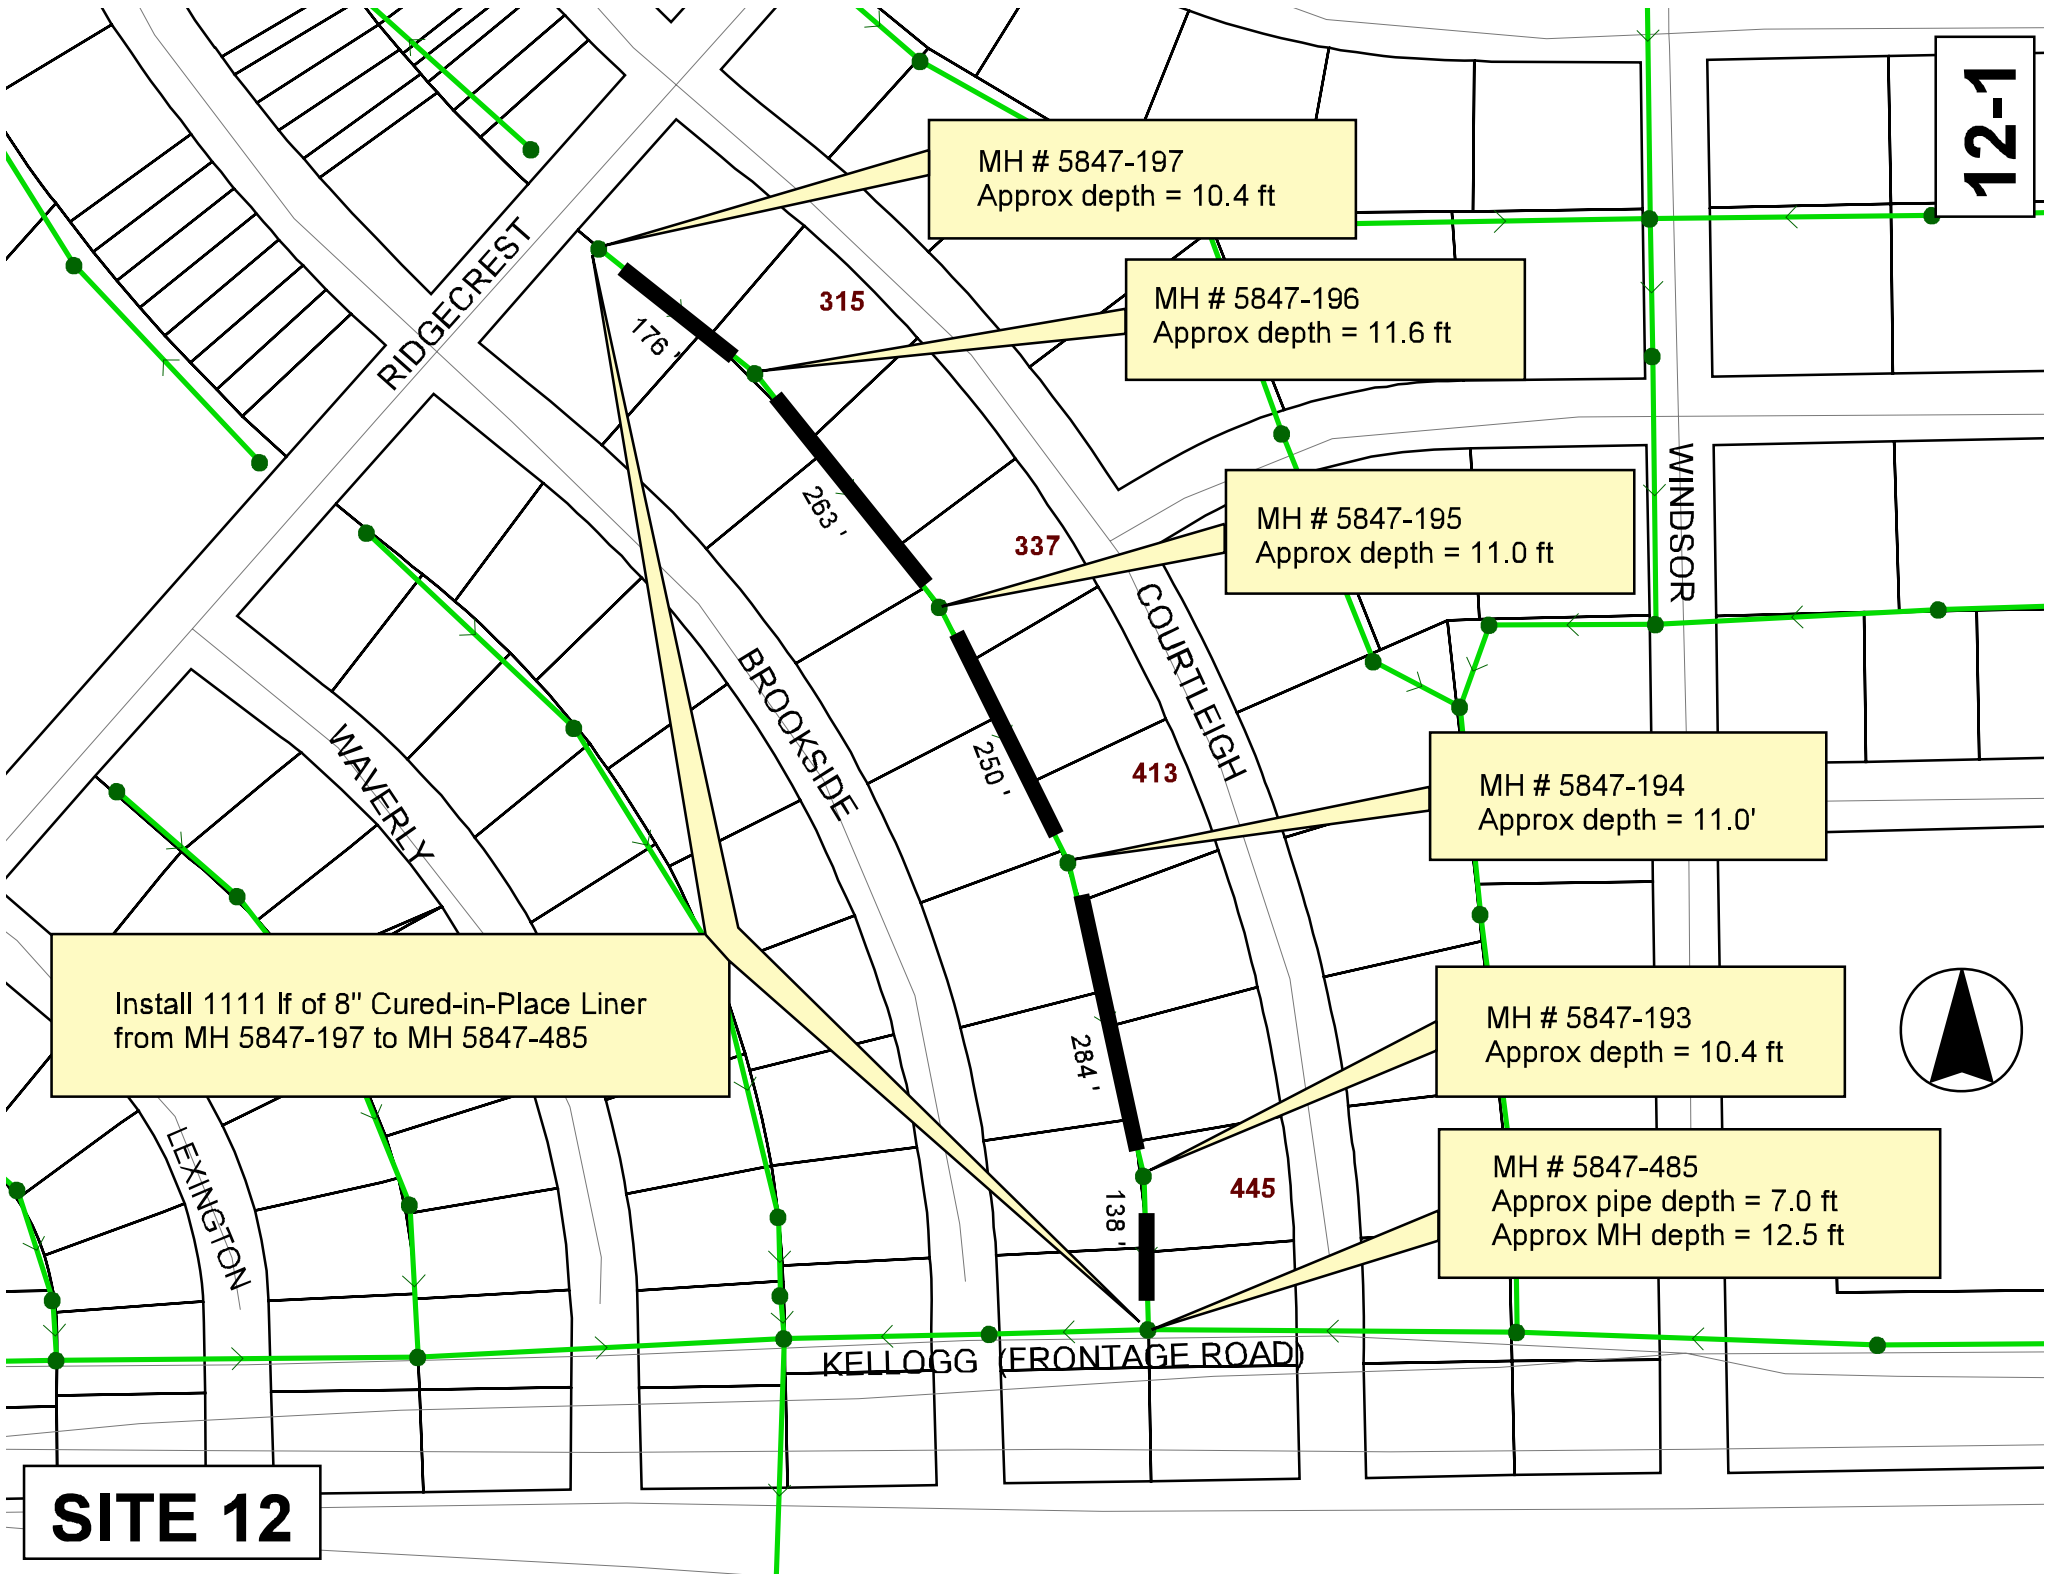
12-1

MH # 5847-197
Approx depth = 10.4 ft

MH # 5847-196
Approx depth = 11.6 ft

MH # 5847-195
Approx depth = 11.0 ft

MH # 5847-194
Approx depth = 11.0'

MH # 5847-193
Approx depth = 10.4 ft

MH # 5847-485
Approx pipe depth = 7.0 ft
Approx MH depth = 12.5 ft
