SITE 4

Install 608 lf of 8" Cured-in-Place Liner from MH 5847-451 to MH 5847-448

Television Inspection Master Report

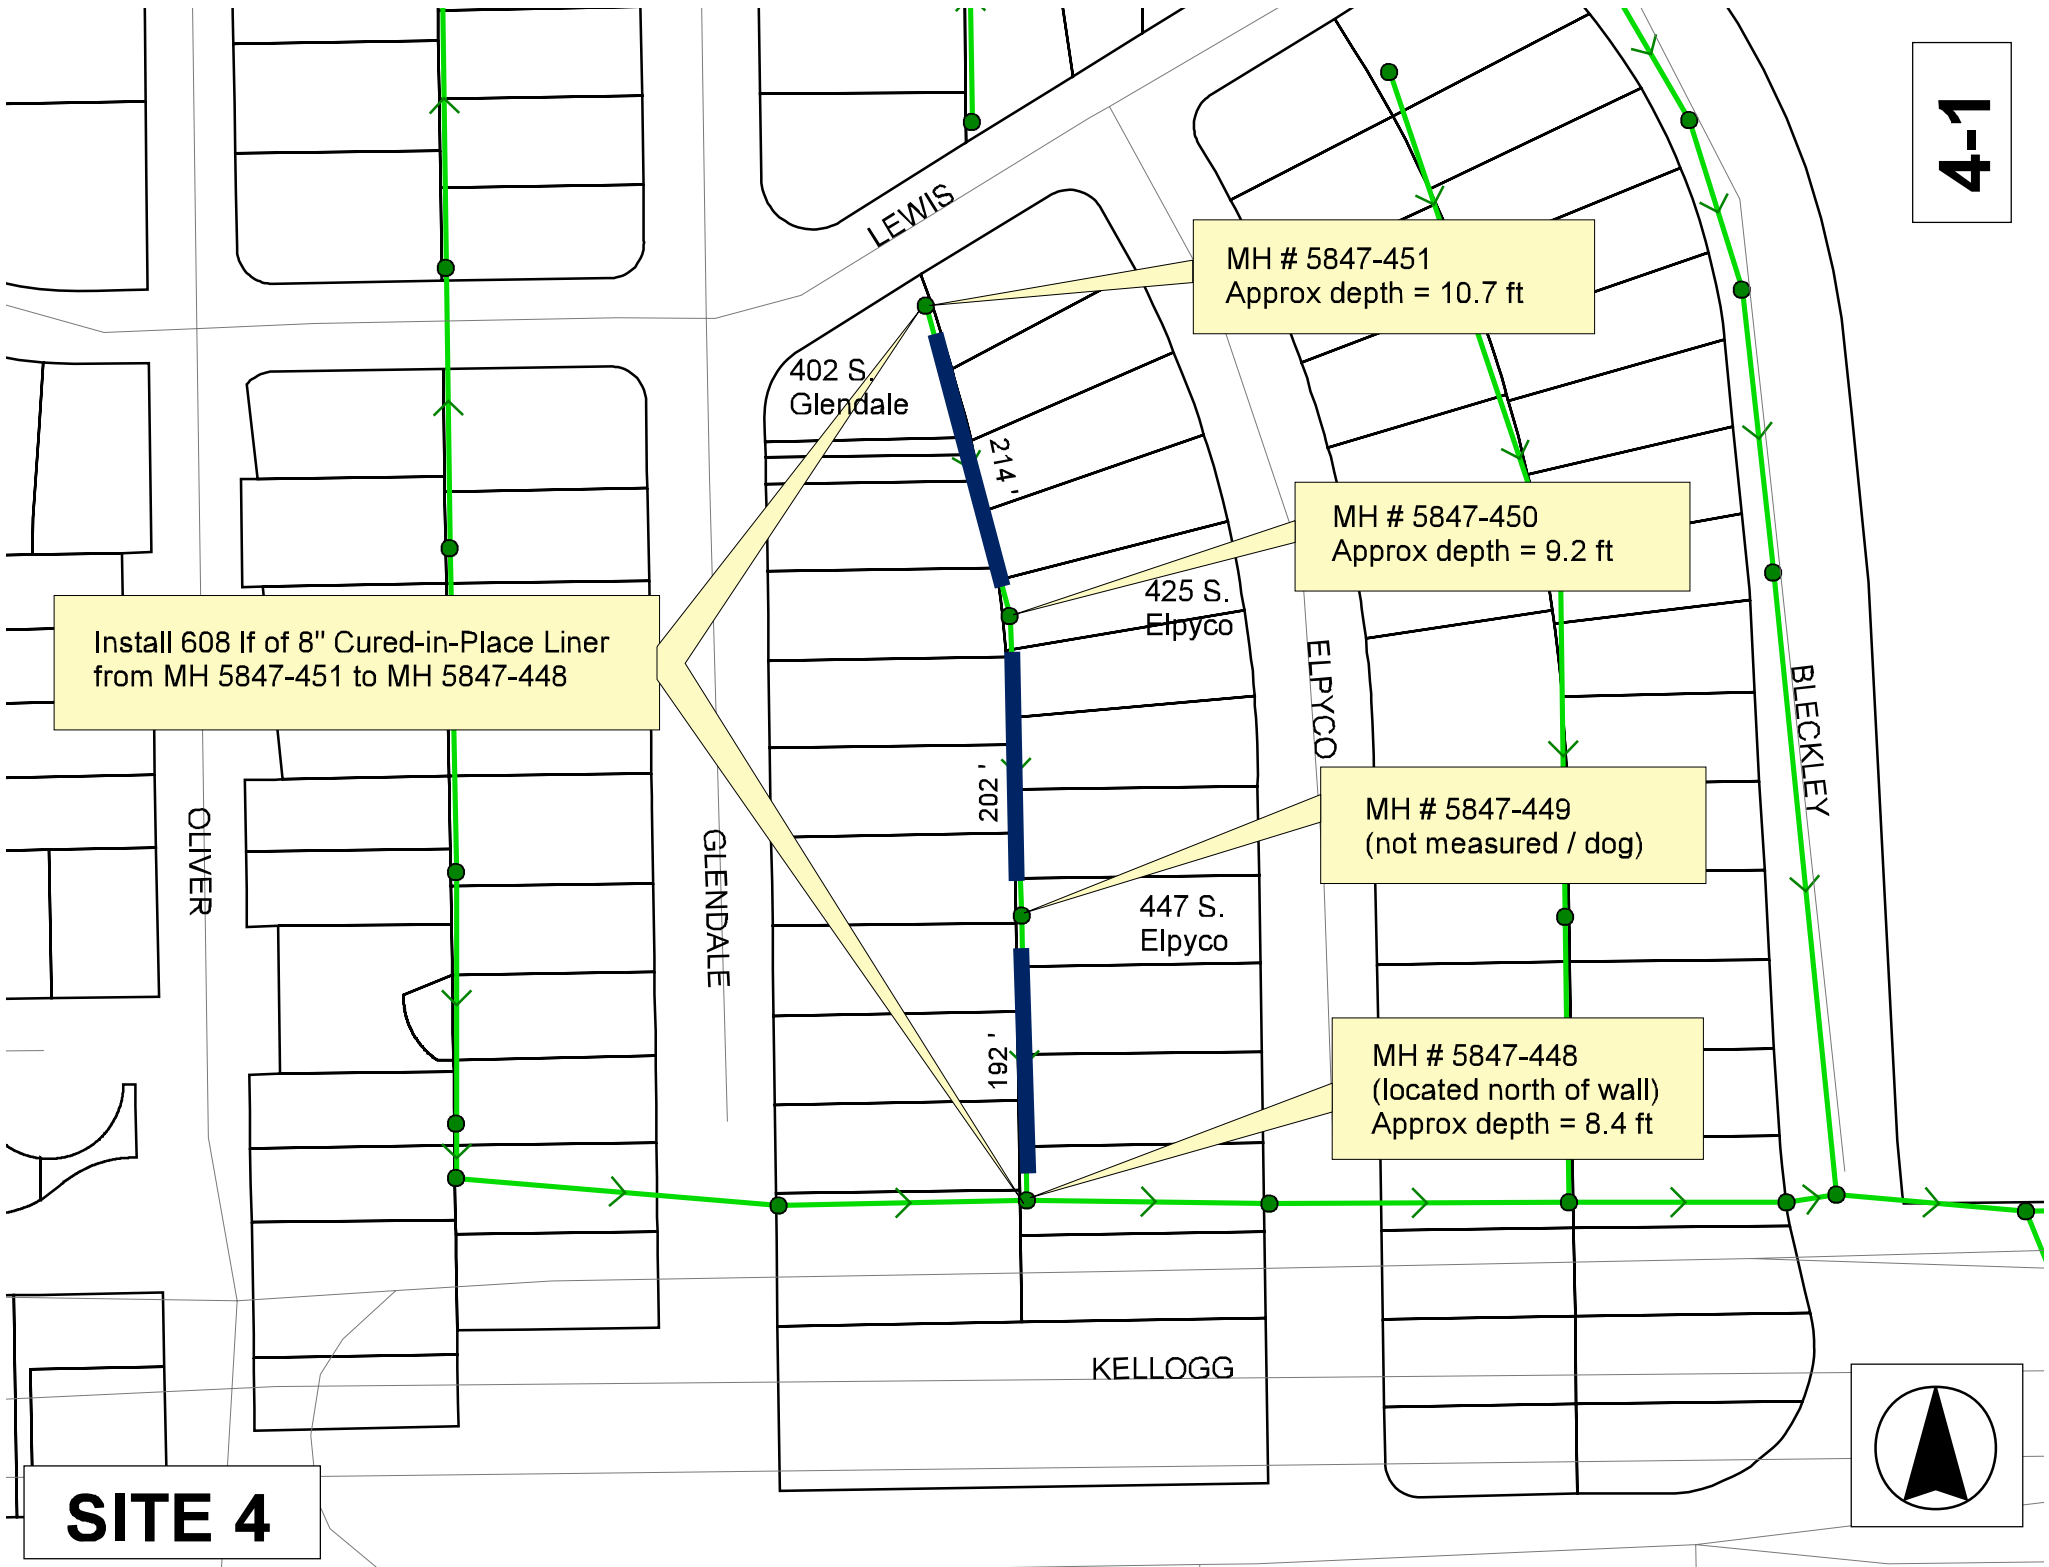
MH # 5847-451
Approx depth = 10.7 ft

MH # 5847-450
Approx depth = 9.2 ft

MH # 5847-449
(not measured / dog)

MH # 5847-448
(located north of wall)
Approx depth = 8.4 ft
