Install 412 lf of 8" Cured-in-Place Liner from MH 5846-501 to MH 5846-319

**SITE 5**

# Television Inspection Master Report

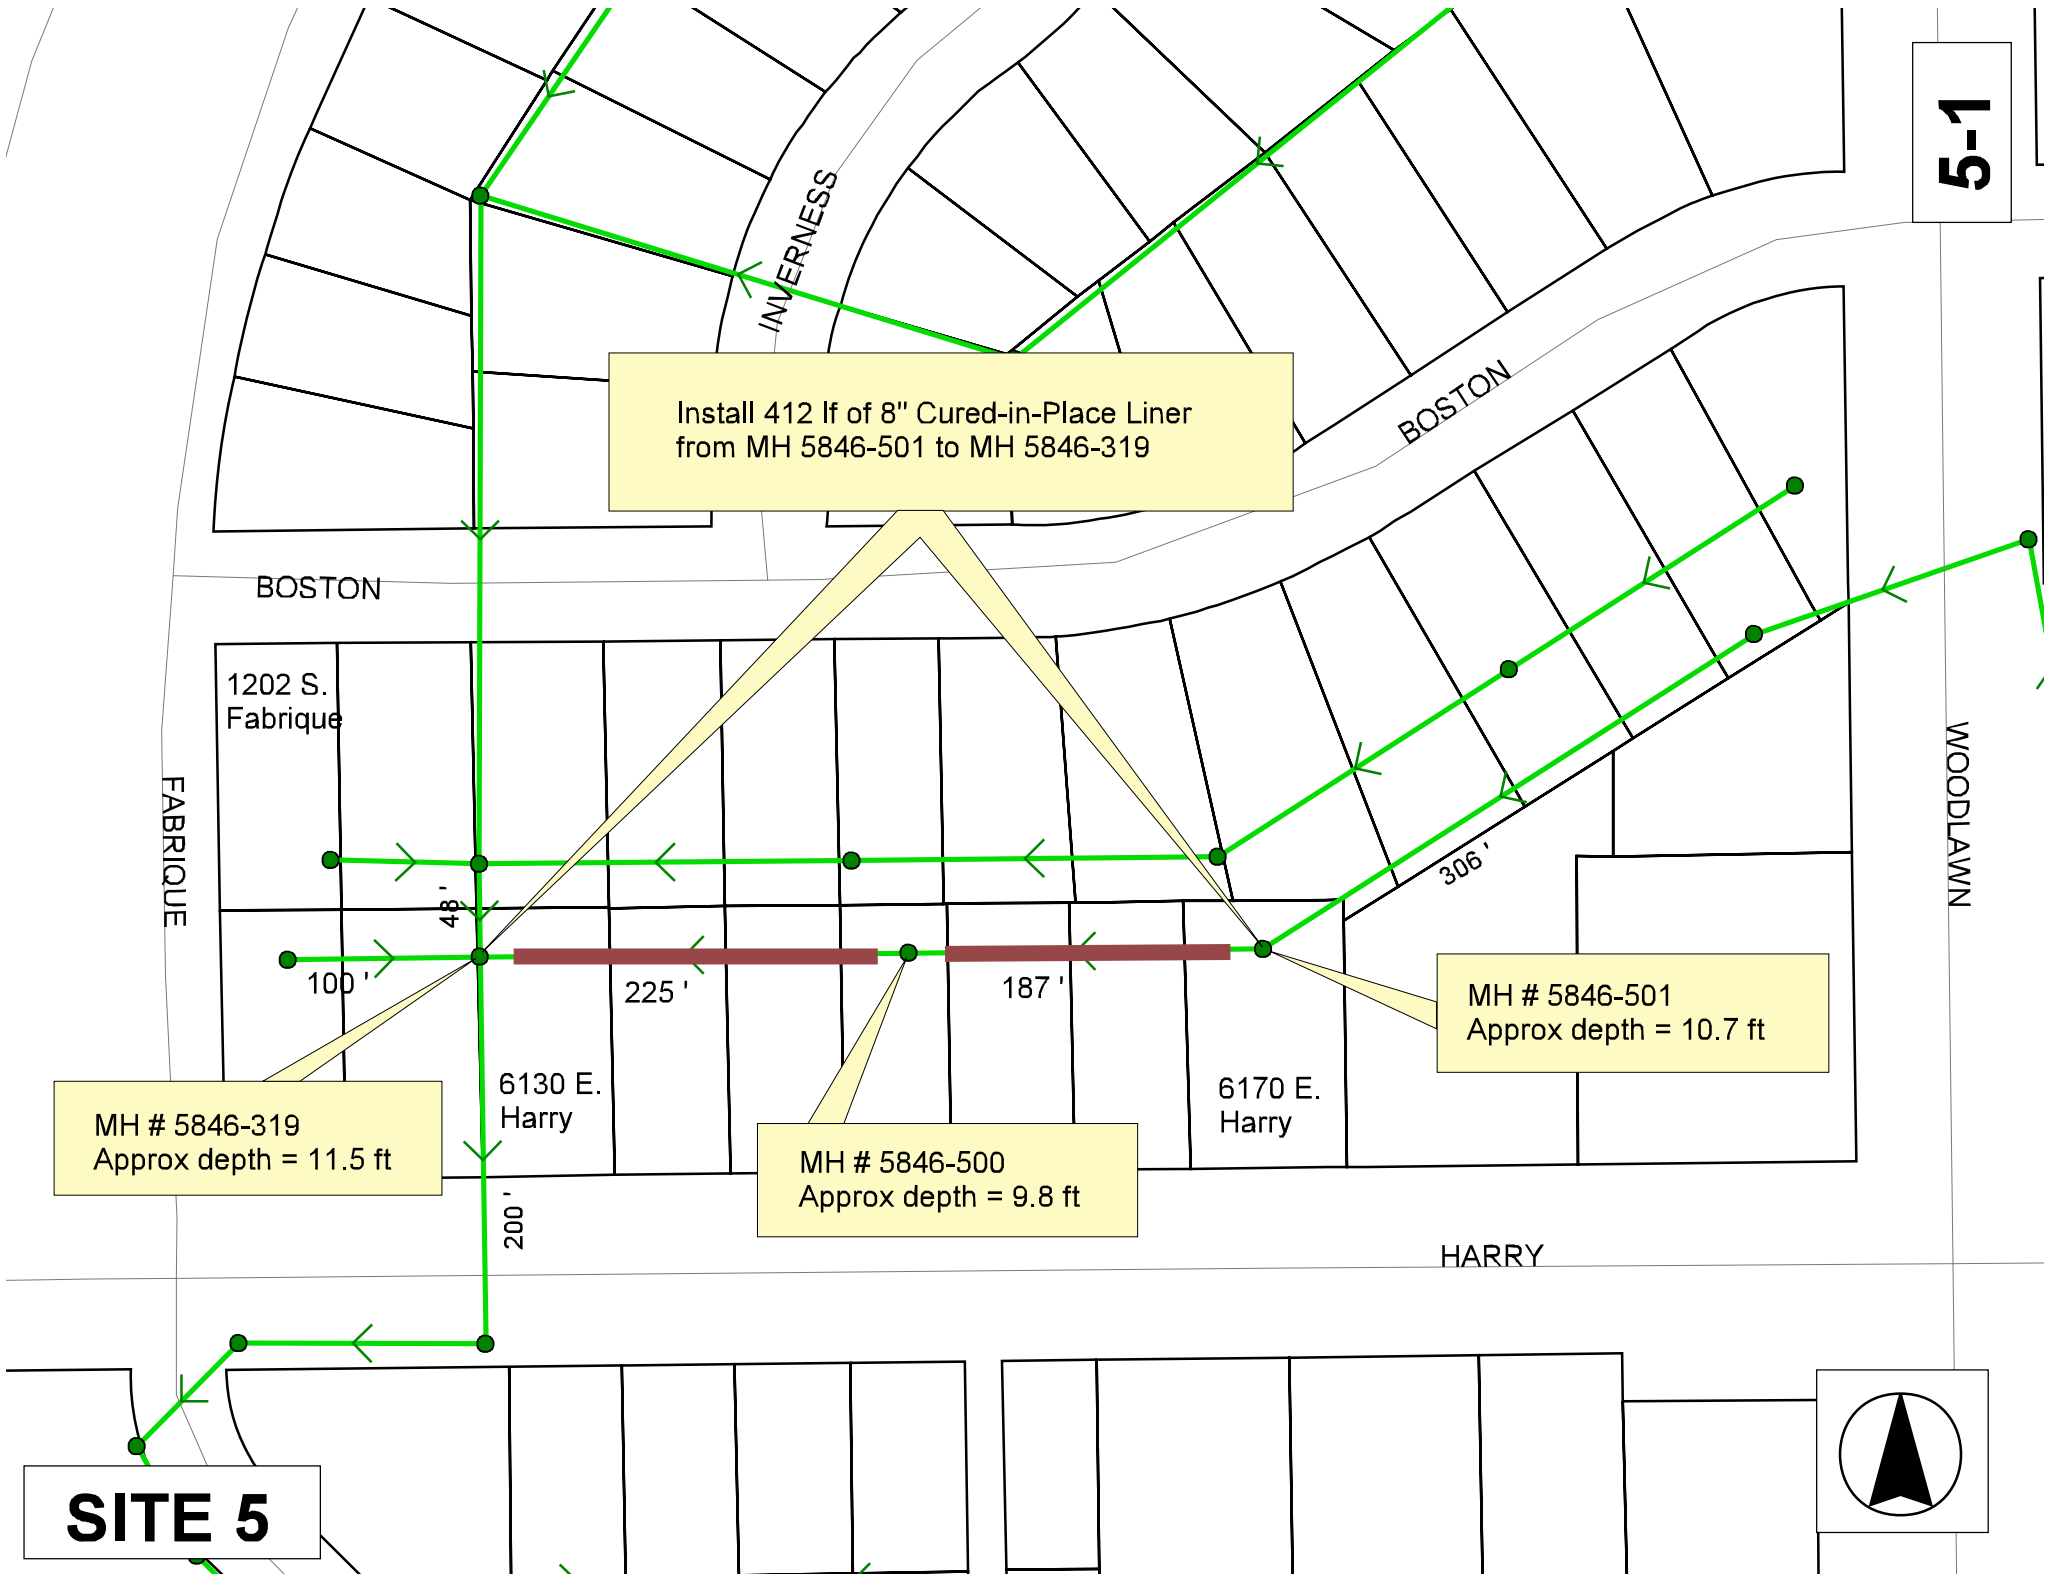
MH # 5846-319  
Approx depth = 11.5 ft

MH # 5846-500  
Approx depth = 9.8 ft

MH # 5846-501  
Approx depth = 10.7 ft
