Install 1184 lf of 8" Cured-in-Place Liner
 from MH 5948-310 to MH 5948-306

SITE #10

Sewer CCTV Observations

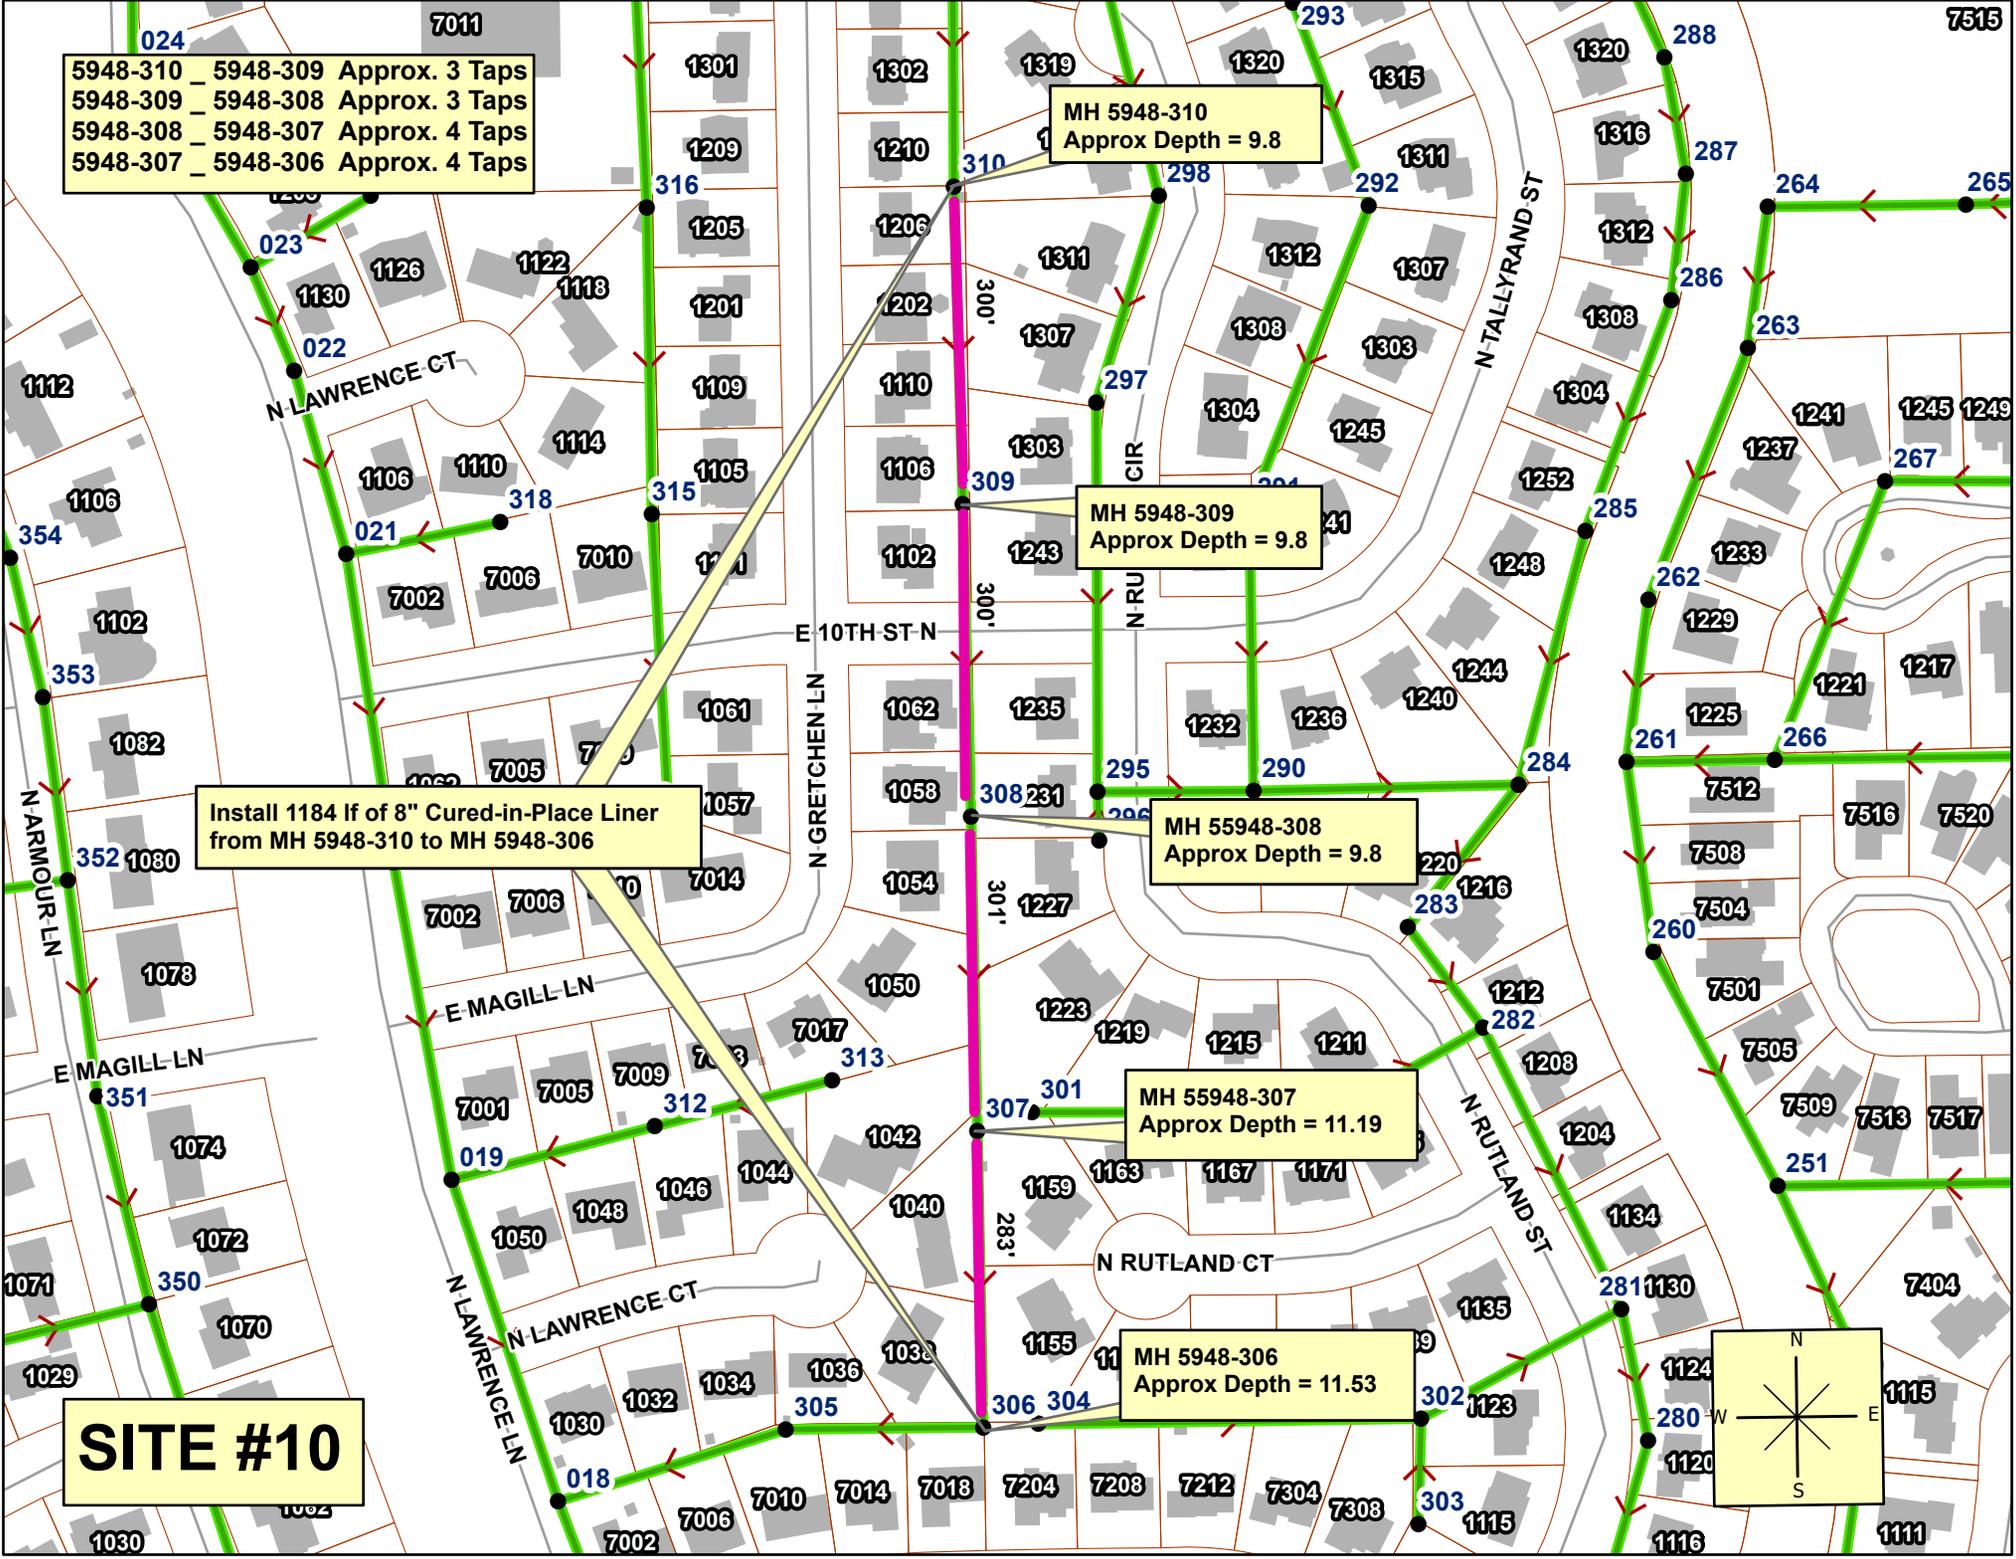
5948-310 - 5948-309 Approx. 3 Taps
 5948-309 - 5948-308 Approx. 3 Taps
 5948-308 - 5948-307 Approx. 4 Taps
 5948-307 - 5948-306 Approx. 4 Taps

MH 5948-310
 Approx Depth = 9.8

MH 5948-309
 Approx Depth = 9.8

MH 55948-308
 Approx Depth = 9.8

MH 55948-307
 Approx Depth = 11.19

MH 5948-306
 Approx Depth = 11.53
