Install 247 lf of 8" Cured-in-Place Liner
from MH 5948-088 to MH 5948-087

SITE 6

Sewer CCTV Observations

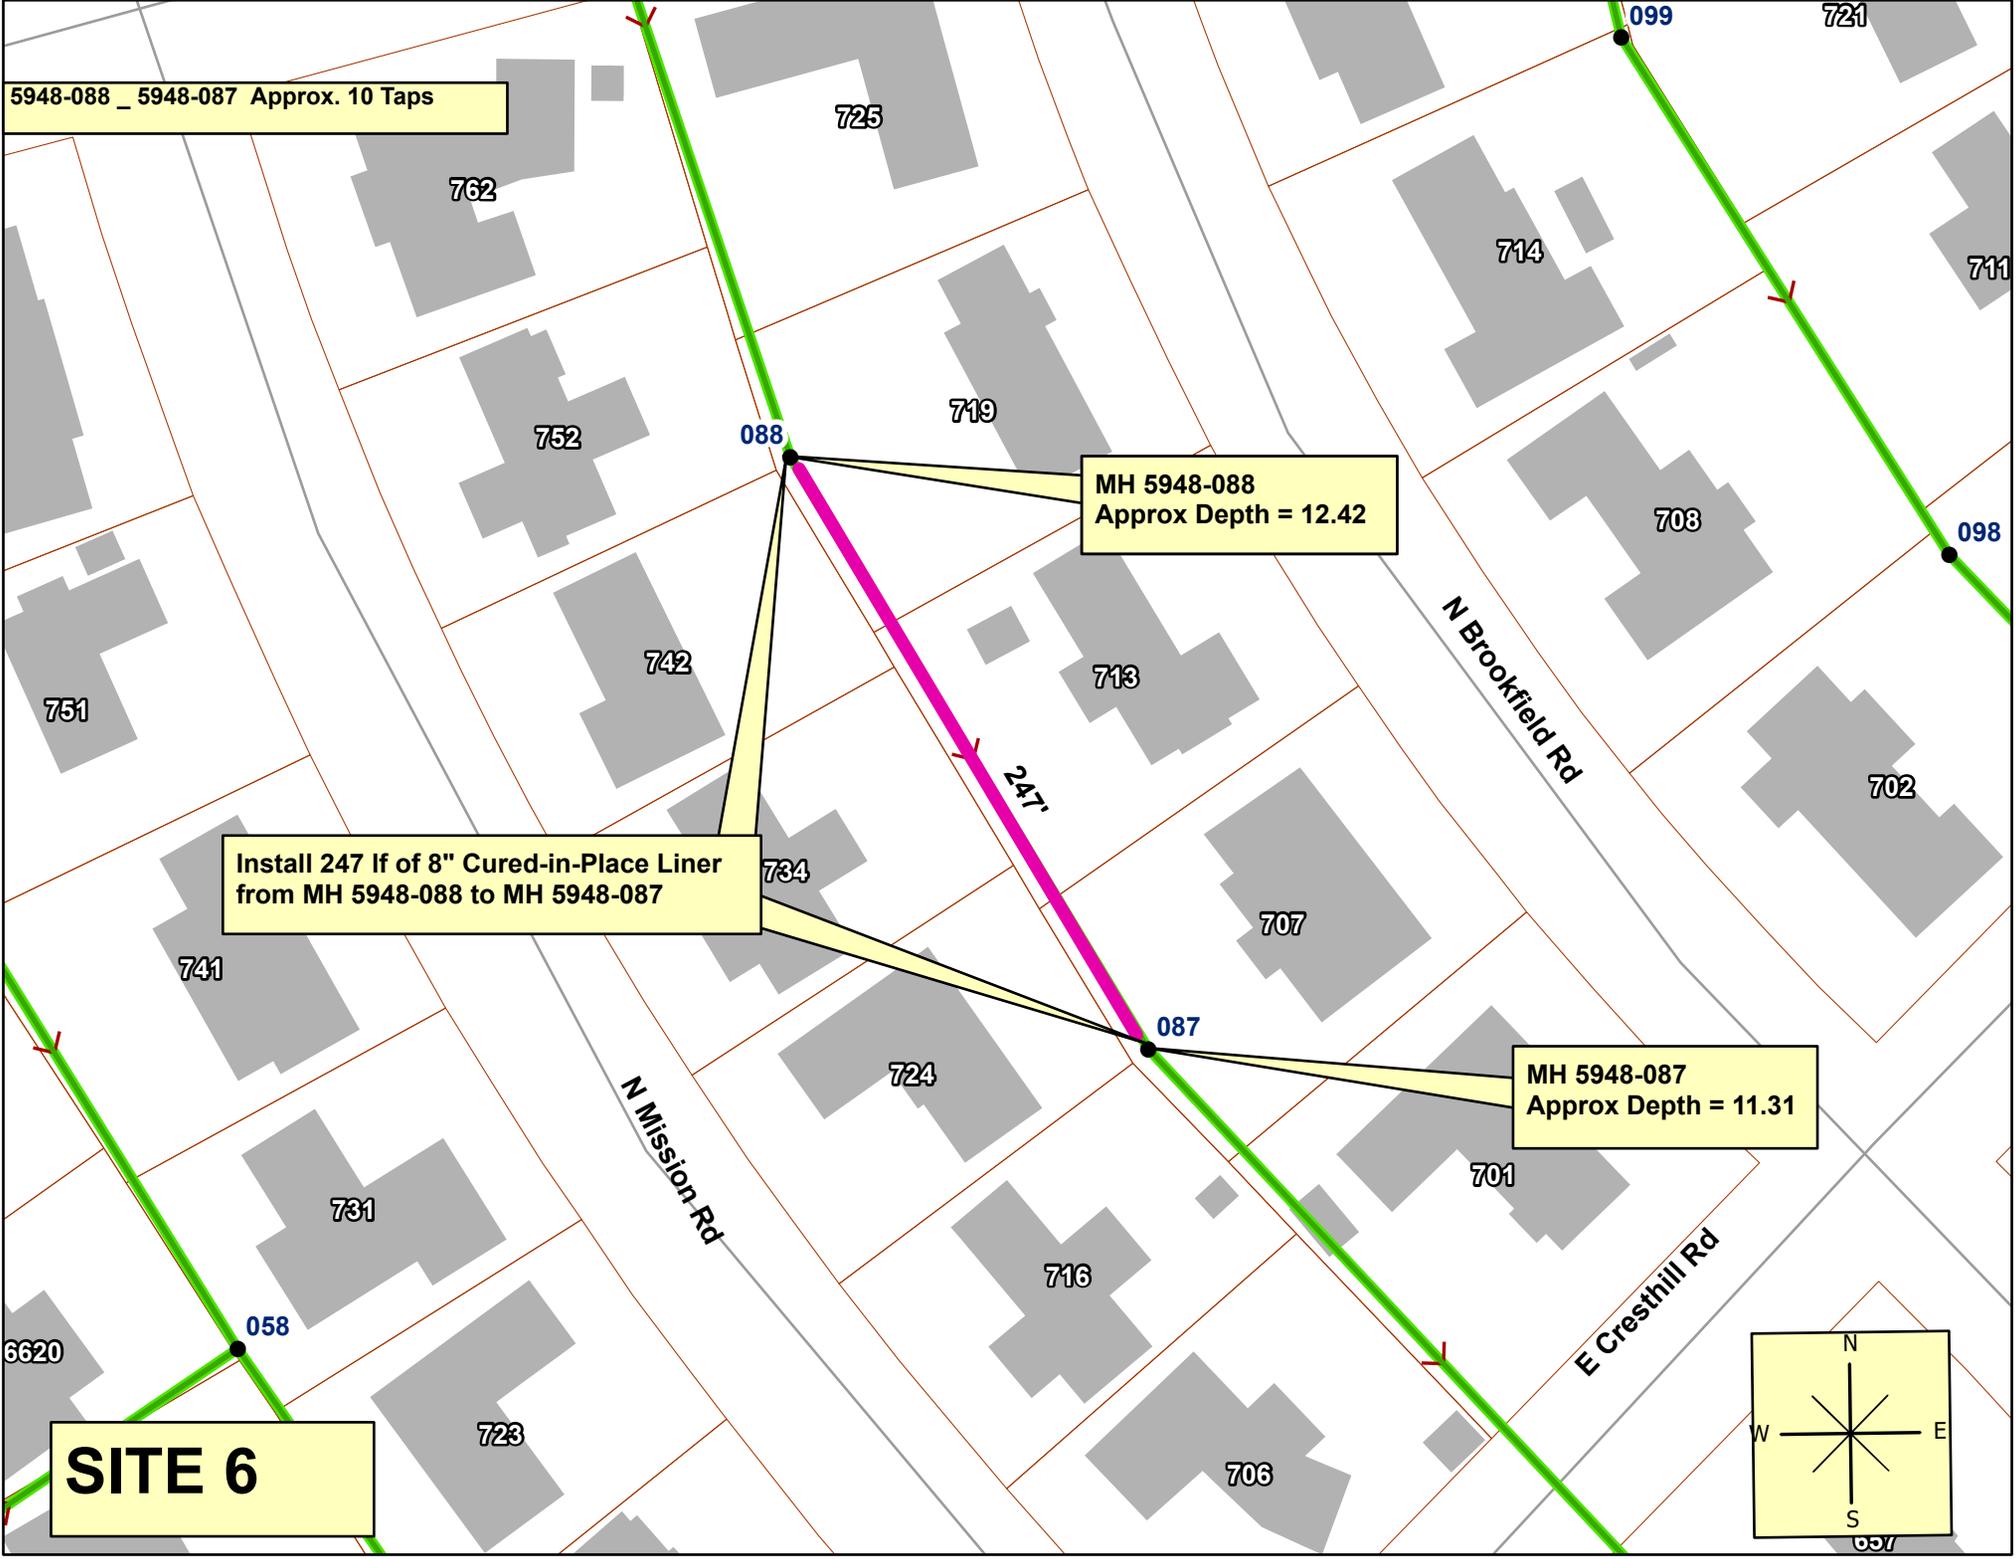
5948-088 _ 5948-087 Approx. 10 Taps

MH 5948-088
Approx Depth = 12.42

MH 5948-087
Approx Depth = 11.31

Alt Pipe ID: 35613			Inspected Date: 9/17/2021				Survey Direction: Upstream			
Distance:	CCTV Defect :		Clock 1:	Clock 2:	%	Contin:	Doc:	Struct:	O&M:	Remarks:
0.00	AMH	Manhole					False	0	0	5948-087
0.00	MWL	Miscellaneous Water Level			5		False	0	0	
1.90	CM	Crack Multiple	8	10			False	3	0	
15.90	TFA	Tap Factory Activity	10				False	0	0	724 N.MISSION RD.
46.60	TFC	Tap Factory Capped	2				False	0	0	
94.50	TFA	Tap Factory Activity	11				False	0	0	734 N.MISSION RD.
97.90	TFC	Tap Factory Capped	11				False	0	0	
101.40	BSV	Broken Soil Visible	7	5			False	5	0	
101.40	MSA	Miscellaneous Survey Abandon					False	0	0	BROKEN PIPE,CAMERA CAN

Alt Pipe ID: 35613			Inspected Date: 9/17/2021				Survey Direction: Downstream			
Distance:	CCTV Defect :		Clock 1:	Clock 2:	%	Contin:	Doc:	Struct:	O&M:	Remarks:
0.00	AMH	Manhole					False	0	0	5948-088
0.00	MWL	Miscellaneous Water Level			5		False	0	0	
18.70	TFC	Tap Factory Capped	11				False	0	0	
41.30	TBA	Tap Break-in Activity	10				False	0	0	719 N.BROOKFIELD RD.
67.80	TFC	Tap Factory Capped	2				False	0	0	
74.80	HSV	Hole Soil Visible	1	2			False	5	0	
75.40	TFA	Tap Factory Activity	2				False	0	0	742 N.MISSION RD.
110.50	TFC	Tap Factory Capped	11				False	0	0	
143.30	BSV	Broken Soil Visible	7	5			False	5	0	
144.40	TFA	Tap Factory Activity	10				False	0	0	713 N.BROOKFIELD RD.
144.40	BSV	Broken Soil Visible	7	5			False	5	0	
144.40	MSA	Miscellaneous Survey Abandon					False	0	0	BRIKEN PIPE,CAMERA CAN N
