SITE 7

Sewer CCTV Observations

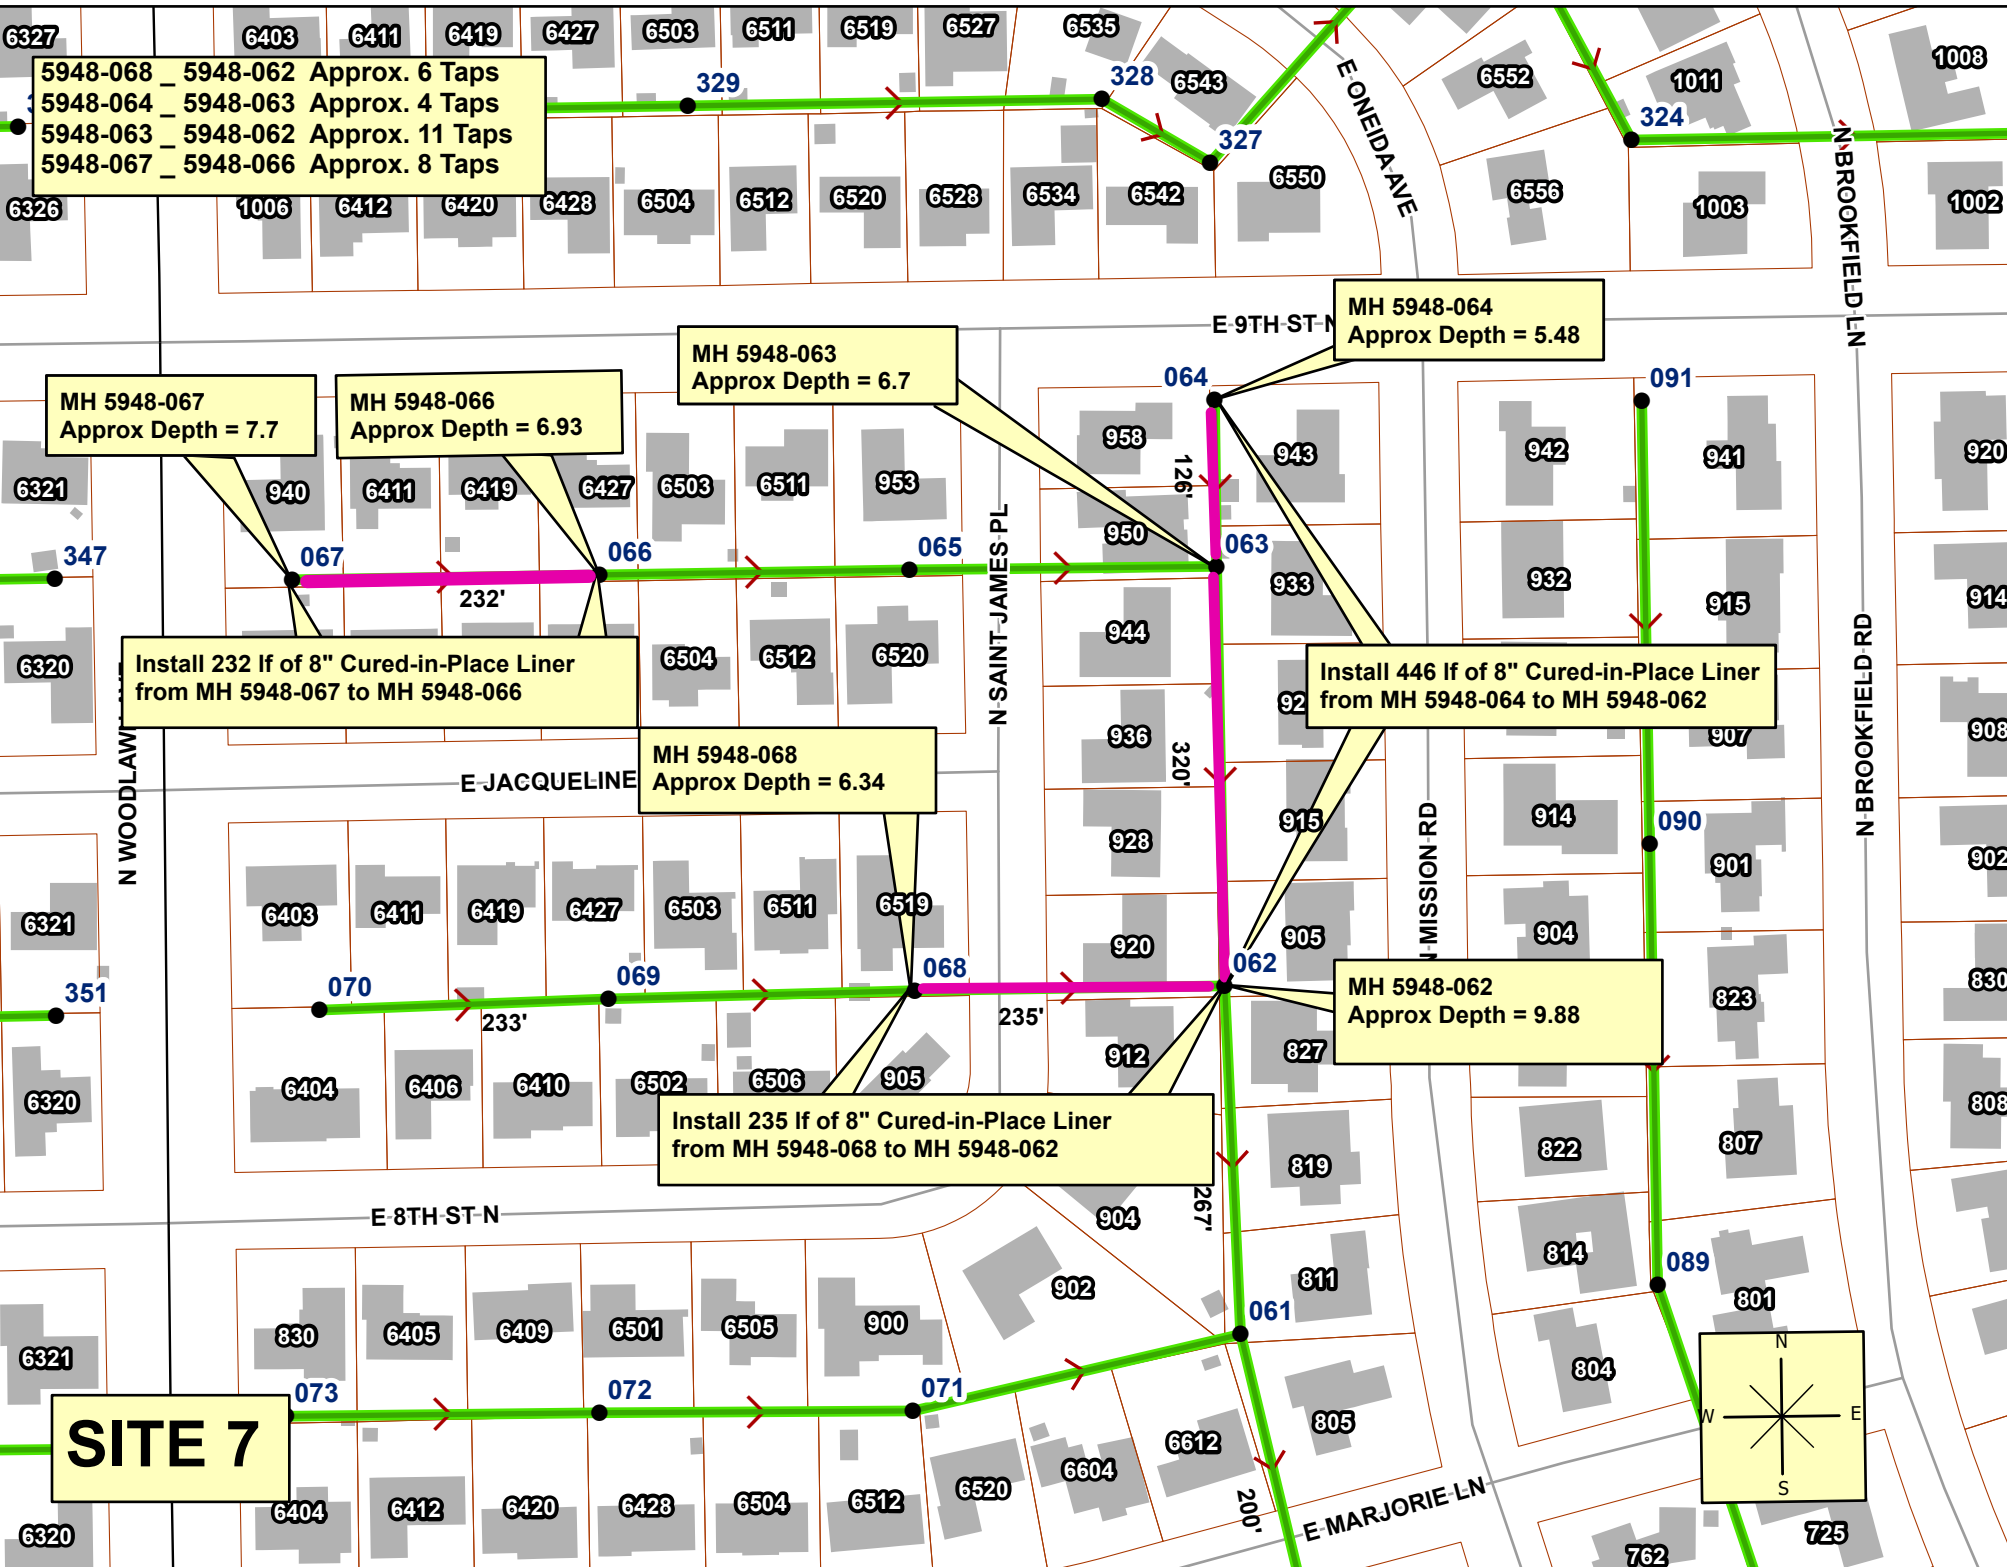
5948-068 - 5948-062 Approx. 6 Taps
 5948-064 - 5948-063 Approx. 4 Taps
 5948-063 - 5948-062 Approx. 11 Taps
 5948-067 - 5948-066 Approx. 8 Taps

MH 5948-067
 Approx Depth = 7.7

MH 5948-066
 Approx Depth = 6.93

MH 5948-063
 Approx Depth = 6.7

MH 5948-064
 Approx Depth = 5.48

MH 5948-068
 Approx Depth = 6.34

MH 5948-062
 Approx Depth = 9.88

Install 232 lf of 8" Cured-in-Place Liner
 from MH 5948-067 to MH 5948-066

Install 446 lf of 8" Cured-in-Place Liner
 from MH 5948-064 to MH 5948-062

Install 235 lf of 8" Cured-in-Place Liner
 from MH 5948-068 to MH 5948-062
