Install 338 lf of 8" Cured-in-Place Liner
from MH 5948-368 to MH 5948-367

Install 238 lf of 8" Cured-in-Place Liner
from MH 5948-372 to MH 5948-371

SITE 8 & 9

Sewer CCTV Observations

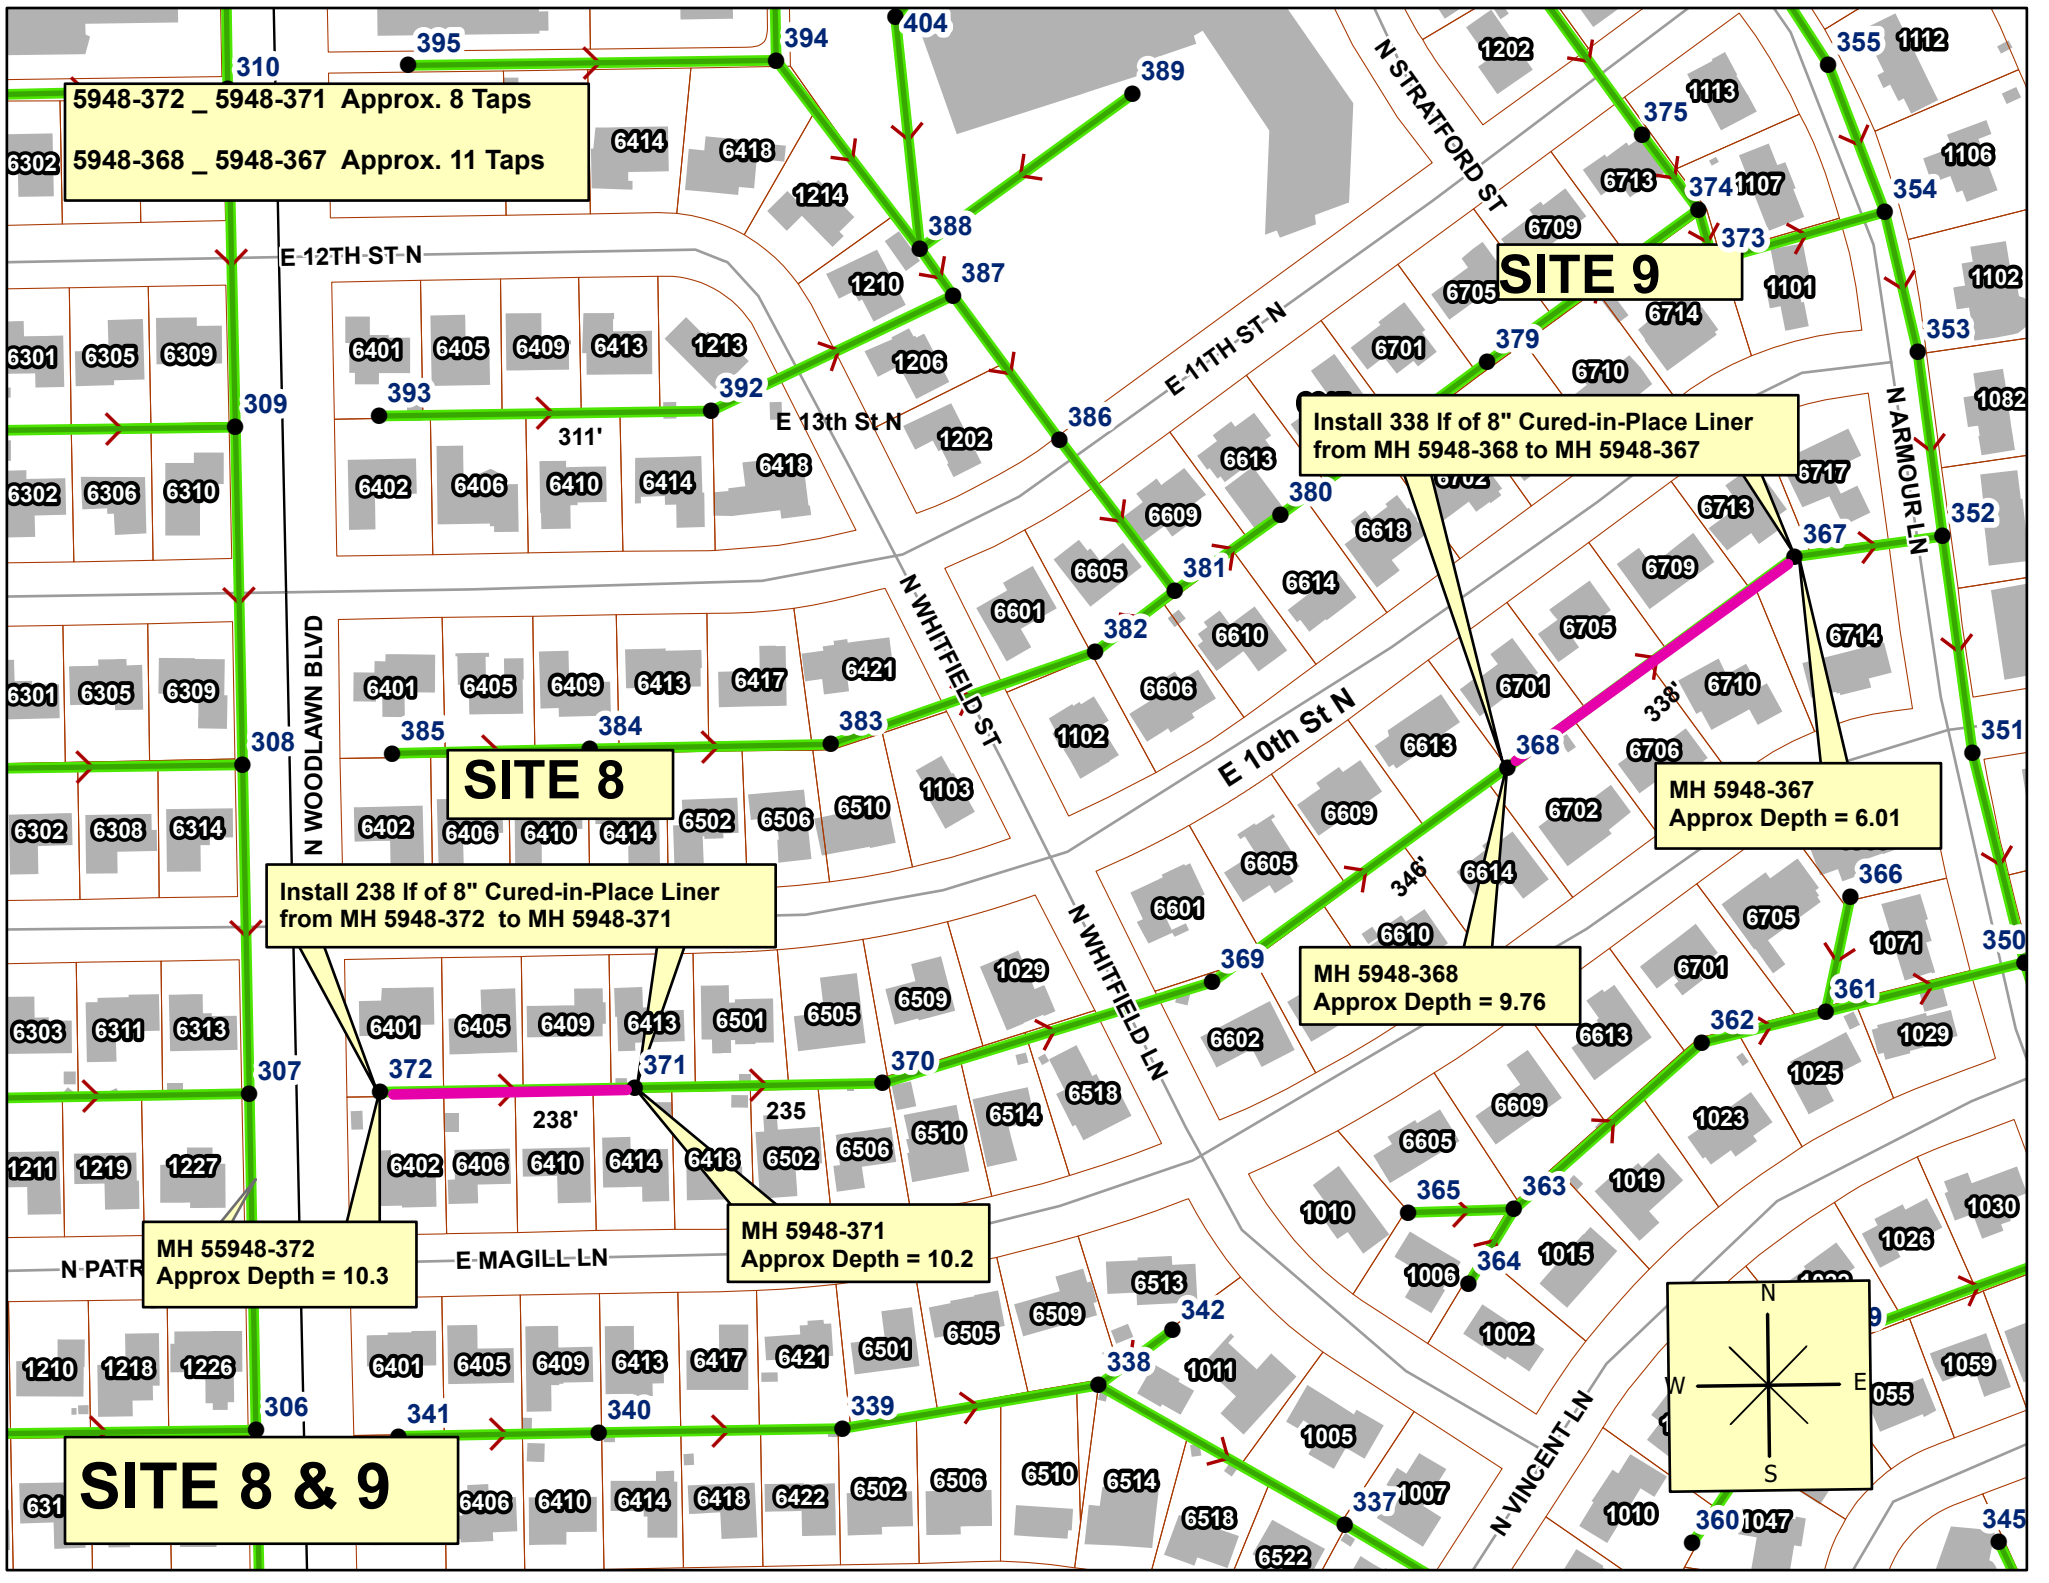
5948-372 _ 5948-371 Approx. 8 Taps
5948-368 _ 5948-367 Approx. 11 Taps

MH 5948-367
Approx Depth = 6.01

MH 5948-368
Approx Depth = 9.76

MH 5948-372
Approx Depth = 10.3

MH 5948-371
Approx Depth = 10.2
