SITE 1

Television Inspection Master Report

US Structure: 6047-242
DS Structure: 6047-241

Date Insp: 8/2/2006
Dir Televised: Downstream to Upstream

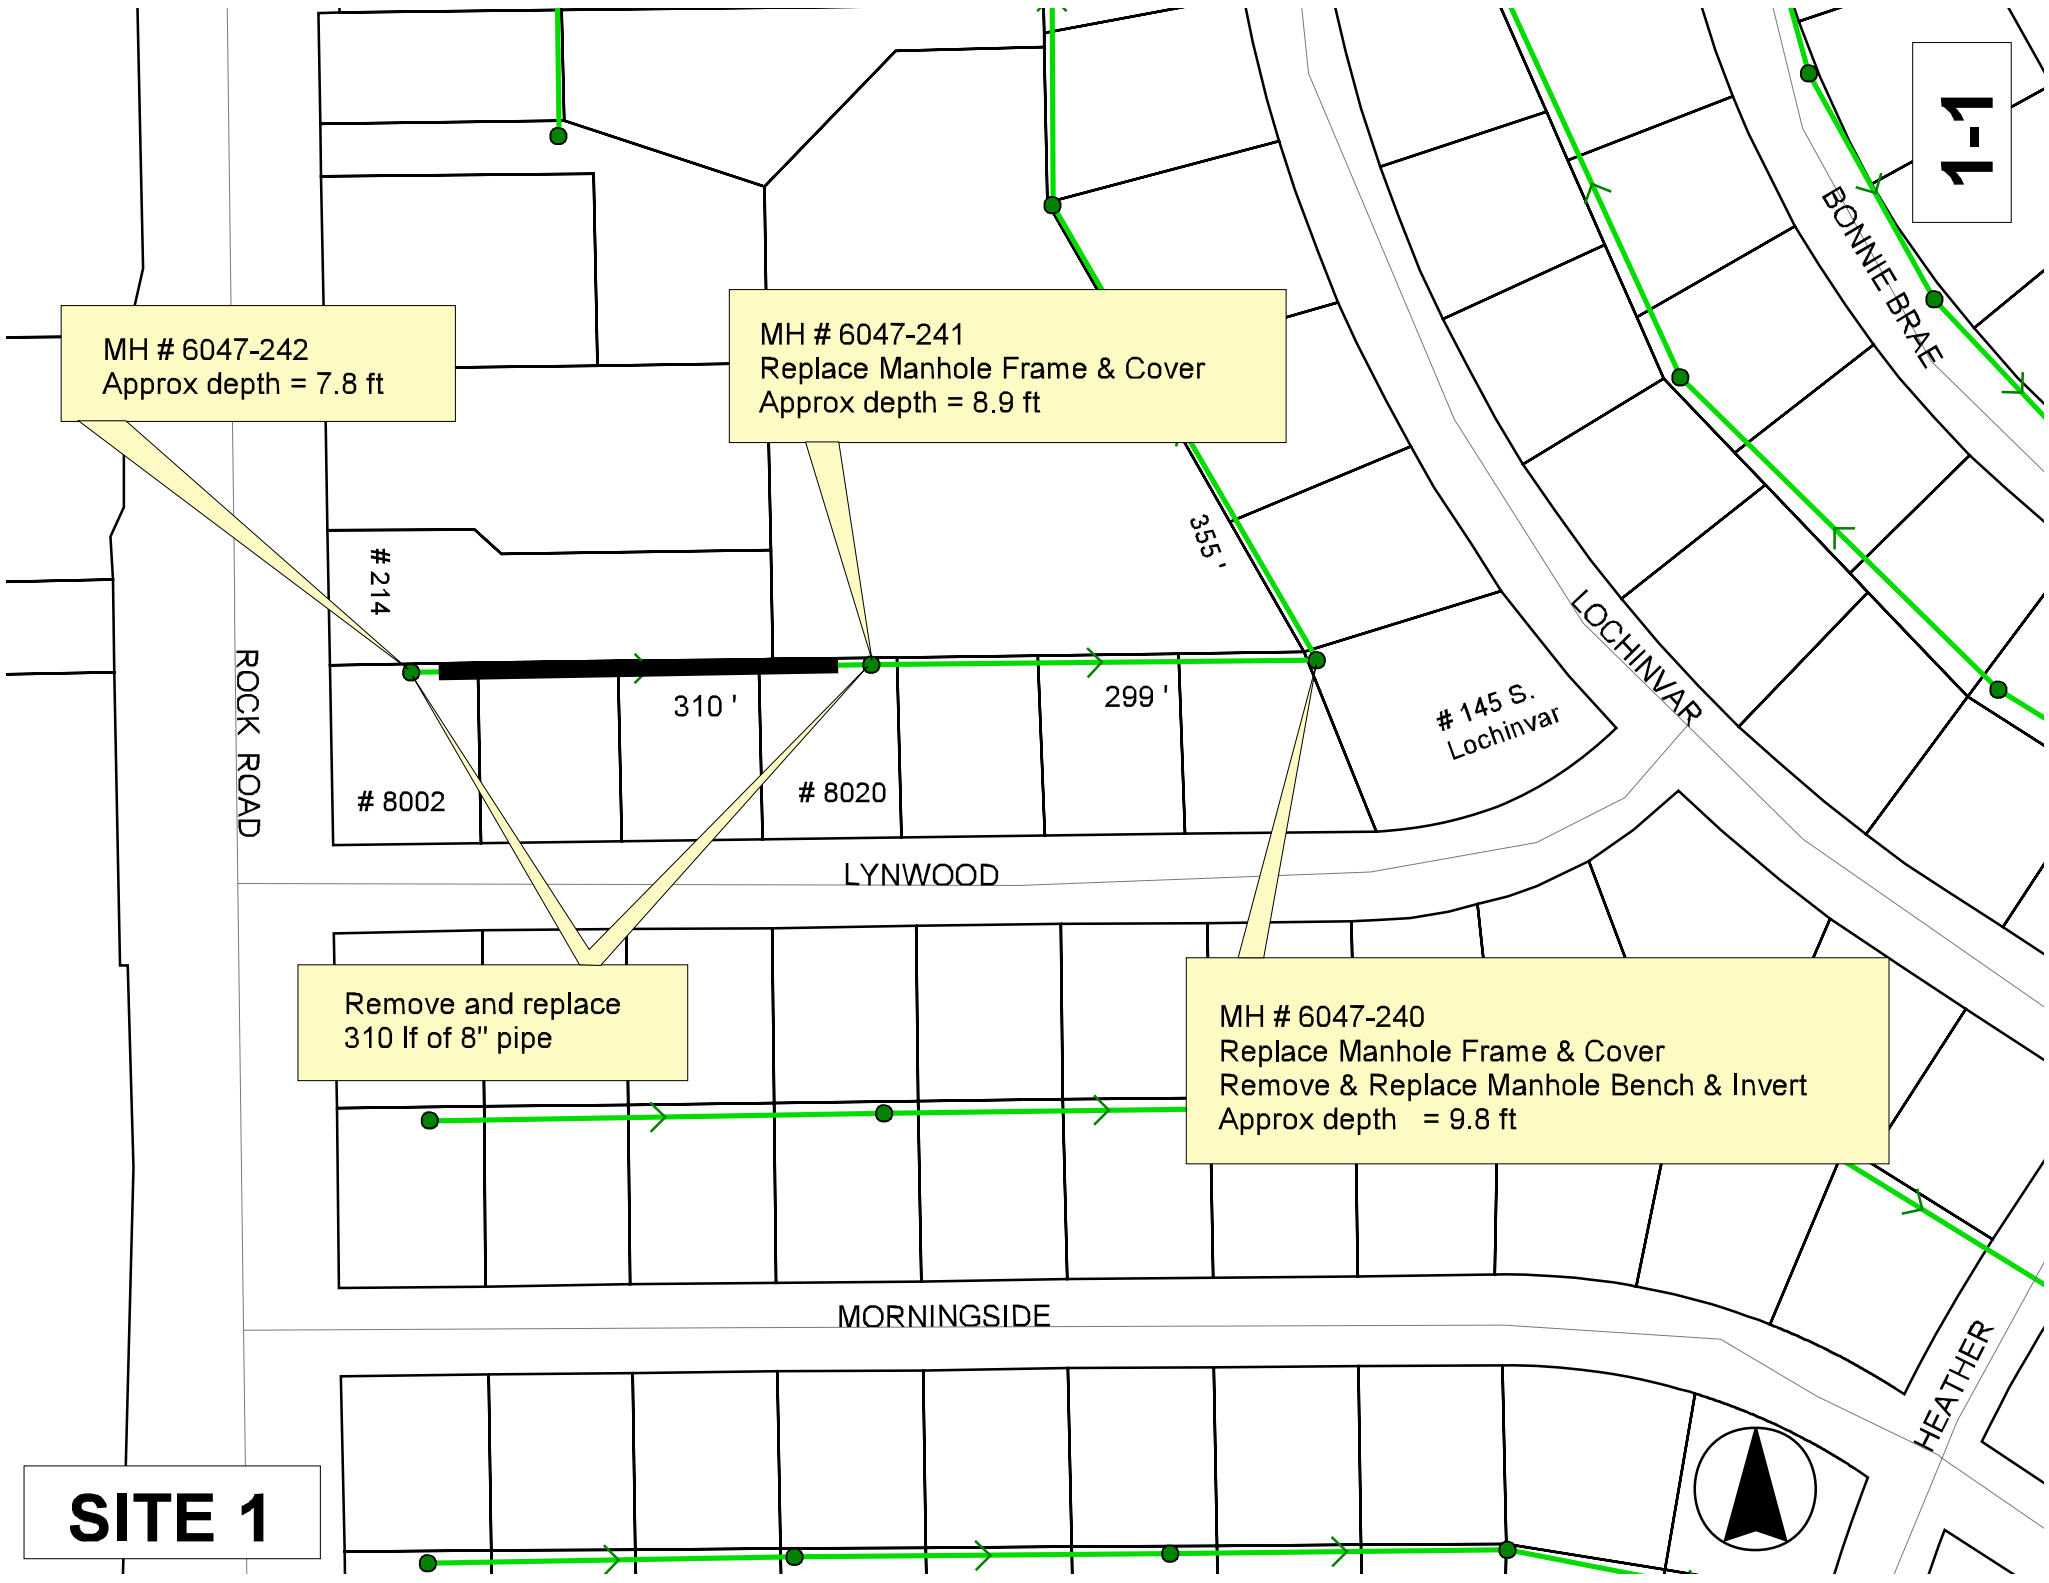
MH # 6047-242
Approx depth = 7.8 ft

MH # 6047-241
Replace Manhole Frame & Cover
Approx depth = 8.9 ft

MH # 6047-240
Replace Manhole Frame & Cover
Remove & Replace Manhole Bench & Invert
Approx depth = 9.8 ft

Remove and replace
310 lf of 8" pipe
