Kansas Food Bank
Warehouse

SITE 4

Television Inspection Master Report

1916 E ENGLISH ST

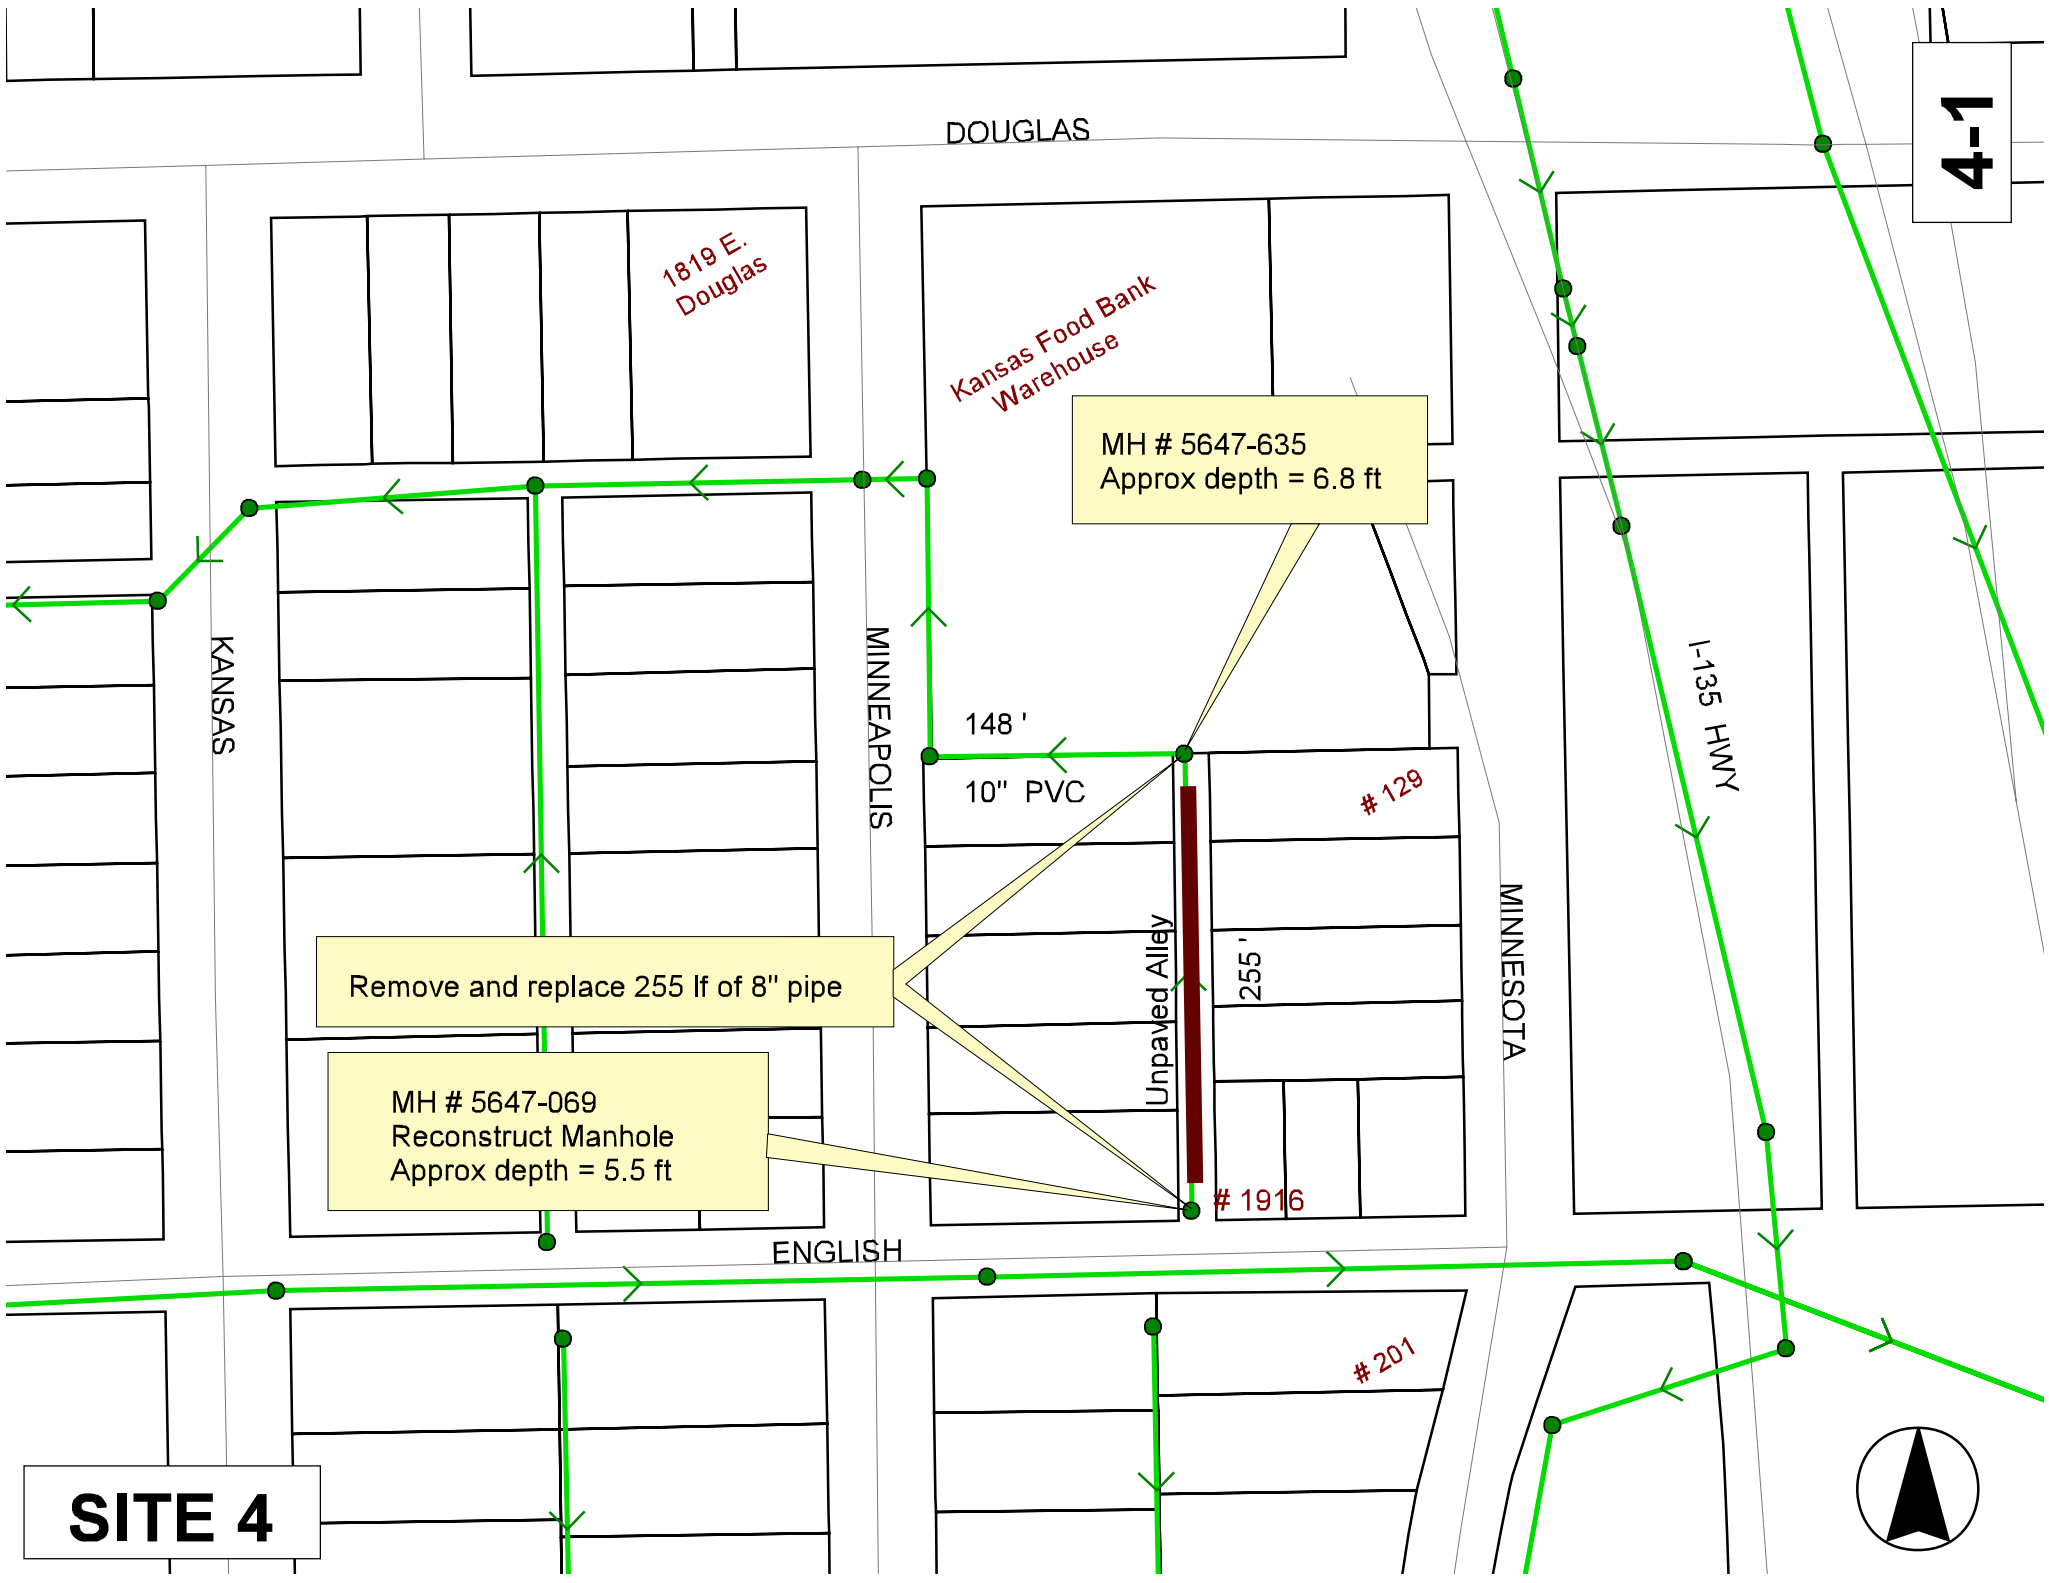
4-1

MH # 5647-635
Approx depth = 6.8 ft

MH # 5647-069
Reconstruct Manhole
Approx depth = 5.5 ft

Remove and replace 255 lf of 8" pipe
