SITE 7

Television Inspection Master Report

US Structure: 5948-073 830 N WOODLAWN BLVD Date Insp: 2/15/2007 Basin: E01H
DS Structure: 5948-072 6501 E 8TH ST Dir Televised: Up->Down

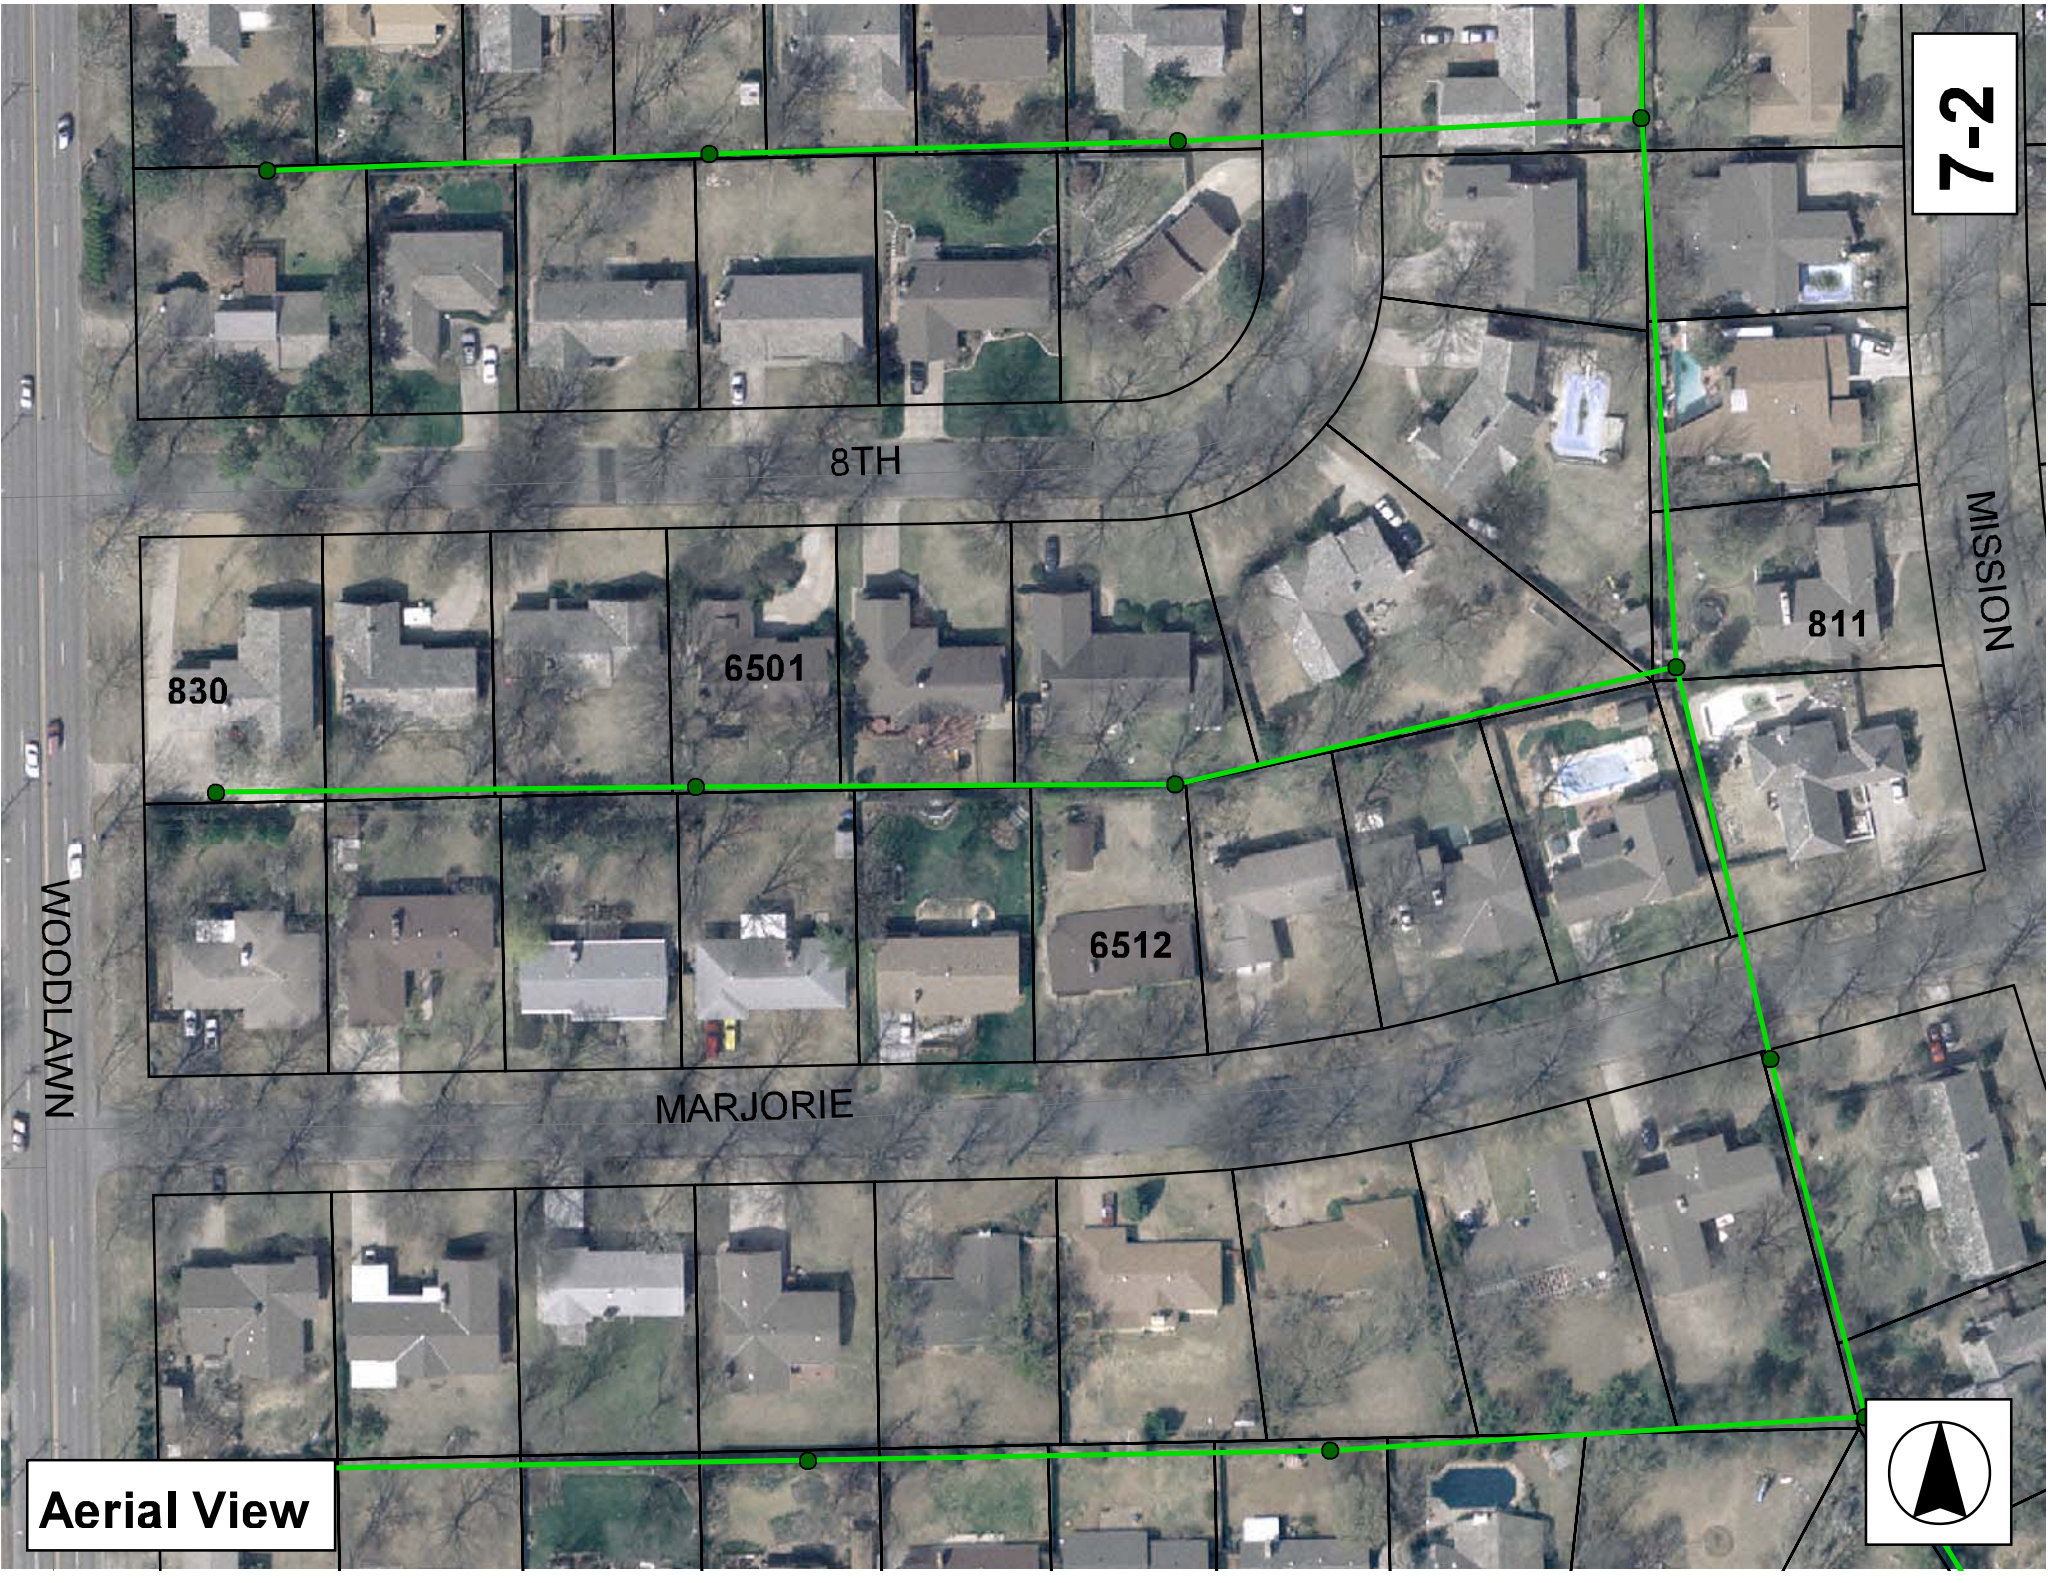
7-2

MH # 5948-071
Replace Manhole Frame & Cover
Remove & Replace Manhole Bench & Invert
Approx depth = 7.8 ft

Remove and Replace 486 lf of 8" pipe
from MH 5948-072 to MH 5948-061

MH # 5948-072
Replace Manhole Frame & Cover
Approx depth = 6.0 ft

MH # 5948-073
Approx depth = 9.0 ft

MH # 5948-061
Replace Manhole Frame & Cover
Remove & Replace Manhole Bench & Invert
Construct Outside Drop for line coming into
manhole from the west
Approx pipe depth = 7.8 ft
Approx manhole depth = 11.5 ft

Point Repair:
Remove and replace 10 lf of 8" pipe from
MH 5948-072 to 10 lf west of MH 5948-072
