SITE 8

Television Inspection Master Report

US Structure: 5948-082
DS Structure: 5948-081

547 N BROOKFIELD RD
521 N BROOKFIELD RD

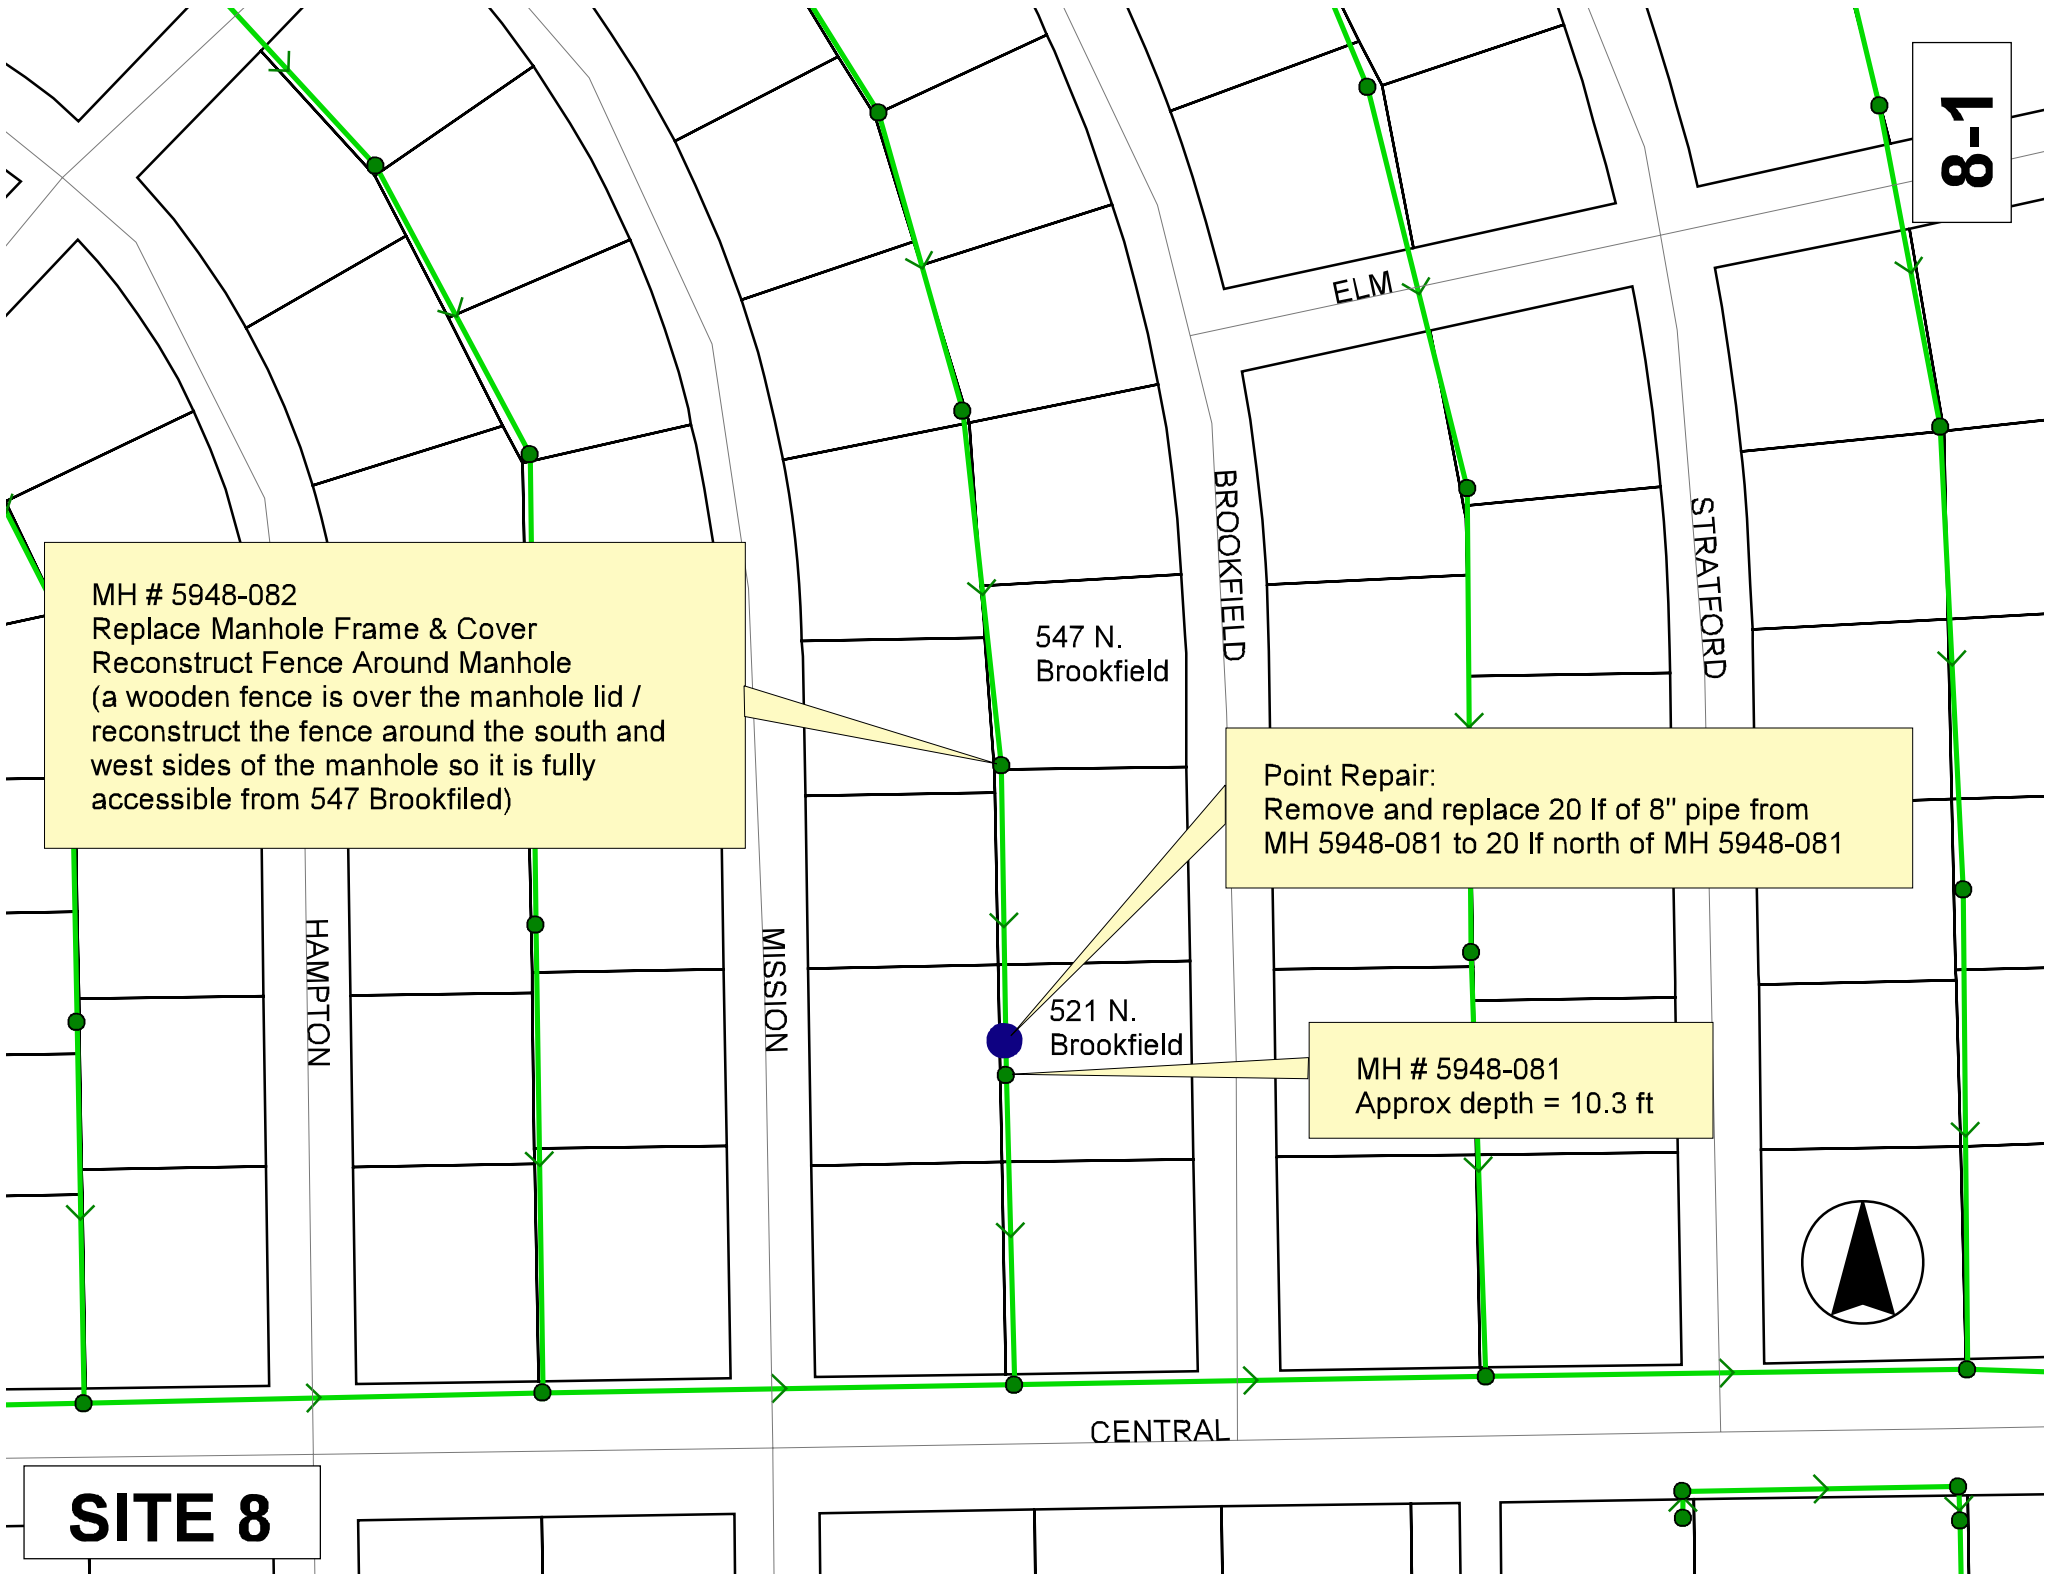
MH # 5948-082
Replace Manhole Frame & Cover
Reconstruct Fence Around Manhole
(a wooden fence is over the manhole lid /
reconstruct the fence around the south and
west sides of the manhole so it is fully
accessible from 547 Brookfield)

MH # 5948-081
Approx depth = 10.3 ft

Point Repair:
Remove and replace 20 lf of 8" pipe from
MH 5948-081 to 20 lf north of MH 5948-081
