**SITE 1**

# Television Inspection Master Report

US Manhole: 5749-172  
DS Manhole: 5749-171

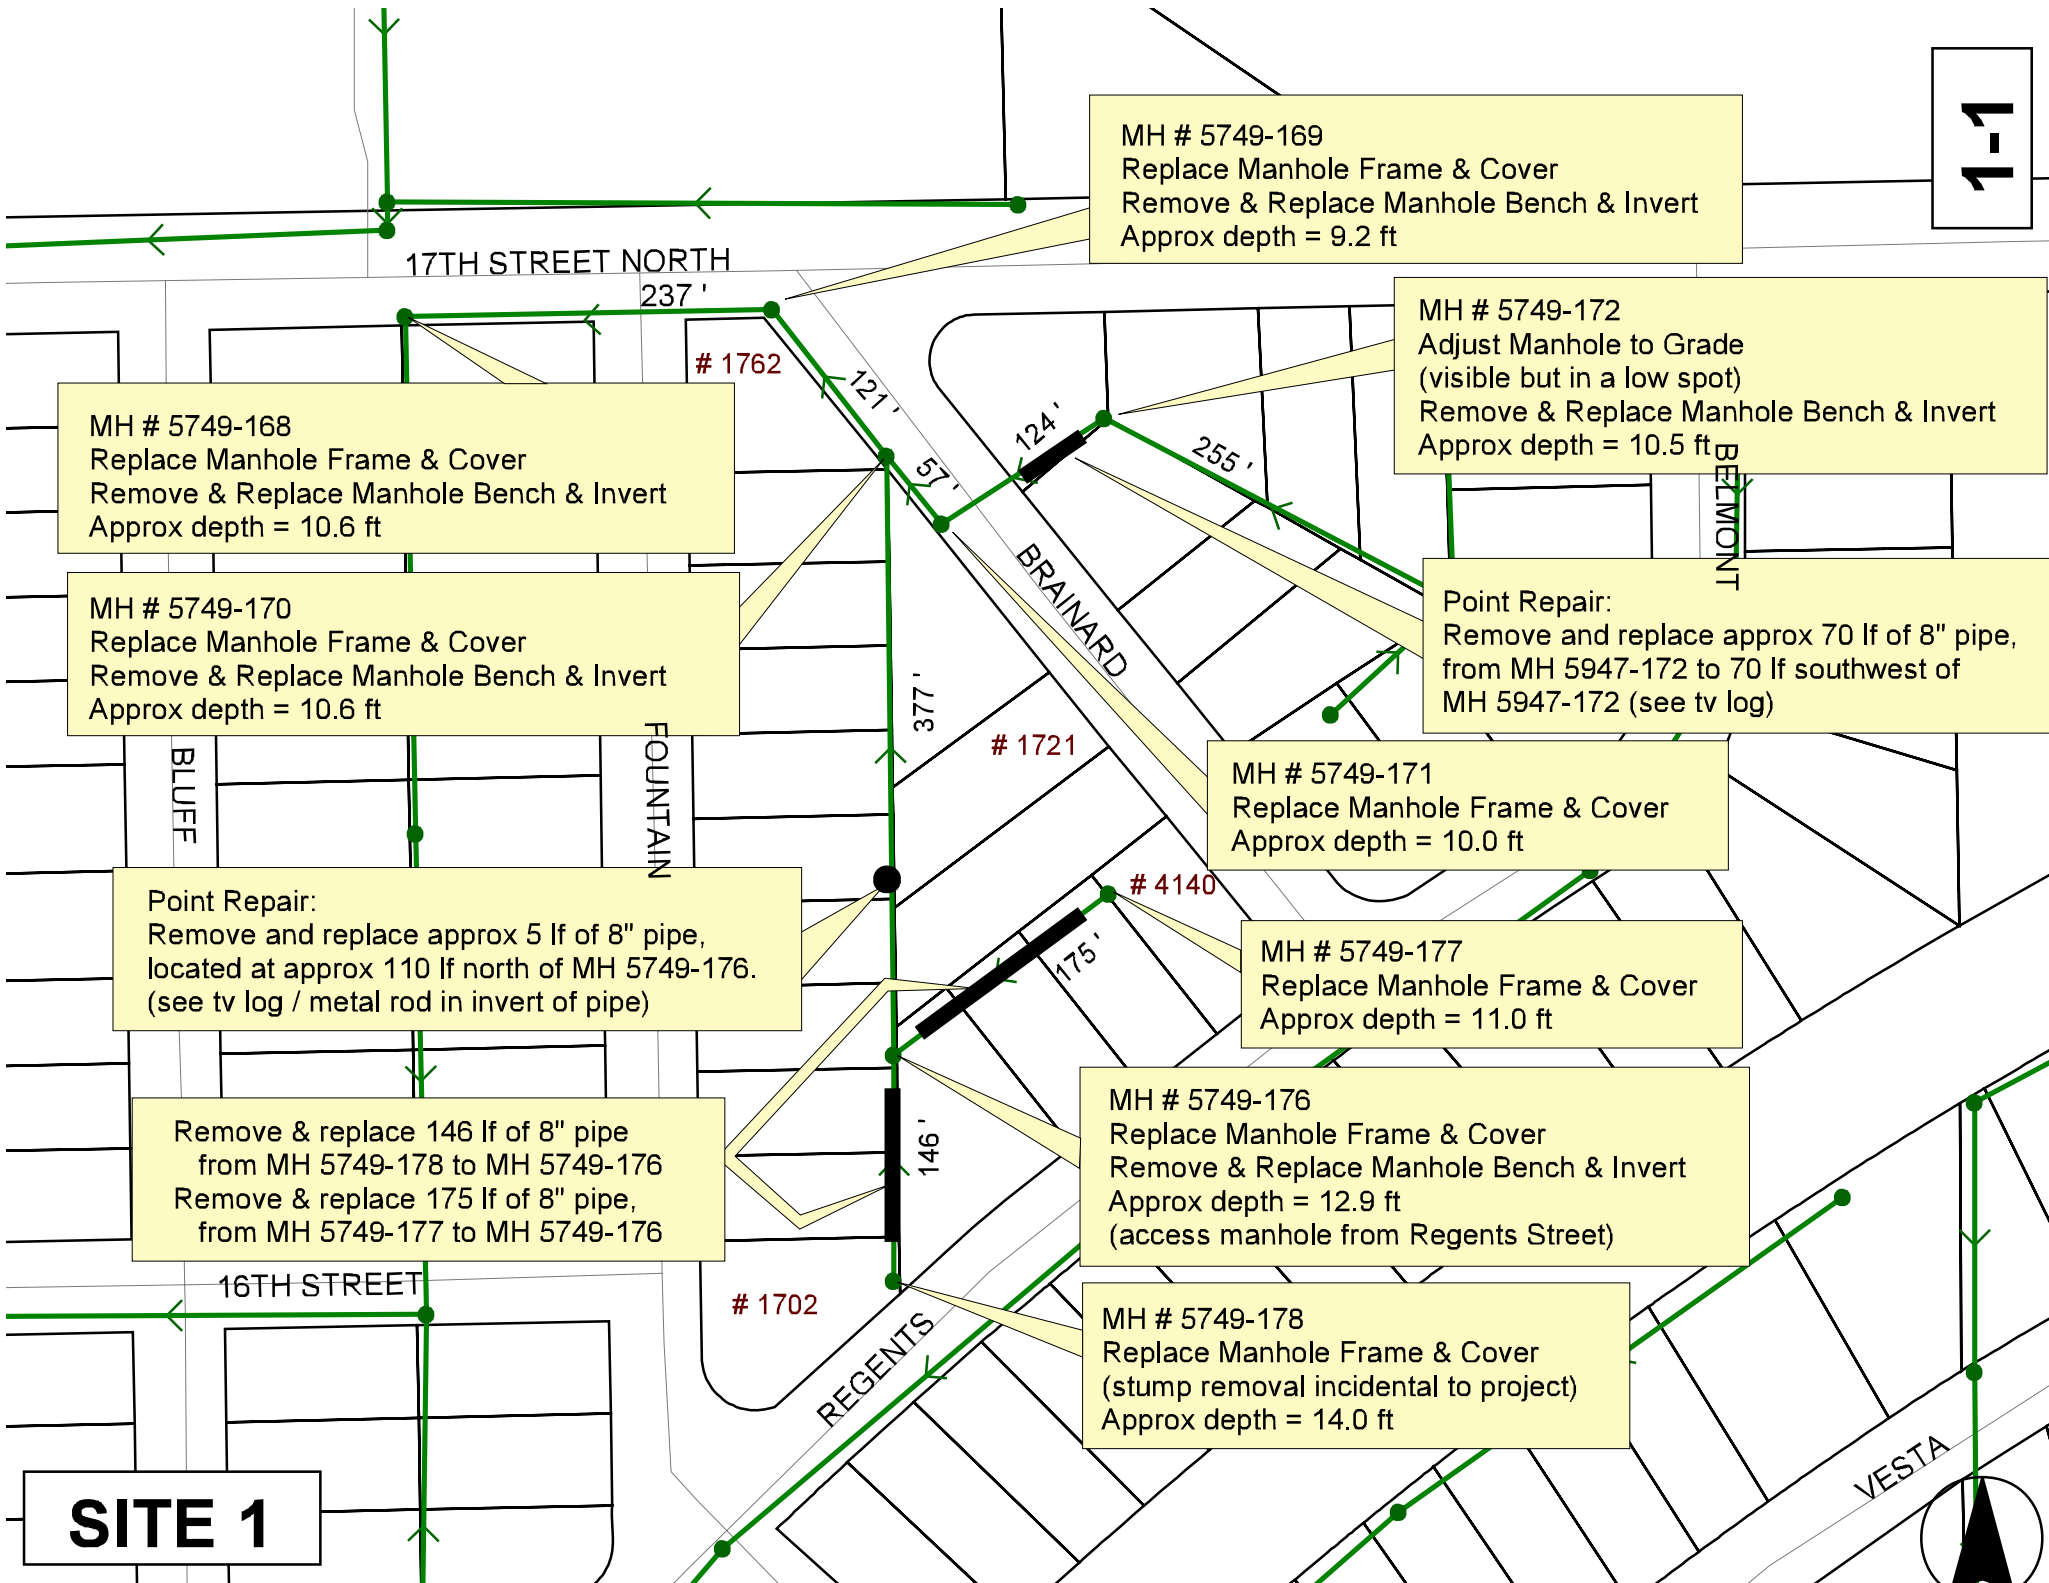
MH # 5749-169  
 Replace Manhole Frame & Cover  
 Remove & Replace Manhole Bench & Invert  
 Approx depth = 9.2 ft

MH # 5749-172  
 Adjust Manhole to Grade  
 (visible but in a low spot)  
 Remove & Replace Manhole Bench & Invert  
 Approx depth = 10.5 ft

MH # 5749-168  
 Replace Manhole Frame & Cover  
 Remove & Replace Manhole Bench & Invert  
 Approx depth = 10.6 ft

MH # 5749-170  
 Replace Manhole Frame & Cover  
 Remove & Replace Manhole Bench & Invert  
 Approx depth = 10.6 ft

MH # 5749-171  
 Replace Manhole Frame & Cover  
 Approx depth = 10.0 ft

MH # 5749-177  
 Replace Manhole Frame & Cover  
 Approx depth = 11.0 ft

MH # 5749-176  
 Replace Manhole Frame & Cover  
 Remove & Replace Manhole Bench & Invert  
 Approx depth = 12.9 ft  
 (access manhole from Regents Street)

MH # 5749-178  
 Replace Manhole Frame & Cover  
 (stump removal incidental to project)  
 Approx depth = 14.0 ft

Point Repair:  
 Remove and replace approx 70 lf of 8" pipe,  
 from MH 5947-172 to 70 lf southwest of  
 MH 5947-172 (see tv log)

Point Repair:  
 Remove and replace approx 5 lf of 8" pipe,  
 located at approx 110 lf north of MH 5749-176.  
 (see tv log / metal rod in invert of pipe)

Remove & replace 146 lf of 8" pipe  
 from MH 5749-178 to MH 5749-176  
 Remove & replace 175 lf of 8" pipe,  
 from MH 5749-177 to MH 5749-176
