SITE 2

# Television Inspection Master Report

US Structure: 5650-073      1703 E 23RD ST N      Date Insp: 3/7/2006      Basin: EC02D  
DS Structure: 5650-072      1727 E 23RD ST      Dir Televised: Upstream To Downstream

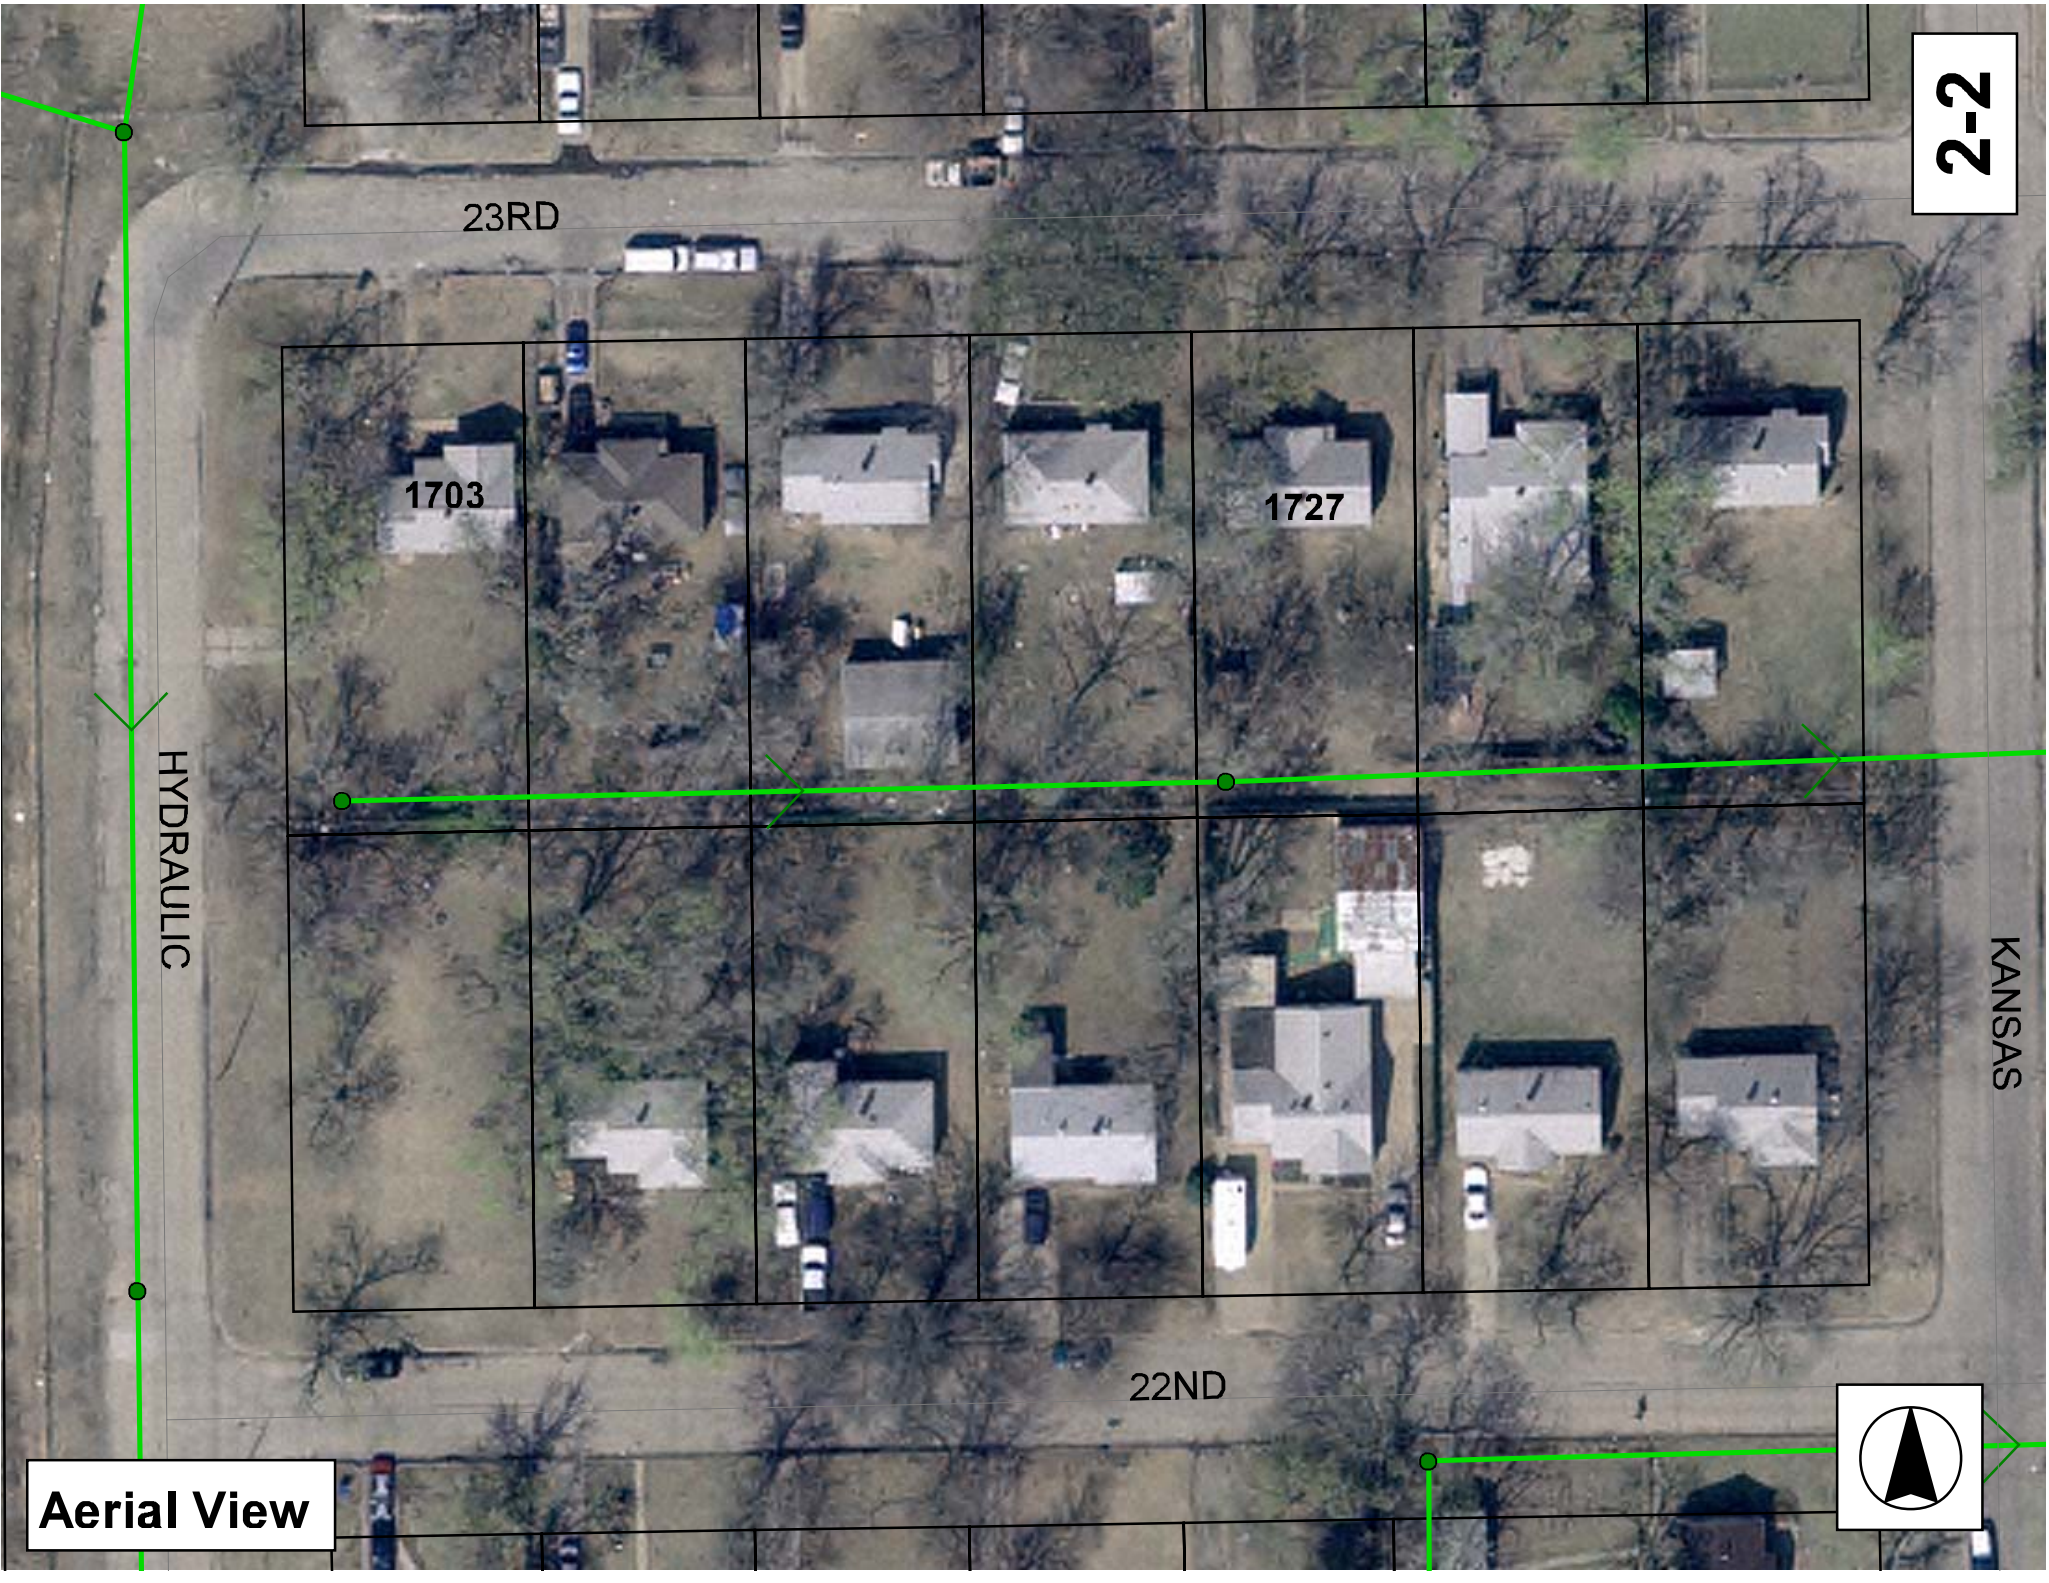
Aerial View

MH # 5650-073  
Replace Manhole Frame & Cover  
Remove & Replace Manhole Bench & Invert  
Approx depth = 7.0 ft

MH # 5650-072  
Replace Manhole Frame & Cover  
Approx depth = 6.9 ft

Remove & Replace 230 lf of 8" Pipe
