**SITE 4**  
Map 1 of 2

**SITE 4**  
Map 2 of 2

# Television Inspection Master Report

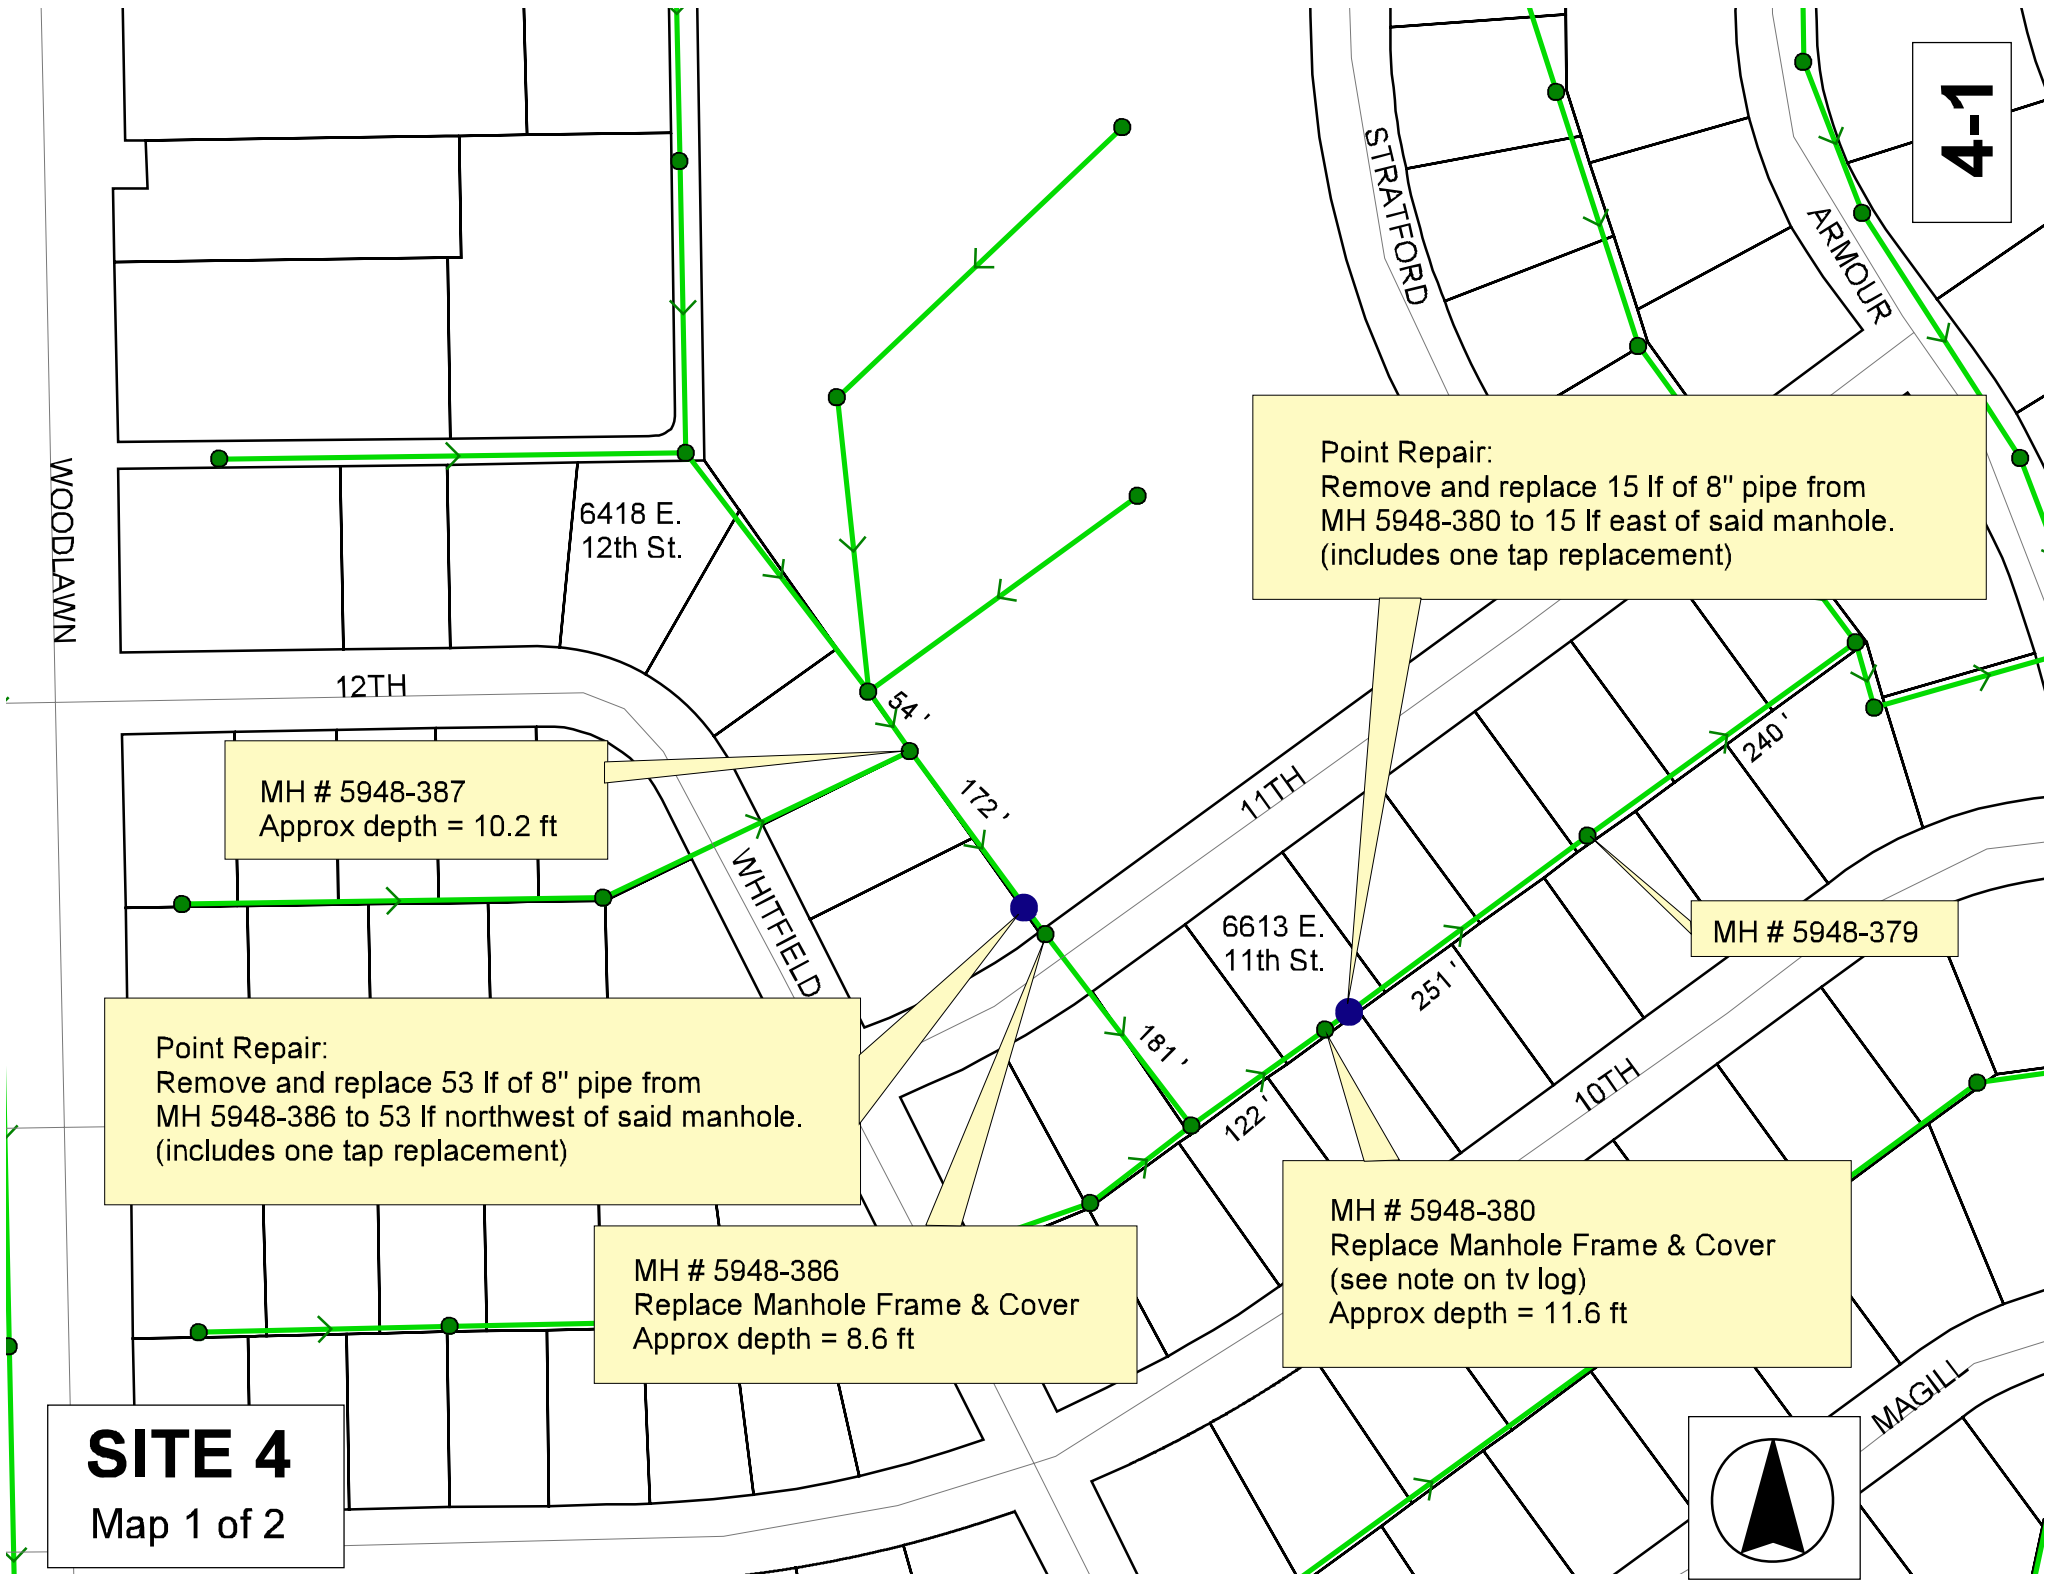
MH # 5948-387  
Approx depth = 10.2 ft

MH # 5948-386  
Replace Manhole Frame & Cover  
Approx depth = 8.6 ft

MH # 5948-380  
Replace Manhole Frame & Cover  
(see note on tv log)  
Approx depth = 11.6 ft

Point Repair:  
Remove and replace 53 lf of 8" pipe from  
MH 5948-386 to 53 lf northwest of said manhole.  
(includes one tap replacement)

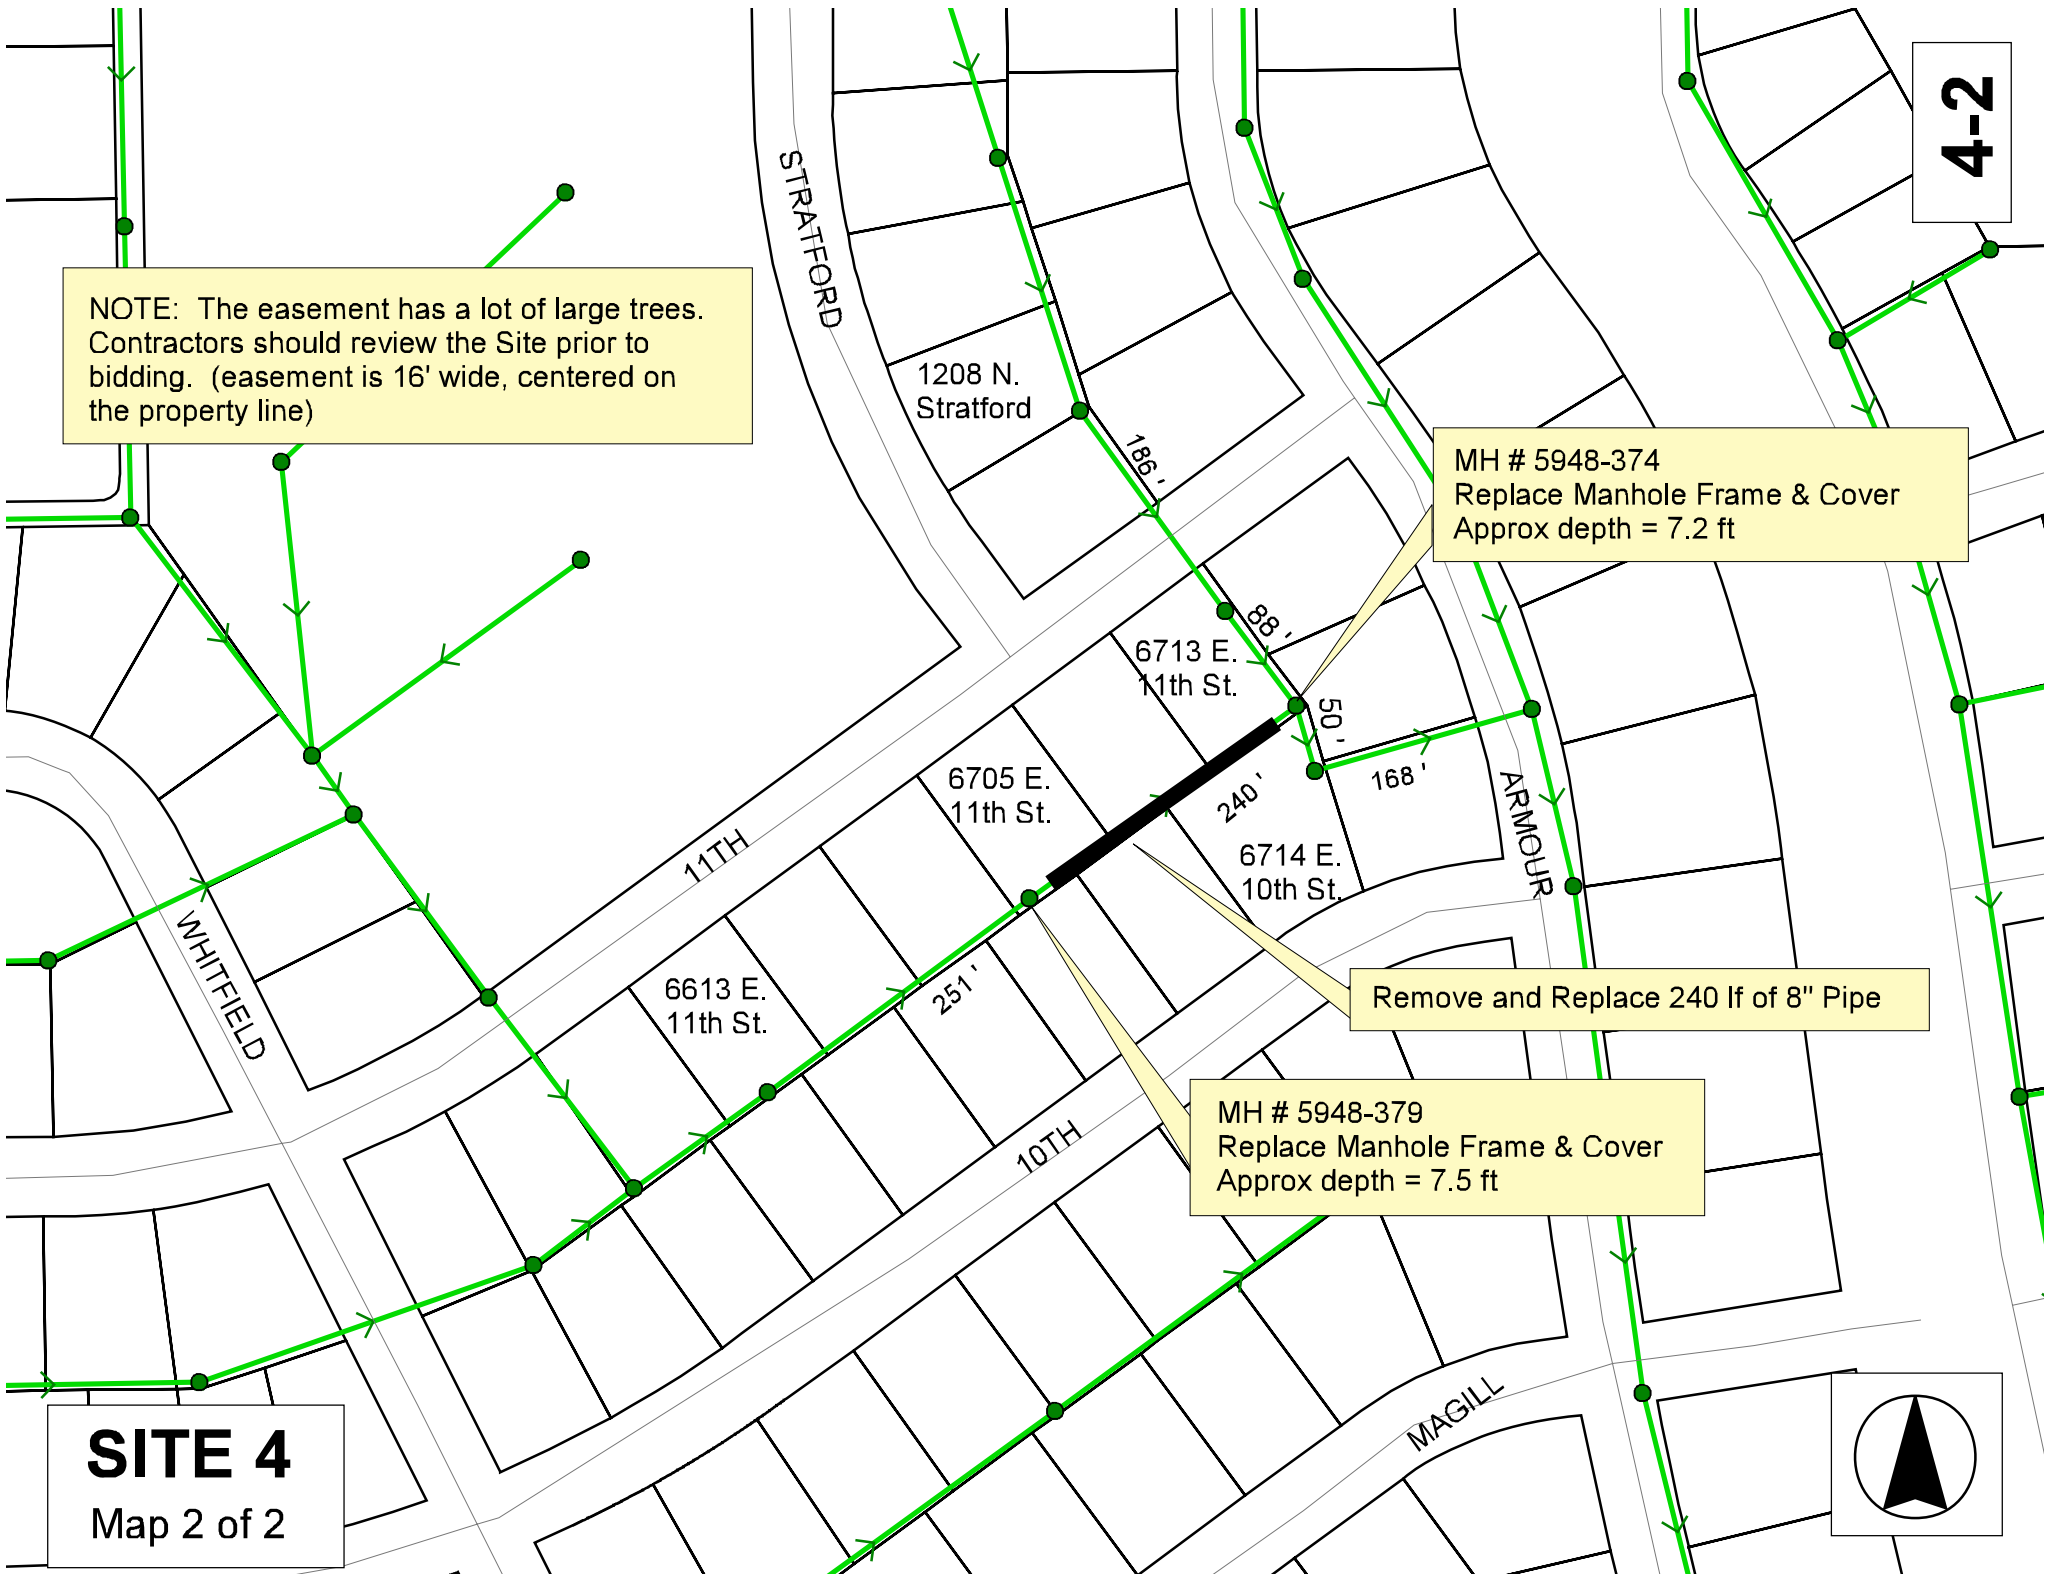
MH # 5948-374  
Replace Manhole Frame & Cover  
Approx depth = 7.2 ft

MH # 5948-379  
Replace Manhole Frame & Cover  
Approx depth = 7.5 ft

Remove and Replace 240 lf of 8" Pipe
