**From:** CHERCHES  
**Sent:** Wednesday, October 13, 1999 3:22 PM  
**To:** LACKEY\_S  
**Cc:** CARRIER\_C; LINDEBAK\_M; SCHROEDER\_K; HOLDEMAN\_C  
**Subject:** Cambridge homeowners assoc.

# CAMBRIDGE/LEXINGTON HOMEOWNER'S ASSOCIATION

This report notes background information, existing conditions, provides an analysis and makes recommendations concerning drainage patterns for two areas in the Lexington Addition. These two areas show conditions of poor drainage due to slow runoff and ponding of drainage water. In effect, these conditions have created tension among impacted neighbors and "finger pointing" as to who is responsible for the situation.

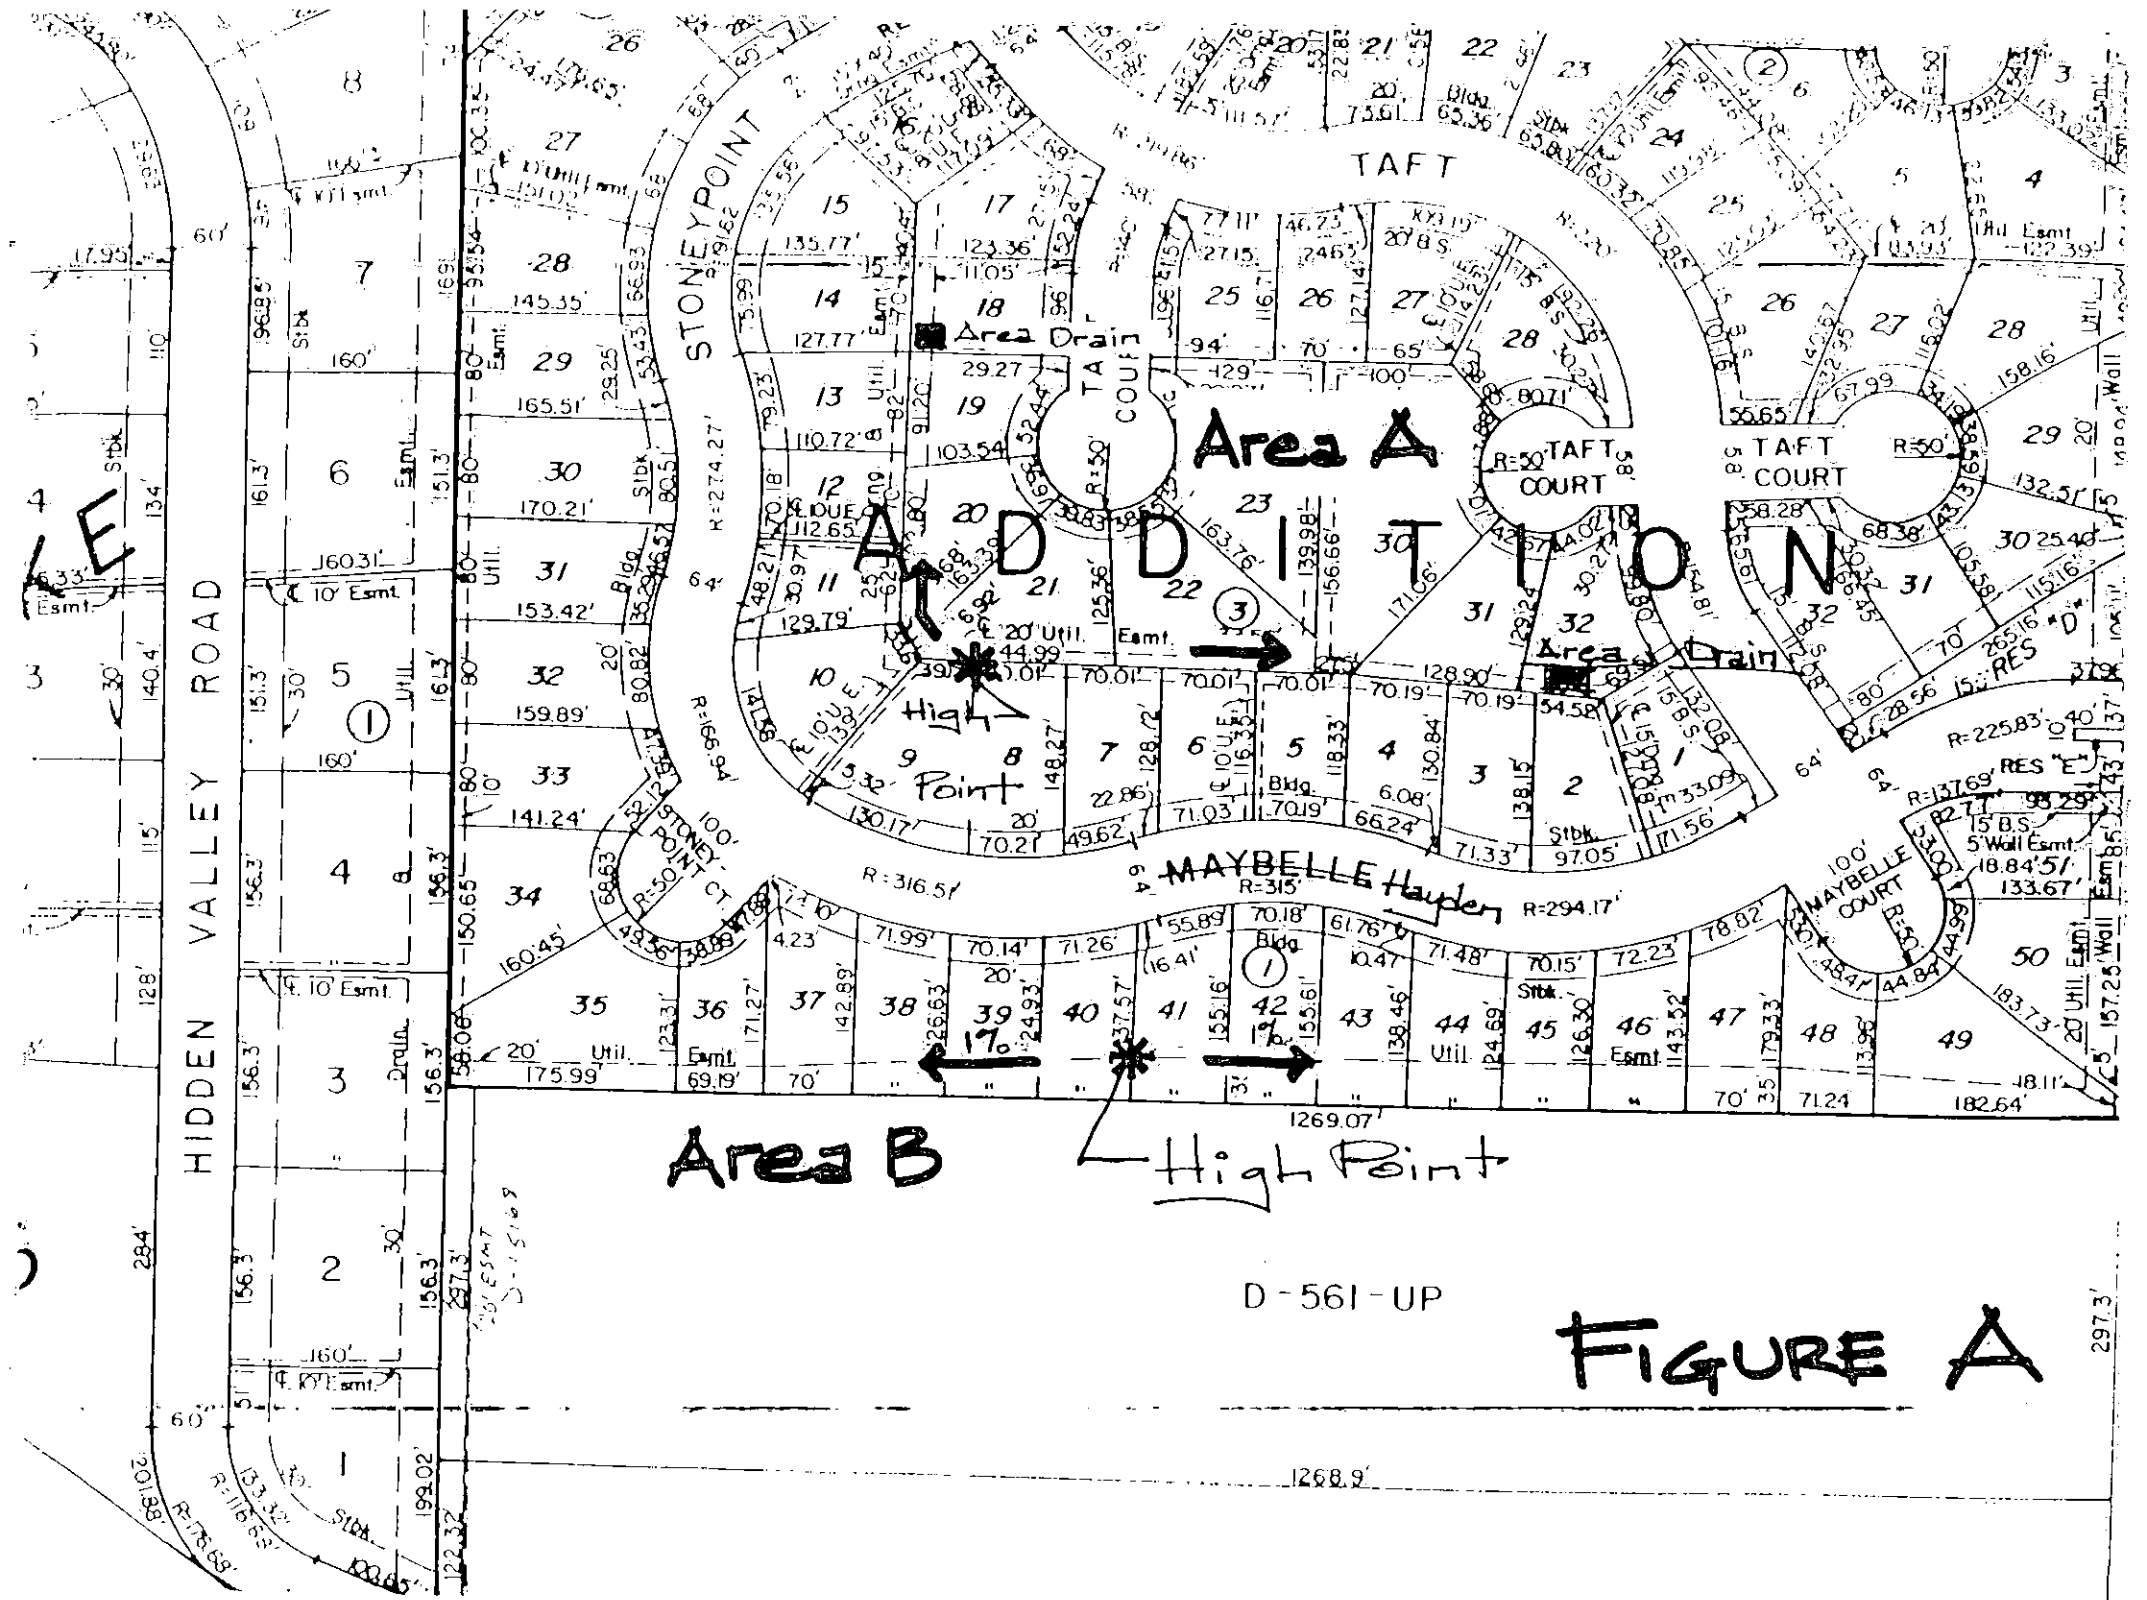
FIGURE A

One problem area (Area A) exists along the north property lines of lots 5 thru 9, Block 3. The problem then continues north along the east property lines of lots 10 thru 12. A second problem area (Area B) exists along the south property lines of lots 36 thru 40 and lots 43 thru 49, Block 1.

The plat and drainage plans for the Addition were prepared by Poe & Associates, Civil Engineers of Wichita. For Area A, the drainage plan exhibits a high point between lots 8 and 9. From the northwest corner of lot 8, drainage is designed to flow east at a 1% slope to an area drain at the rear of lot 32. Running northwesterly then north from the high point the drainage is designed to flow at a 1% slope to an area drain at the southwest corner of lot 18. For Area B, the drainage plan exhibits a high point between lots 40 and 41. Drainage flows east and west in a swale along the easement line north of the south property line. A 1% slope is designed for lots 36 thru 46 and lots 47 and 48 are slightly less at 0.85% and .84% respectively. At the time of original development, the drainage plan was designed to meet current City regulations. Recent revisions to the City's subdivision regulations require a 1% minimum slope for drainage runoff. Figure A shows the planned pattern of the drainage plan for these two areas.

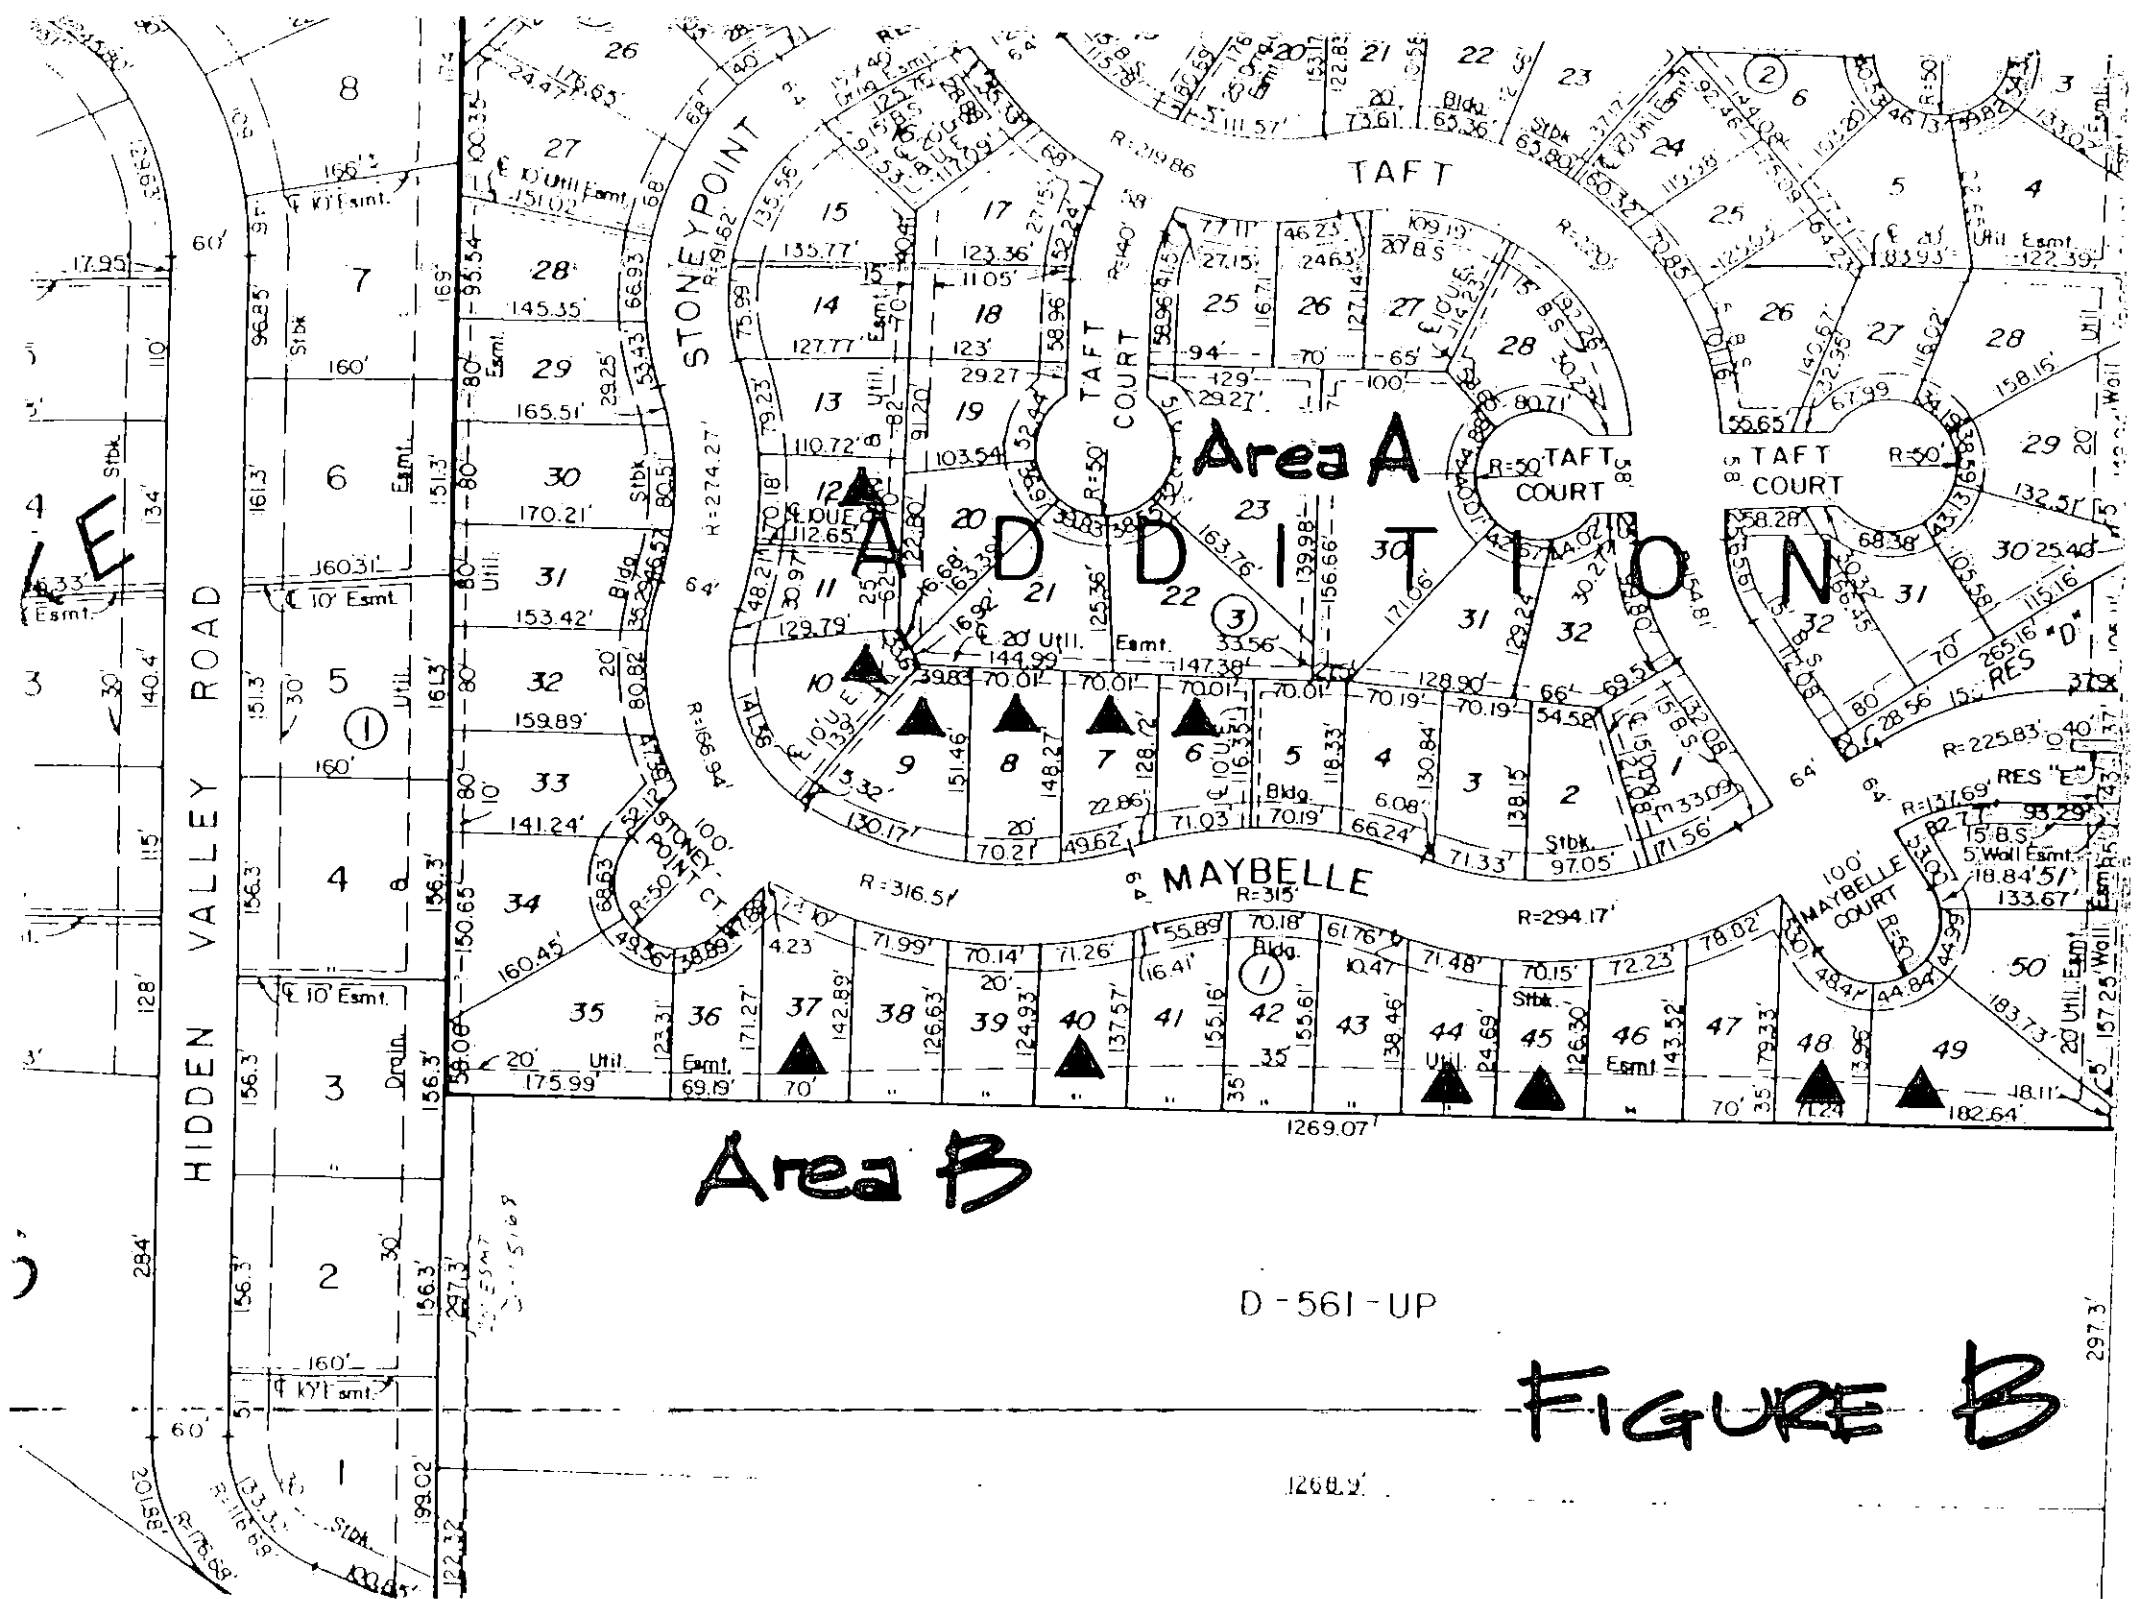
FIGURE B

The varied slopes shown in the existing conditions indicates there are drainage problems. Most slopes less than 1.0 % and several flat areas will cause slow drainage and ponding. If the slopes are studied between existing conditions and the planned drainage it is possible to examine the problem more broadly. For area A, from the high point northward to the area drain on lot 18 there would be a 0.93 % if existing conditions in between were not considered. This is close to the planned drainage. Going east from the high point the drainage is only at 0.62% to the northeast corner of lot 5. Note that the grade shot there was taken at the general low point along the fence which would be the drainage flow once the soil is removed from the bottom of the fence. Further grade shots would need to be taken to relate to the area drain to the east.

For area B, from the high point west to the southwest corner of lot 37 the slope is 0.67%. If the slope is taken from the existing elevation at the southwest corner of lot 40 west to the same corner of lot 37 the slope increases to 1.05%. From the southwest corner of lot 44 to the southeast corner of lot 47 the slope is 1.02%. Further analysis such as this along with the sequence of grading work for lots could be done to understand why 1.0% grades were not achieved uniformly as planned. This would not be practical now because improvements exist which limit the possibility of going back and regrading the subdivision throughout all of these problem areas.

While it would be ideal to regrade the problem areas to conform to the drainage plan it is not practical due to the improvements along rear lot lines made by homeowners. These improvements include grass, irrigation systems, swimming pools, fences and ornamental landscaping. It is important to note that all of these improvements were made by homeowners following grading and drainage work established by the builder. Due to the improvements in place, it is recommended that a system of area drains and French drains be implemented to solve the drainage problems of all lots which stand water after rains or irrigation use and have slope gradients of less than 1%. Figure B exhibits these lots. This work will require minor regrading and repairs to irrigation systems, lawn areas and perhaps damaged utility lines. To avoid adverse impact to adjacent lots by dumping drainage water from effected lots, it is recommended that underground drain pipes be extended to the area drains in place. Slopes of 2% minimum are recommended for regrading to new area drains and French drains on lots.

An estimate of cost to install drain lines would be \$700 to \$1050 per lot. Typical costs for installation run \$10 to \$15 per lineal foot. There would be additional cost for repair work, extending lines across neighbors' lots and engineering fees.

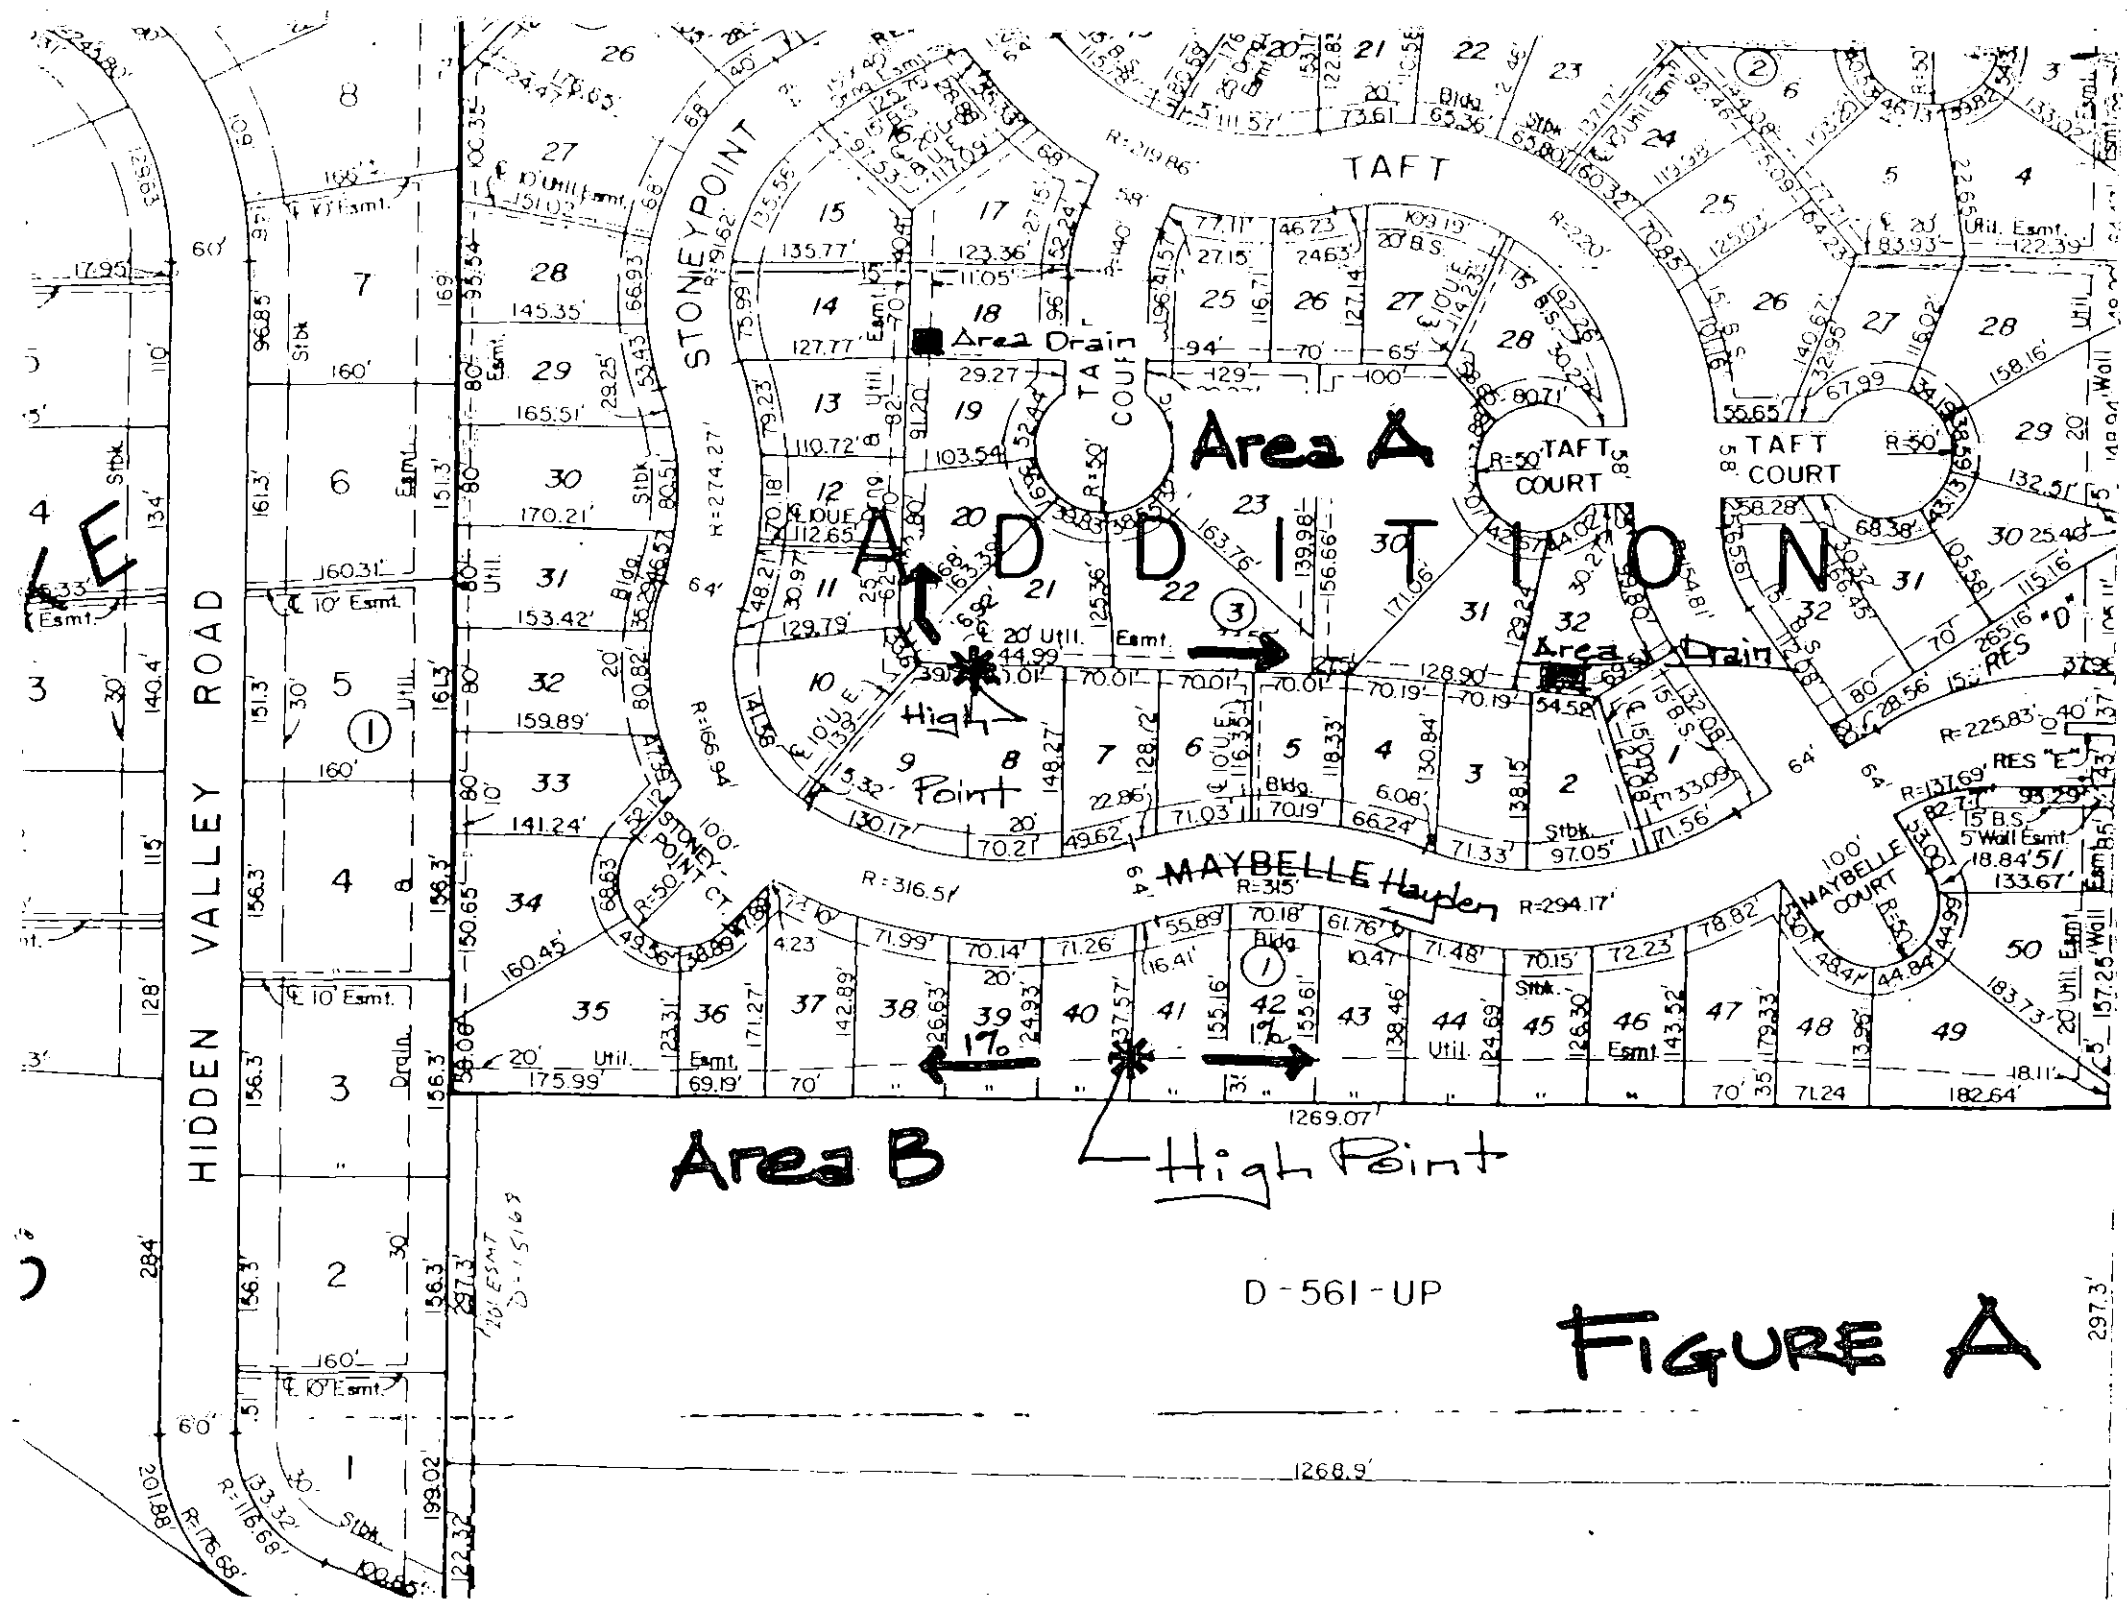
**FIGURE A**

One problem area (Area A) exists along the north property lines of lots 5 thru 9, Block 3. The problem then continues north along the east property lines of lots 10 thru 12. A second problem area (Area B) exists along the south property lines of lots 36 thru 40 and lots 43 thru 49, Block 1.

The plat and drainage plans for the Addition were prepared by Poe & Associates, Civil Engineers of Wichita. For Area A, the drainage plan exhibits a high point between lots 8 and 9. From the northwest corner of lot 8, drainage is designed to flow east at a 1% slope to an area drain at the rear of lot 32. Running northwesterly then north from the high point the drainage is designed to flow at a 1% slope to an area drain at the southwest corner of lot 18. For Area B, the drainage plan exhibits a high point between lots 40 and 41. Drainage flows east and west in a swale along the easement line north of the south property line. A 1% slope is designed for lots 36 thru 46 and lots 47 and 48 are slightly less at 0.85% and .84% respectively. At the time of original development, the drainage plan was designed to meet current City regulations. Recent revisions to the City's subdivision regulations require a 1% minimum slope for drainage runoff. Figure A shows the planned pattern of the drainage plan for these two areas.

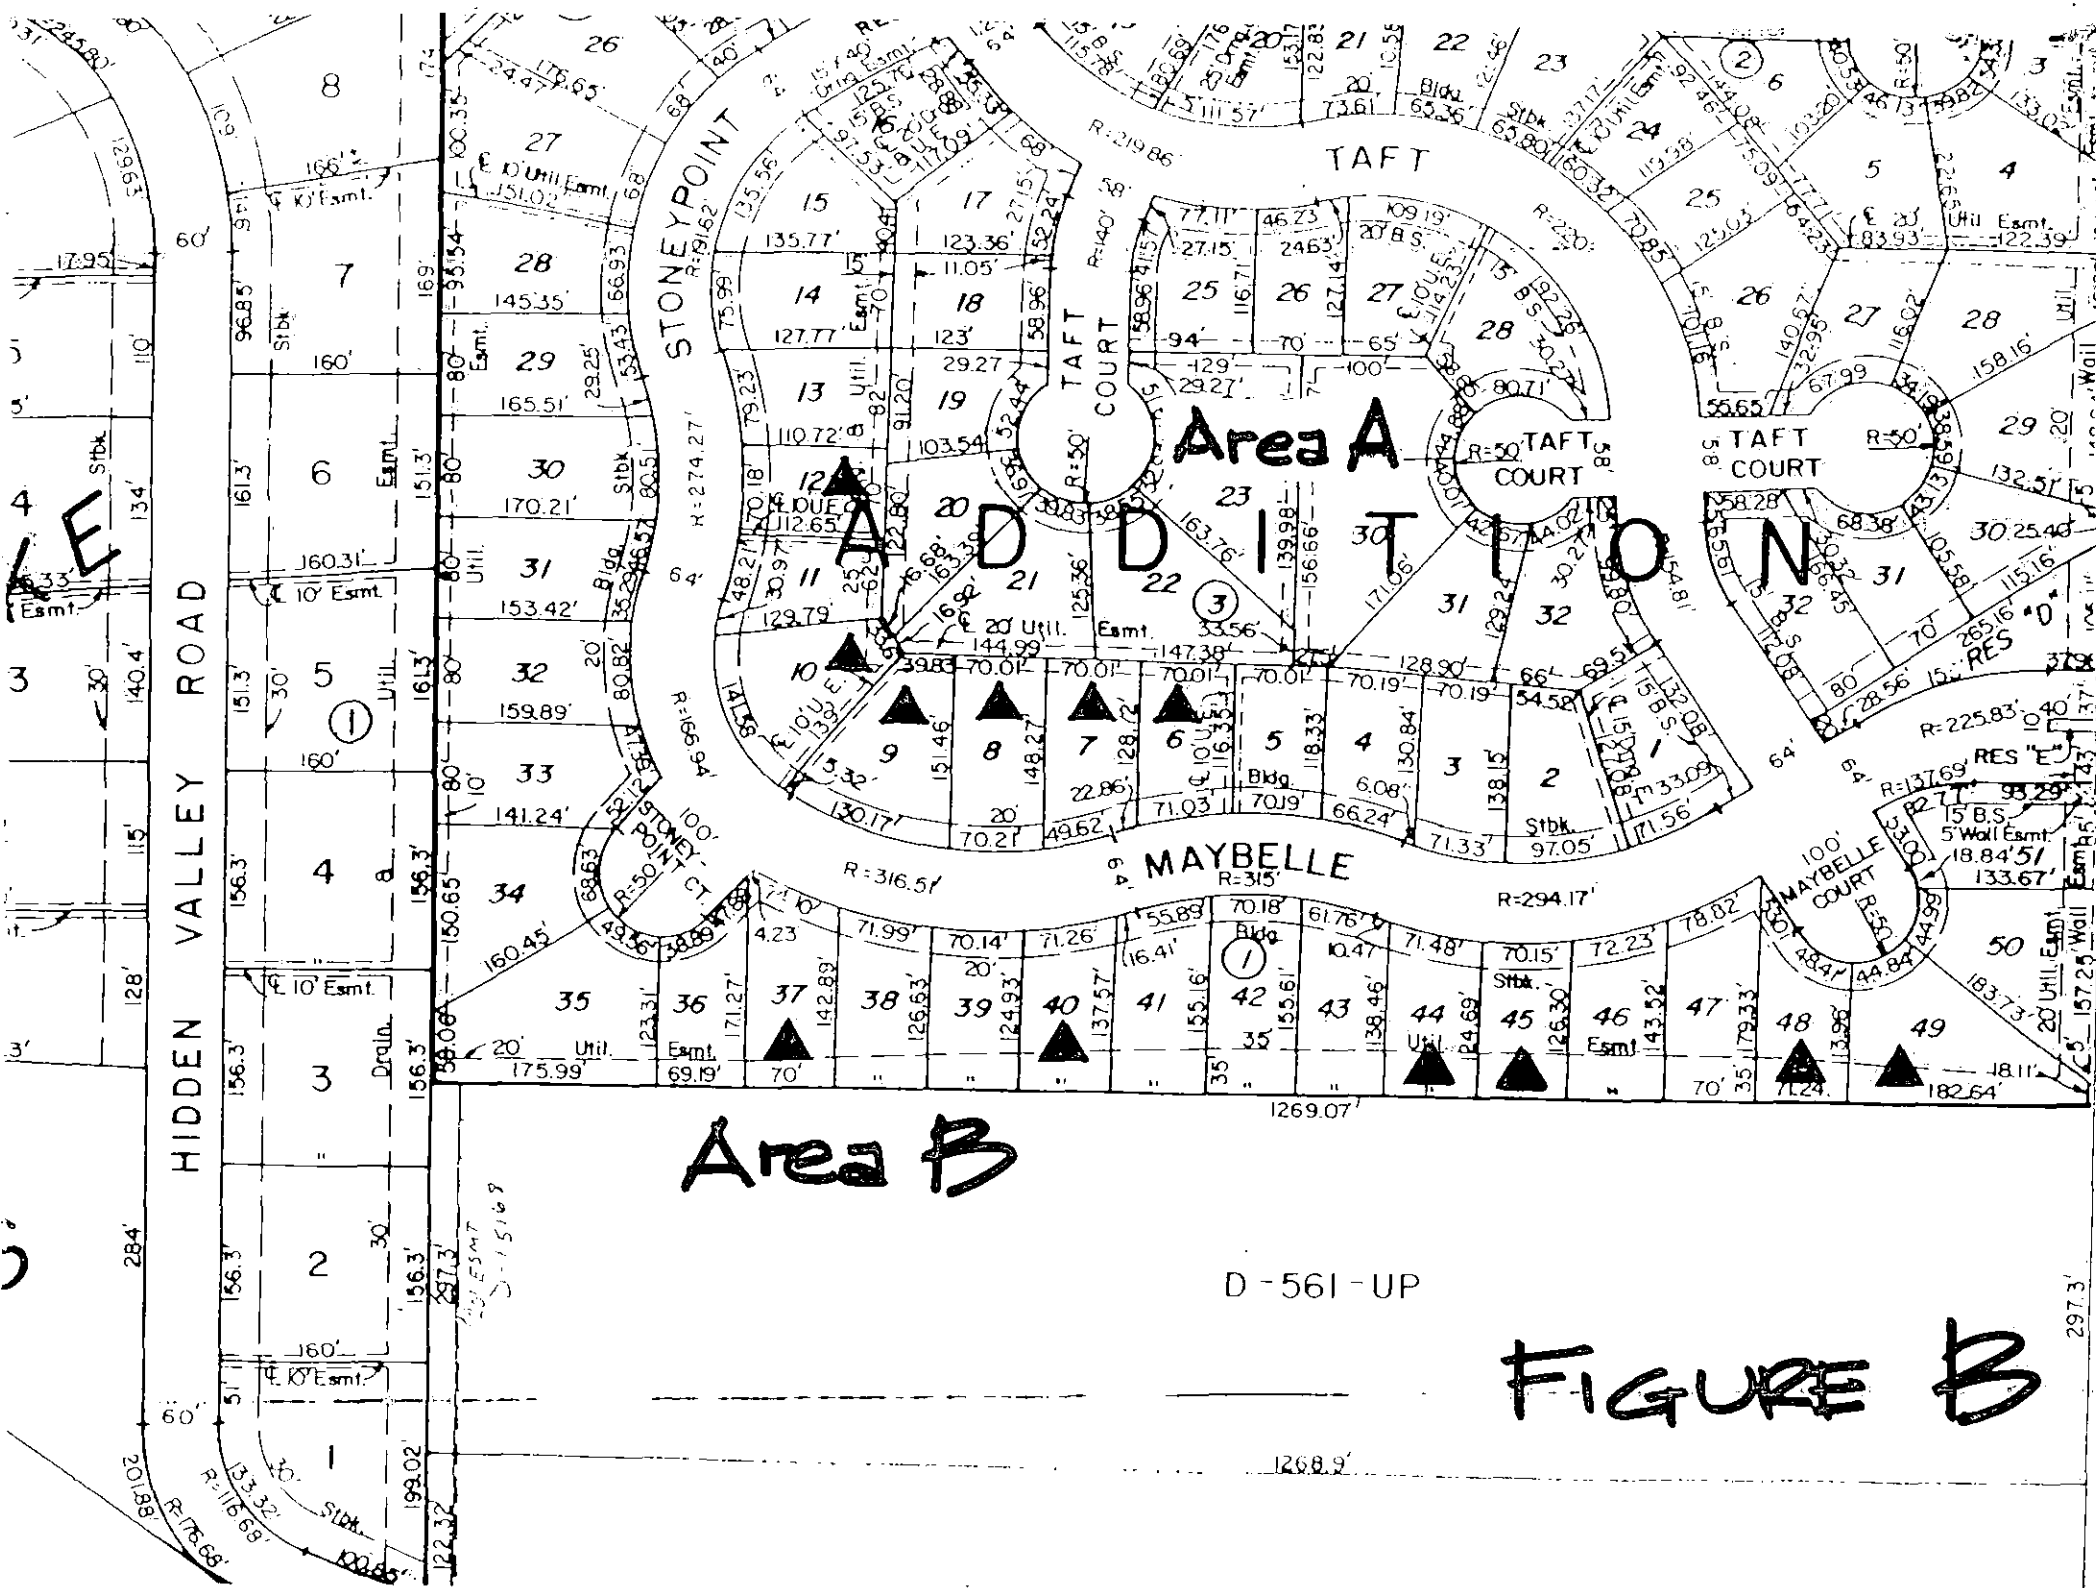
**FIGURE B**

The varied slopes shown in the existing conditions indicates there are drainage problems. Most slopes less than 1.0 % and several flat areas will cause slow drainage and ponding. If the slopes are studied between existing conditions and the planned drainage it is possible to examine the problem more broadly. For area A, from the high point northward to the area drain on lot 18 there would be a 0.93 % if existing conditions in between were not considered. This is close to the planned drainage. Going east from the high point the drainage is only at 0.62% to the northeast corner of lot 5. Note that the grade shot there was taken at the general low point along the fence which would be the drainage flow once the soil is removed from the bottom of the fence. Further grade shots would need to be taken to relate to the area drain to the east.

For area B, from the high point west to the southwest corner of lot 37 the slope is 0.67%. If the slope is taken from the existing elevation at the southwest corner of lot 40 west to the same corner of lot 37 the slope increases to 1.05%. From the southwest corner of lot 44 to the southeast corner of lot 47 the slope is 1.02%. Further analysis such as this along with the sequence of grading work for lots could be done to understand why 1.0% grades were not achieved uniformly as planned. This would not be practical now because improvements exist which limit the possibility of going back and regrading the subdivision throughout all of these problem areas.

While it would be ideal to regrade the problem areas to conform to the drainage plan it is not practical due to the improvements along rear lot lines made by homeowners. These improvements include grass, irrigation systems, swimming pools, fences and ornamental landscaping. It is important to note that all of these improvements were made by homeowners following grading and drainage work established by the builder. Due to the improvements in place, it is recommended that a system of area drains and French drains be implemented to solve the drainage problems of all lots which stand water after rains or irrigation use and have slope gradients of less than 1%. Figure B exhibits these lots. This work will require minor regrading and repairs to irrigation systems, lawn areas and perhaps damaged utility lines. To avoid adverse impact to adjacent lots by dumping drainage water from effected lots, it is recommended that underground drain pipes be extended to the area drains in place. Slopes of 2% minimum are recommended for regrading to new area drains and French drains on lots.

An estimate of cost to install drain lines would be \$700 to \$1050 per lot. Typical costs for installation run \$10 to \$15 per lineal foot. There would be additional cost for repair work, extending lines across neighbors' lots and engineering fees.

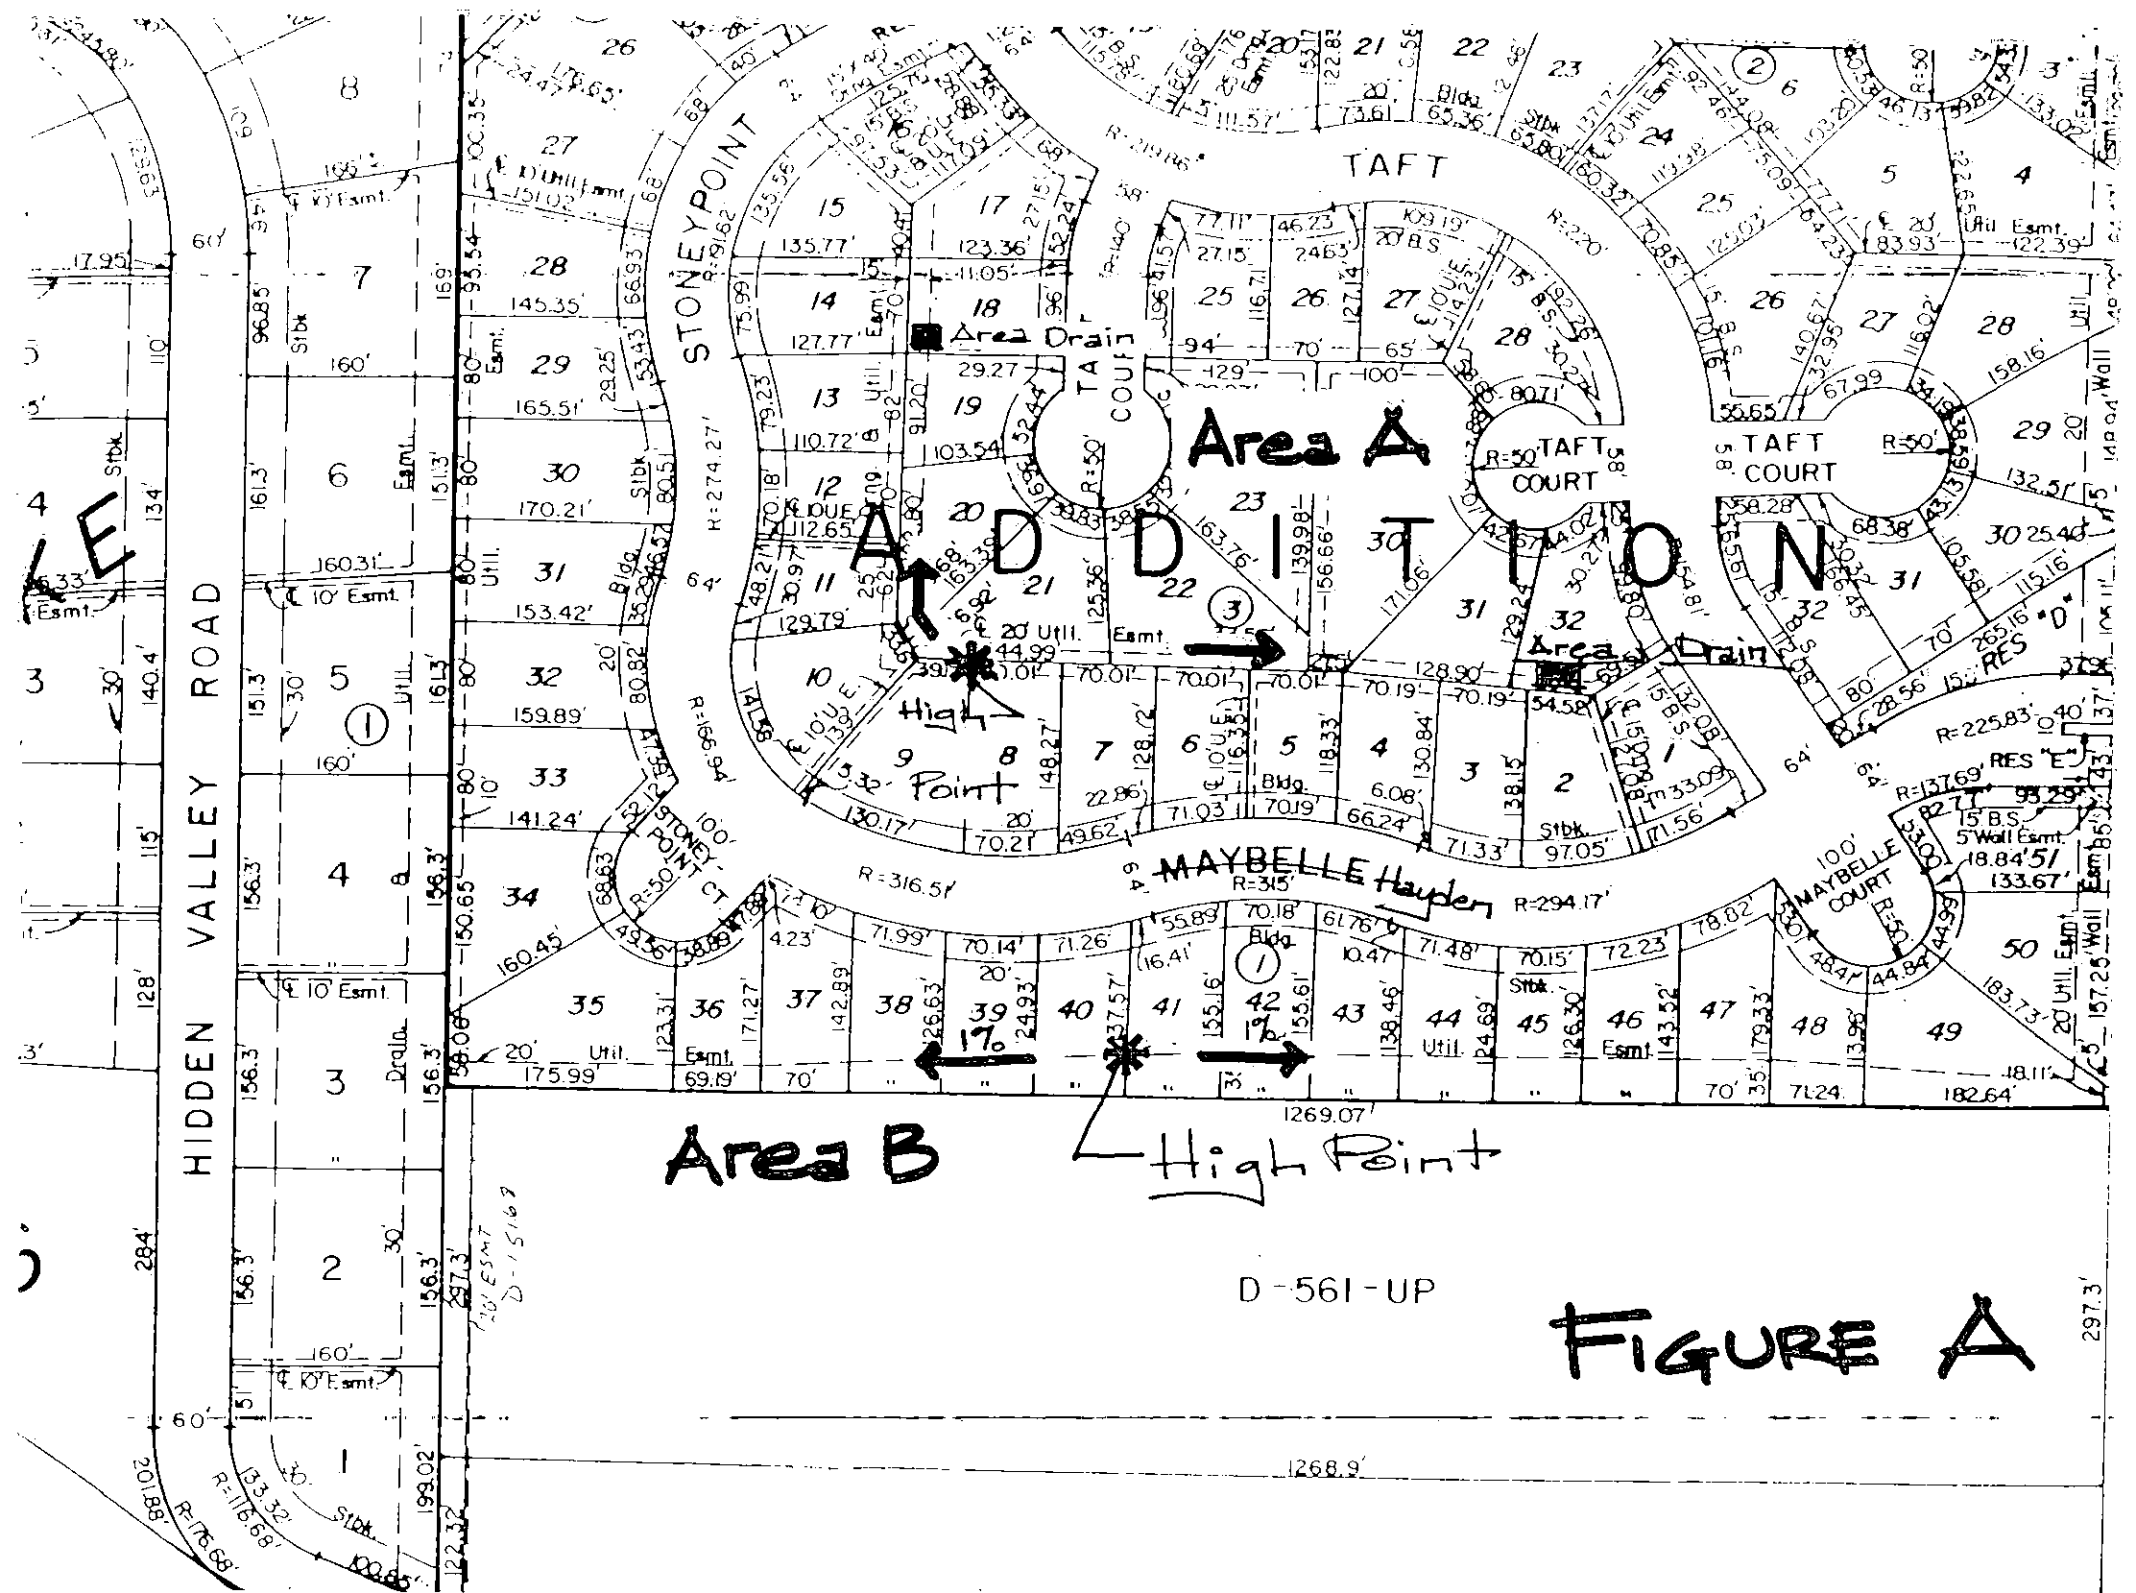
FIGURE A

One problem area (Area A) exists along the north property lines of lots 5 thru 9, Block 3. The problem then continues north along the east property lines of lots 10 thru 12. A second problem area (Area B) exists along the south property lines of lots 36 thru 40 and lots 43 thru 49, Block 1.

The plat and drainage plans for the Addition were prepared by Poe & Associates, Civil Engineers of Wichita. For Area A, the drainage plan exhibits a high point between lots 8 and 9. From the northwest corner of lot 8, drainage is designed to flow east at a 1% slope to an area drain at the rear of lot 32. Running northwesterly then north from the high point the drainage is designed to flow at a 1% slope to an area drain at the southwest corner of lot 18. For Area B, the drainage plan exhibits a high point between lots 40 and 41. Drainage flows east and west in a swale along the easement line north of the south property line. A 1% slope is designed for lots 36 thru 46 and lots 47 and 48 are slightly less at 0.85% and .84% respectively. At the time of original development, the drainage plan was designed to meet current City regulations. Recent revisions to the City's subdivision regulations require a 1% minimum slope for drainage runoff. Figure A shows the planned pattern of the drainage plan for these two areas.
