**From:** CHERCHES  
**Sent:** Wednesday, October 13, 1999 3:22 PM  
**To:** LACKEY\_S  
**Cc:** CARRIER\_C; LINDEBAK\_M; SCHROEDER\_K; HOLDEMAN\_C  
**Subject:** Cambridge homeowners assoc.

# CAMBRIDGE/LEXINGTON HOMEOWNER'S ASSOCIATION

This report notes background information, existing conditions, provides an analysis and makes recommendations concerning drainage patterns for two areas in the Lexington Addition. These two areas show conditions of poor drainage due to slow runoff and ponding of drainage water. In effect, these conditions have created tension among impacted neighbors and "finger pointing" as to who is responsible for the situation.

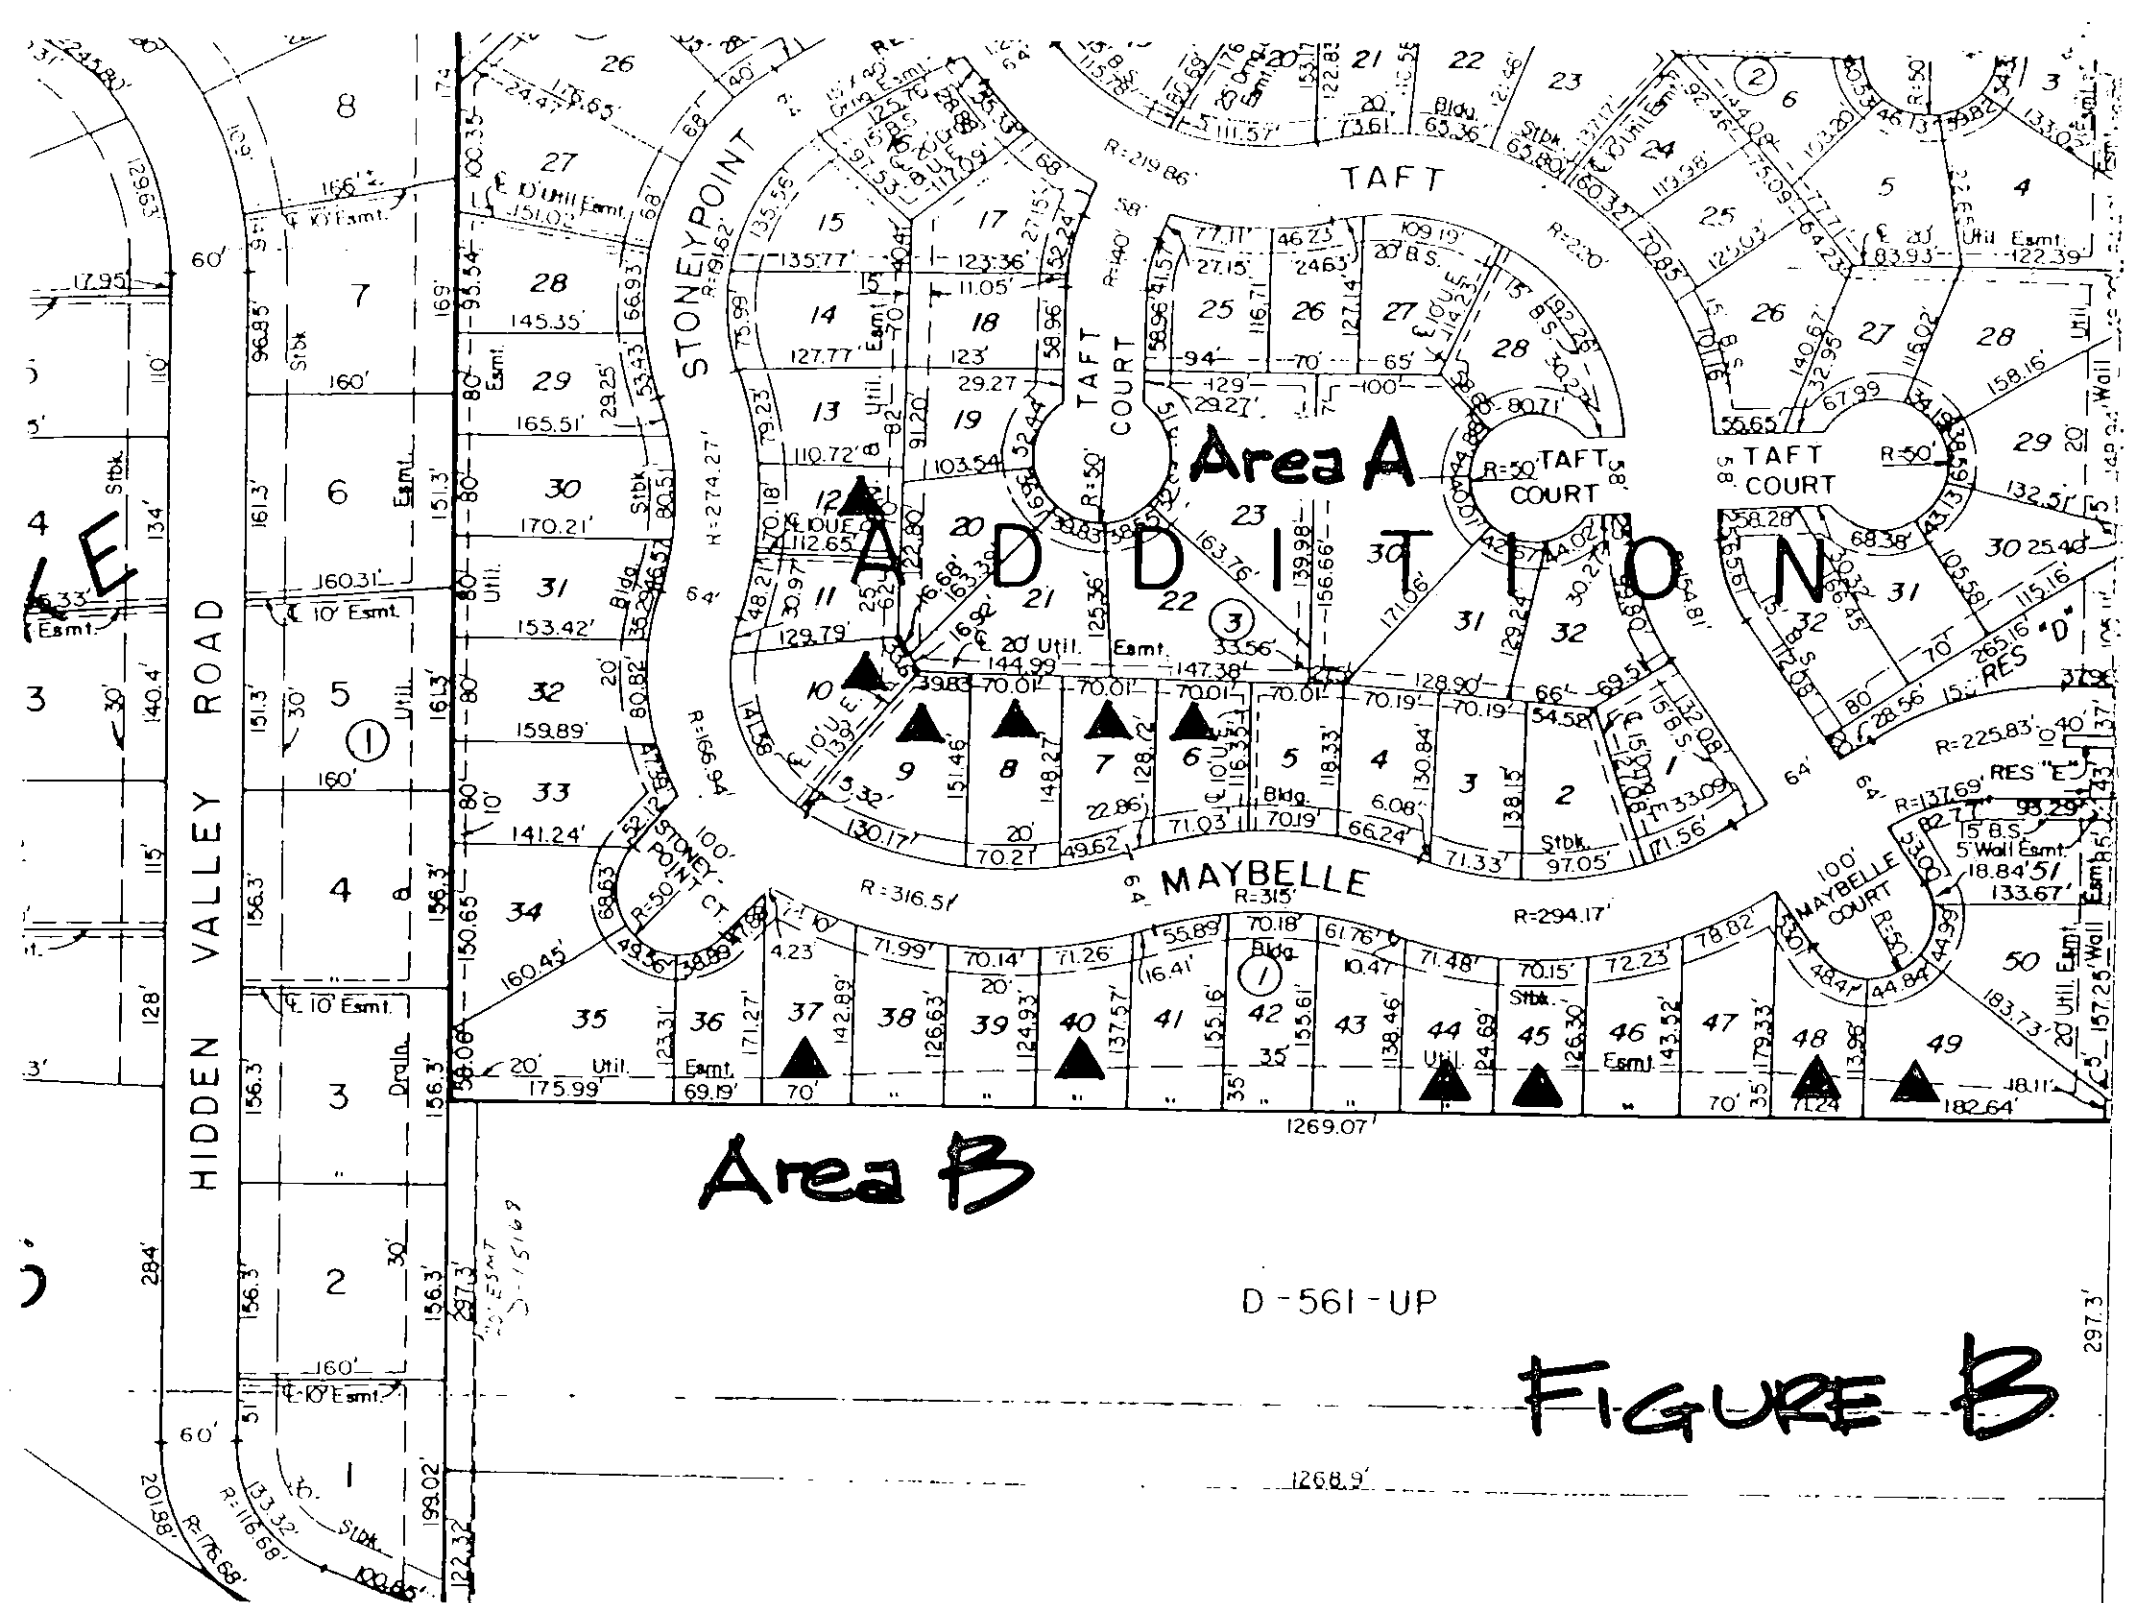
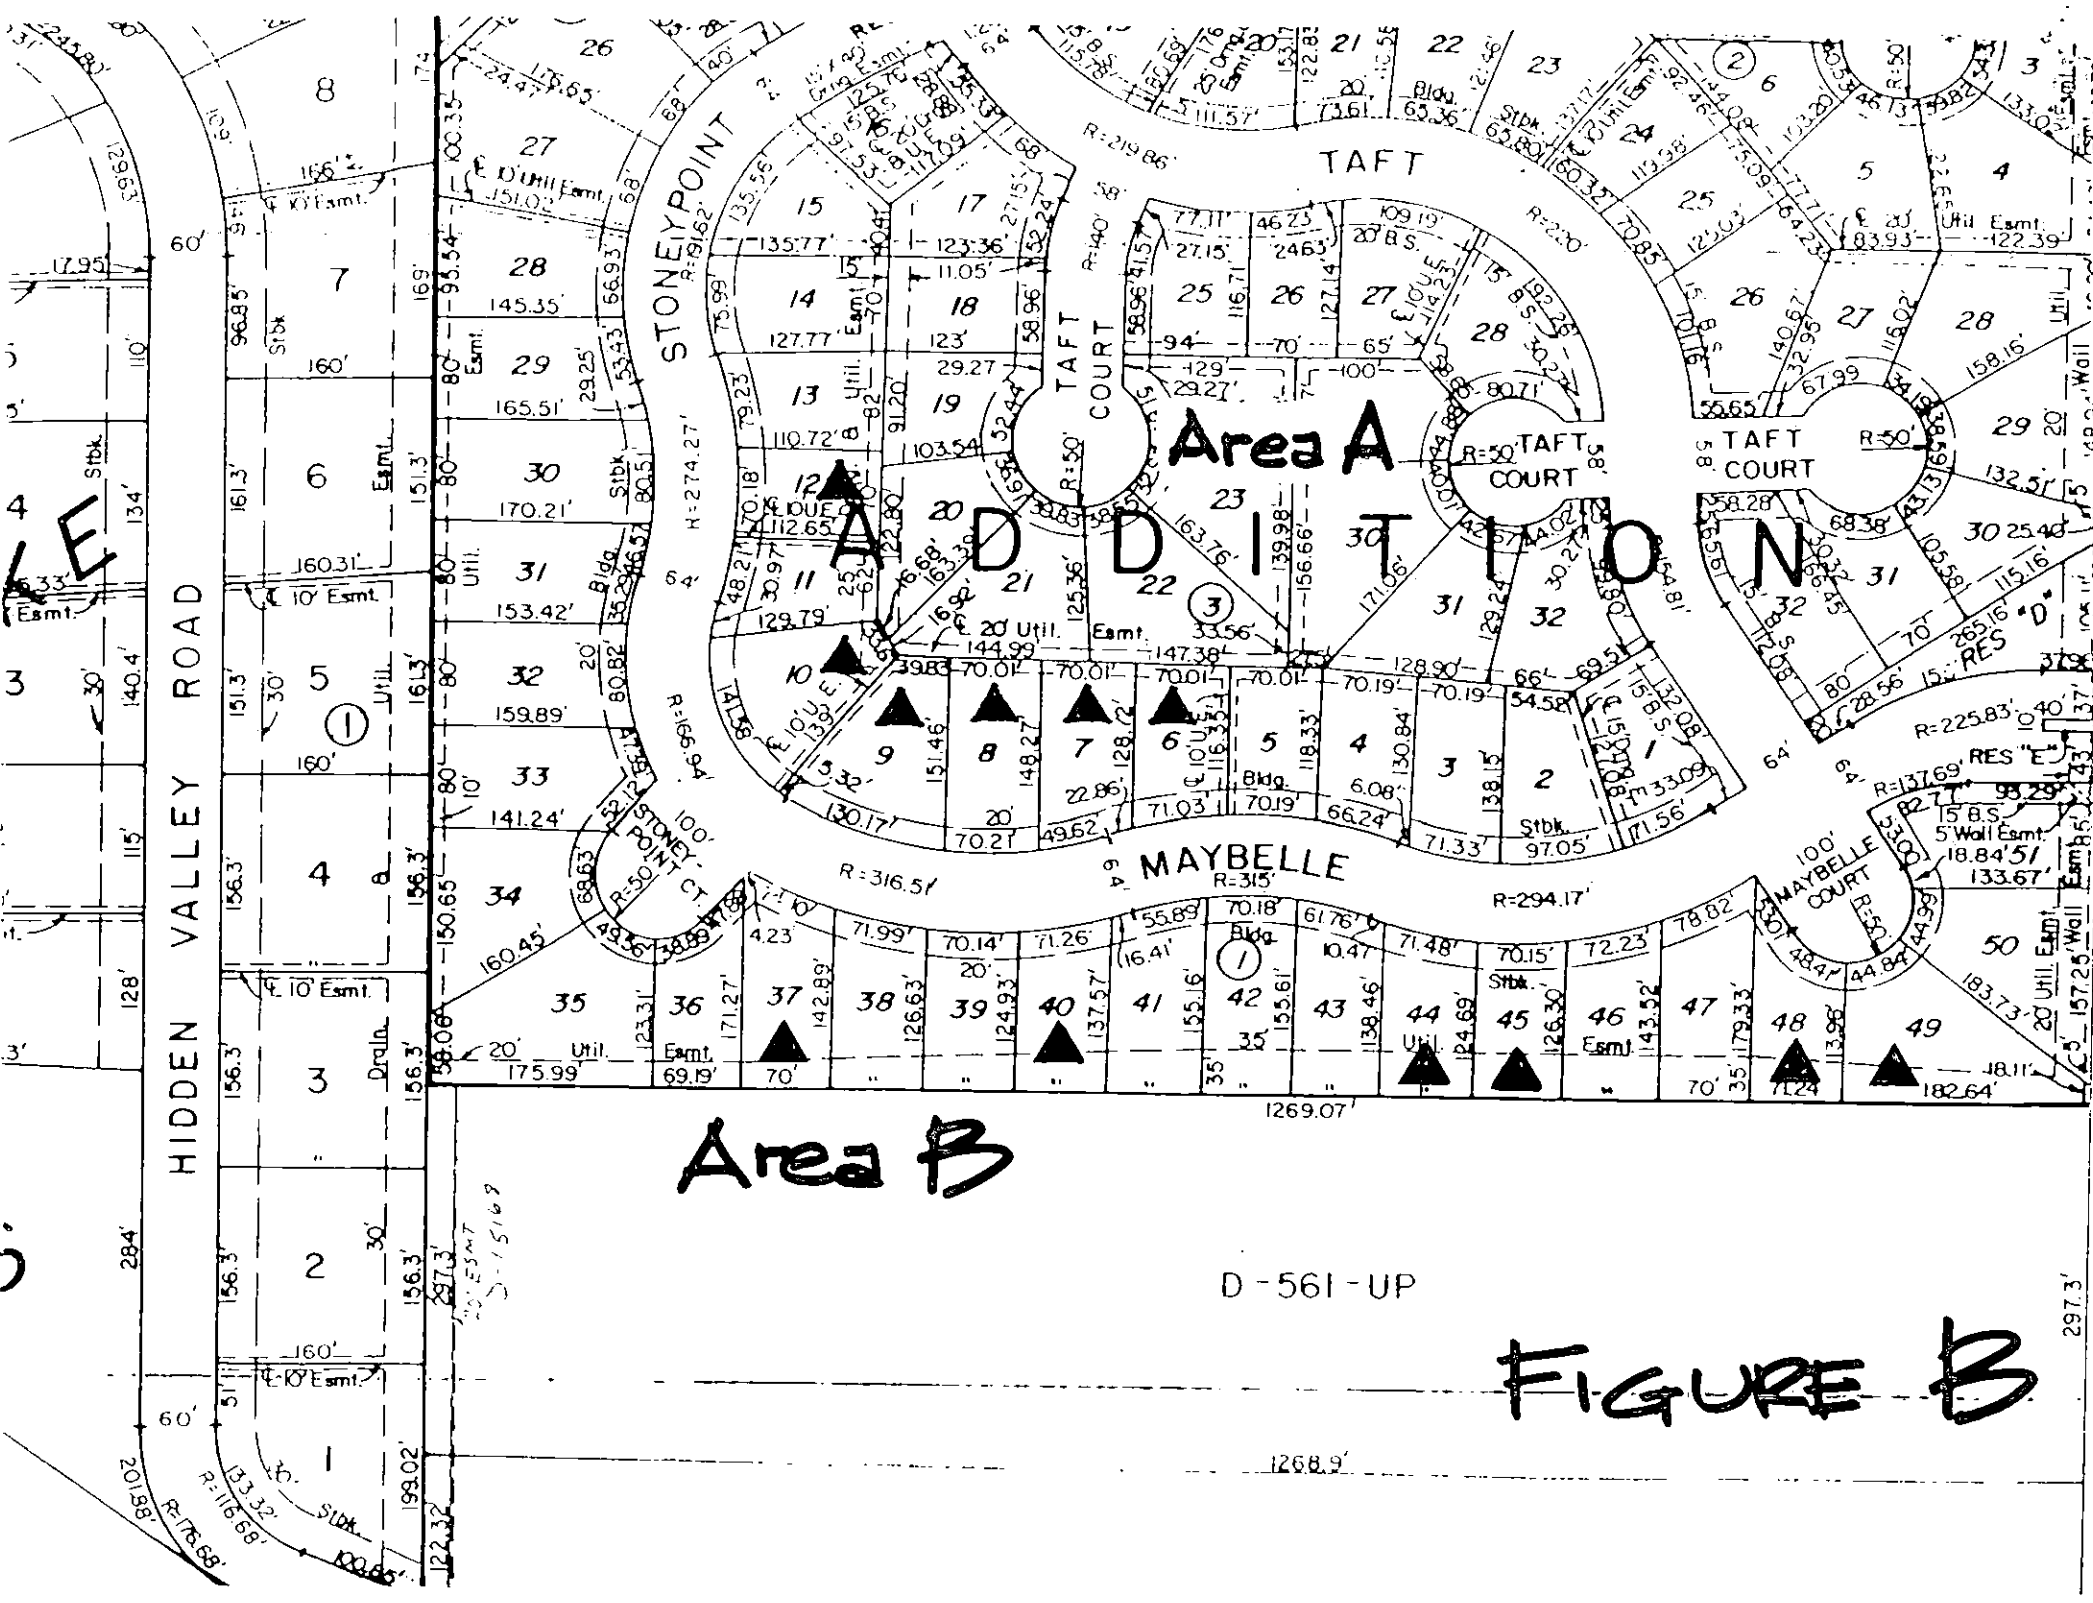
The varied slopes shown in the existing conditions indicates there are drainage problems. Most slopes less than 1.0 % and several flat areas will cause slow drainage and ponding. If the slopes are studied between existing conditions and the planned drainage it is possible to examine the problem more broadly. For area A, from the high point northward to the area drain on lot 18 there would be a 0.93 % if existing conditions in between were not considered. This is close to the planned drainage. Going east from the high point the drainage is only at 0.62% to the northeast corner of lot 5. Note that the grade shot there was taken at the general low point along the fence which would be the drainage flow once the soil is removed from the bottom of the fence. Further grade shots would need to be taken to relate to the area drain to the east.

While it would be ideal to regrade the problem areas to conform to the drainage plan it is not practical due to the improvements along rear lot lines made by homeowners. These improvements include grass, irrigation systems, swimming pools, fences and ornamental landscaping. It is important to note that all of these improvements were made by homeowners following grading and drainage work established by the builder. Due to the improvements in place, it is recommended that a system of area drains and French drains be implemented to solve the drainage problems of all lots which stand water after rains or irrigation use and have slope gradients of less than 1%. Figure B exhibits these lots. This work will require minor regrading and repairs to irrigation systems, lawn areas and perhaps damaged utility lines. To avoid adverse impact to adjacent lots by dumping drainage water from effected lots, it is recommended that underground drain pipes be extended to the area drains in place. Slopes of 2% minimum are recommended for regrading to new area drains and French drains on lots.

An estimate of cost to install drain lines would be \$700 to \$1050 per lot. Typical costs for installation run \$10 to \$15 per lineal foot. There would be additional cost for repair work, extending lines across neighbors' lots and engineering fees.
